UNITED STATES
DEPARTMENT OF LABOR
MINE SAFETY AND HEALTH ADMINISTRATION

REPORT OF INVESTIGATION

Fatal Powered Haulage Accident
May 2, 2023

Plant 280
Bowes Construction Inc
Brookings, Brookings County, South Dakota
ID No. 39-01505

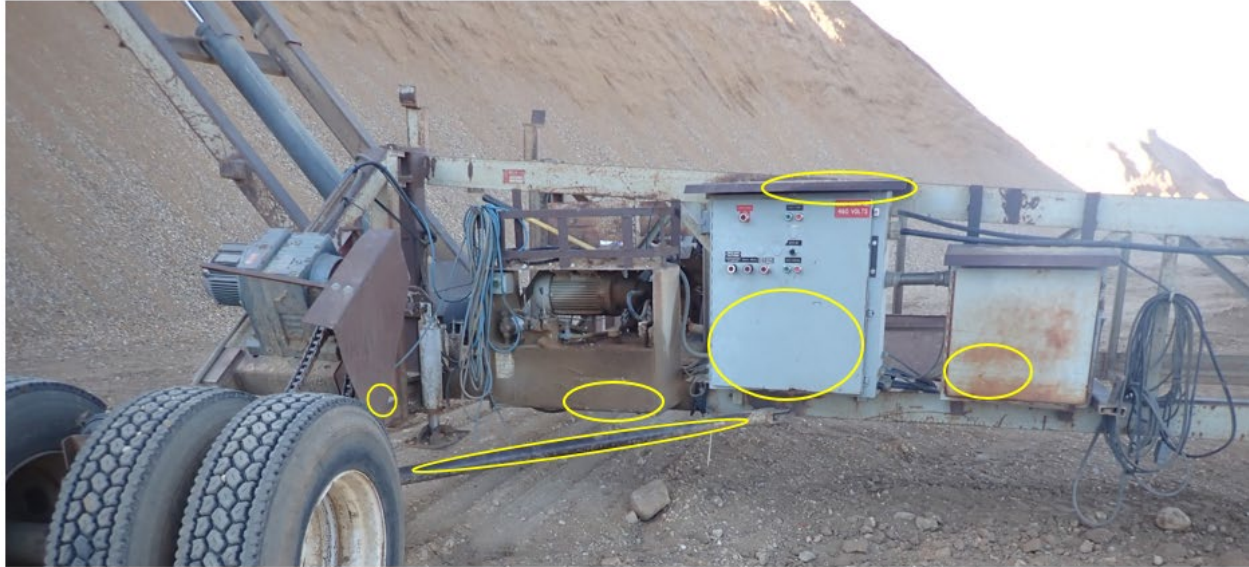
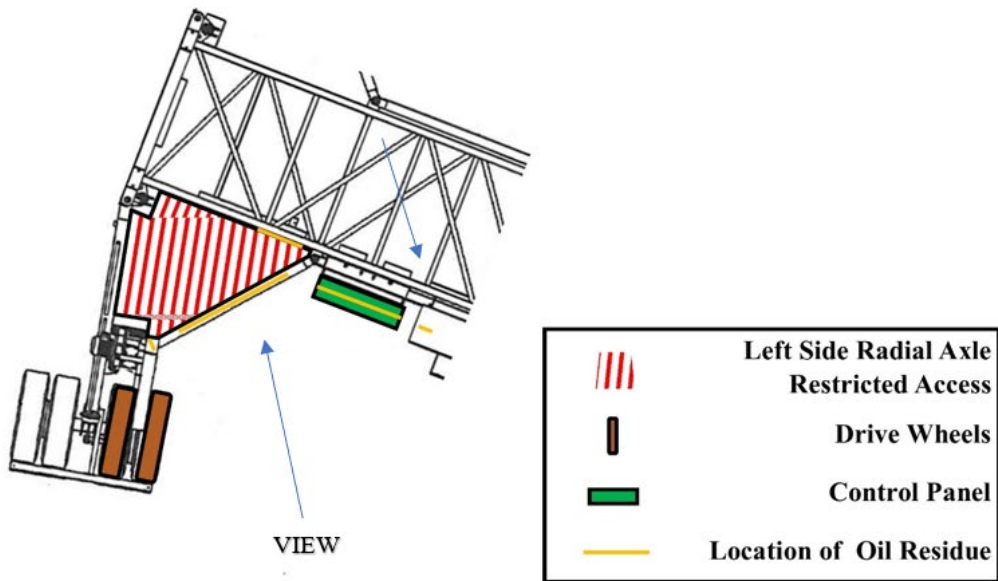
APPENDIX C – Penetrating Oil Residue Location

The accident occurred at the plant's radial stacker, located on the north end of the mine (see Appendix B). Interviews revealed that Waddel found Wixon with a crushed can of penetrating oil at his side. A pattern of oily residue distributed throughout the left side radial axle restricted access area indicates the location of the accident (see Appendix C). The manufacturer designed the area to allow miners to have access to the controls for the hydraulic jacking cylinders while the radial stacker was not in motion. The radial axle support, the left radial axle arm, the undercarriage, and the left radial arm locking bar enclose the left side radial drive access area, with no signage or conspicuous markings to warn against entry into this area when the equipment is operating. To travel into the area, a miner must step on or over the left radial arm locking bar which is approximately eight feet long and 19 inches above grade.

Location of oil residue

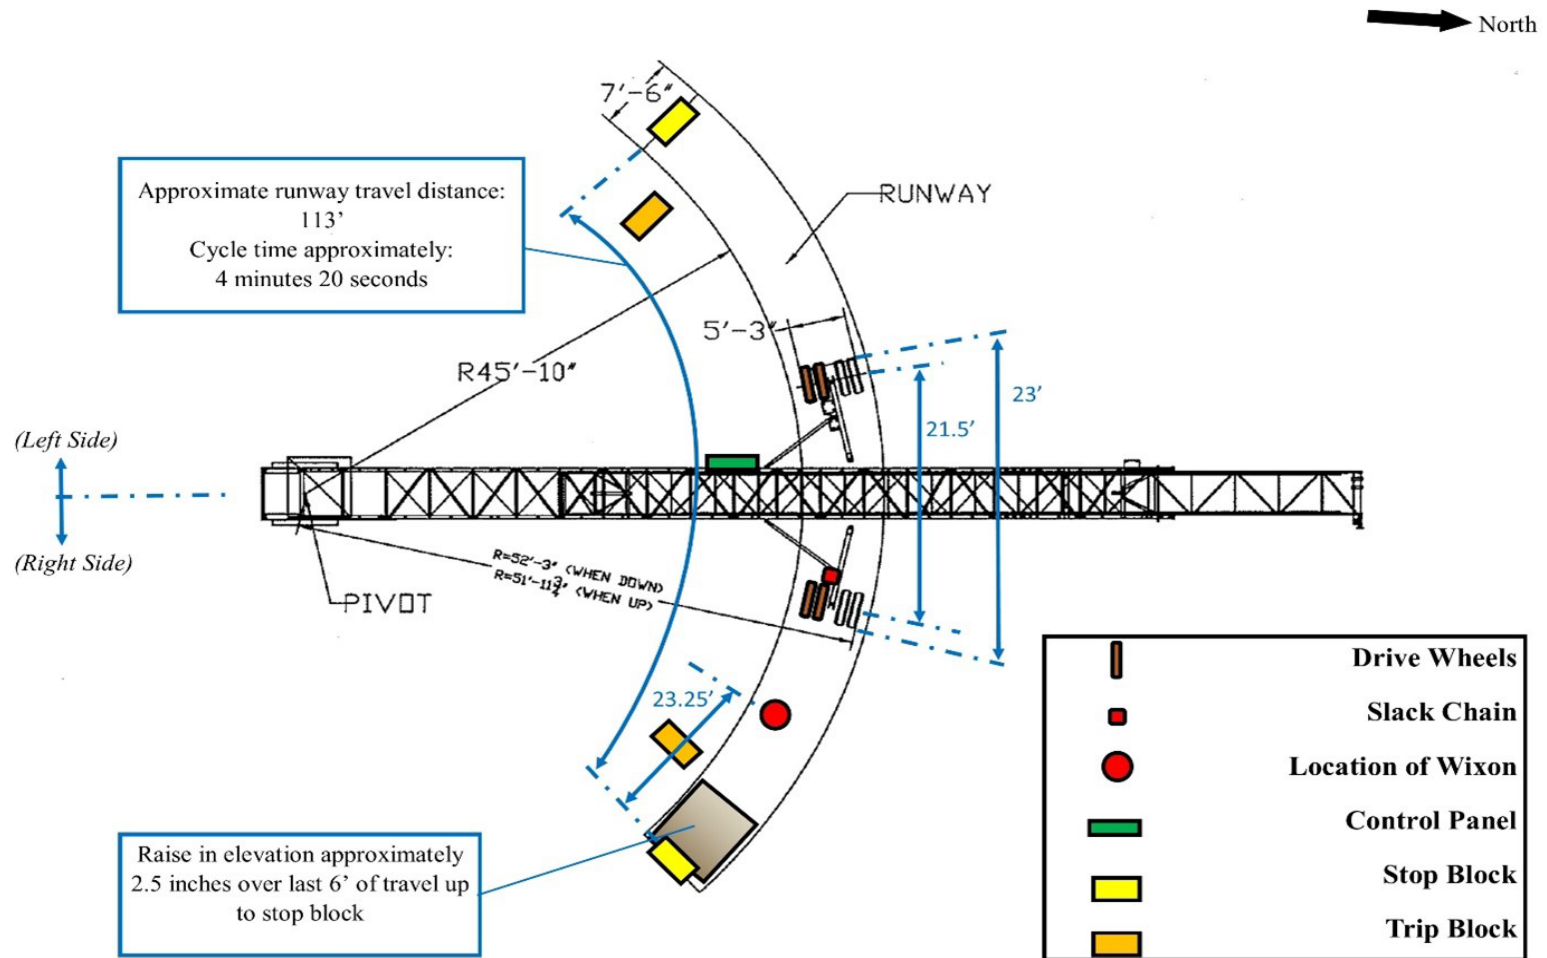
APPENDIX D – Aerial Diagram Radial Stacker Accident

Wixon was 23¼ feet from the east end of the radial stacker's travel runway, in line with the drive wheels, which corresponds with the left side radial drive restricted access area at the time of the accident (see Appendix D). Investigators determined the mine operator did not conspicuously mark this restricted area, which contributed to the accident.

Corrective Action: The mine operator has installed signage stating that left and right side drive tire areas adjacent to the respective drive tires prohibiting miners from accessing the stacker while in automated operation.

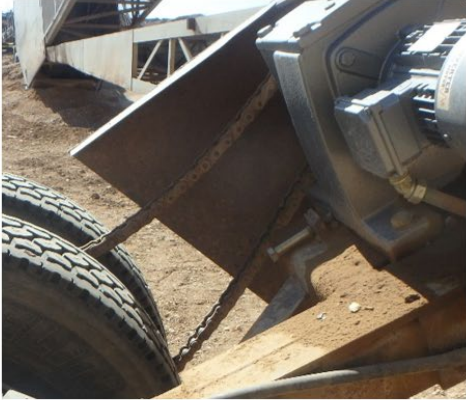
APPENDIX E – Examples of Excessive Right Side Drive Chain Slack

While Granum and Donald Bingham, Mechanic, demonstrated the automated functionality, investigators observed the right-side drive motor chain had excess slack. When movement produced tension on the top portion of the chain, the chain did not fall from the small upper

Drive chain resting without tension.

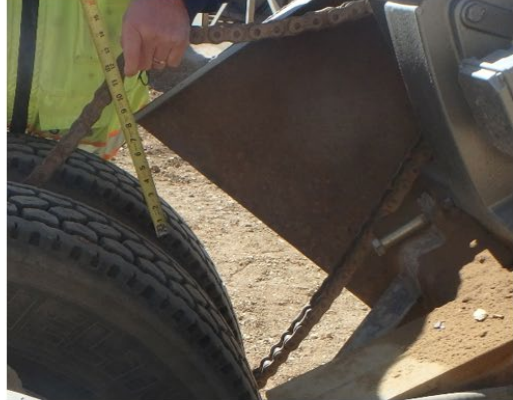
Drive chain slack approximately 14 inches.

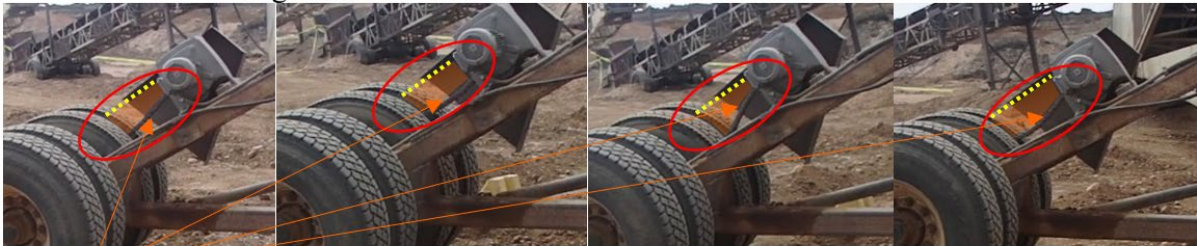
drive sprocket. This tendency to maintain contact with the small sprocket teeth allowed the chain to nearly wrap upon itself. When movement produced tension on the bottom portion of the chain, the upper portion produced a slapping action. This slack in the chain caused erratic motion of the right-side drive wheels (see Appendix E). Once the radial stacker was at rest, the deflection in the top portion of the chain measured approximately 14 inches. Investigators determined the mine operator did not maintain the right-side drive chain and keep the runway level at the time of the accident, both of which contributed to the accident.

Right hand Drive Chain reaction when bottom in tension.

Loose portion
of chain

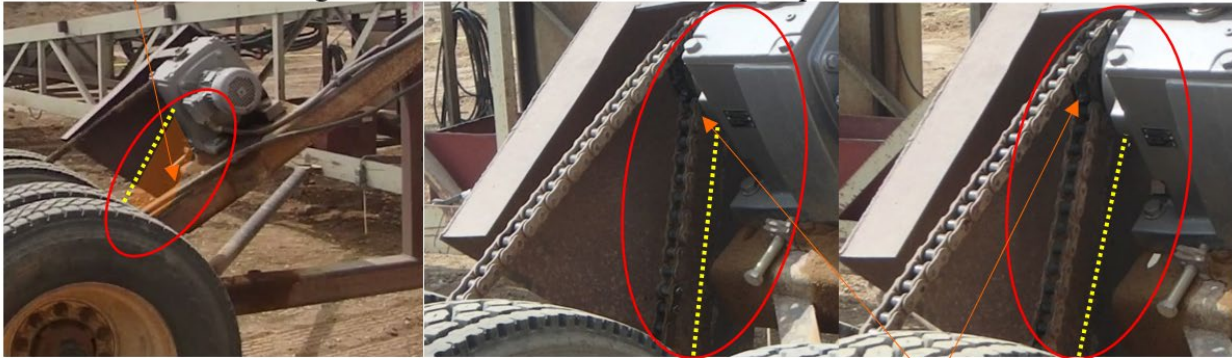
Right hand Drive Chain reaction when top in tension.

Loose portion
of chain riding
up cogs.

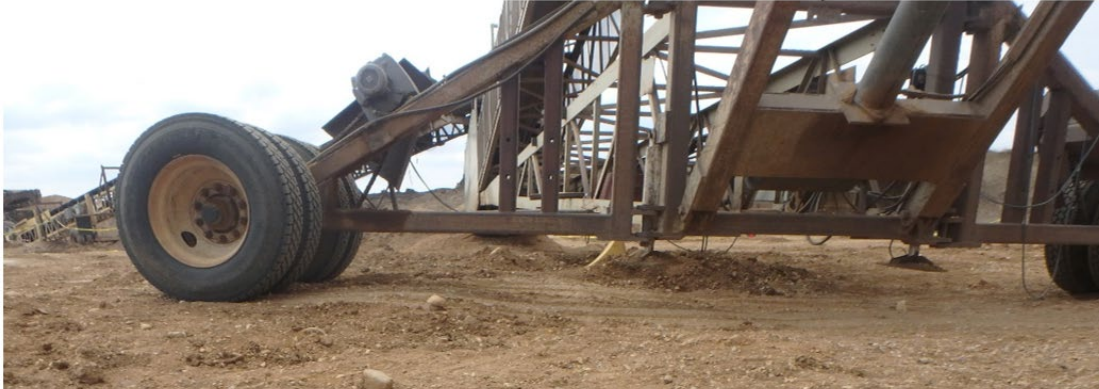
APPENDIX F – Uneven Ground at East End of Radial Stacker Runway Travel

The operation of the radial stacker demonstrated inconsistency between the wheel speeds along the runway which caused the wheels to dig into the ground. According to interviews, when the radial stacker no longer advanced, normal practice was to bump the radial stacker with the bucket of the skid steer loader and fill in the displaced material immediately with the skid steer's bucket. When investigators attempted to stop the radial stacker near the inclined area at the east end of the runway, the radial stacker stopped unreliably and rolled approximately six to 12 inches in an inconsistent direction correlating to which portion of the right-side drive chain had slack. At the east end of the runway, the final six feet inclines approximately 2½ inches. The operations manual states, "IMPORTANT – The "runway" for the radial wheels must be level."

Radial stacker at east end of travel in runway.

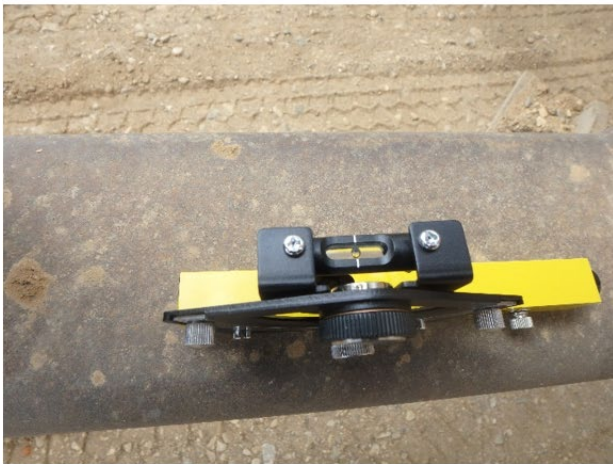
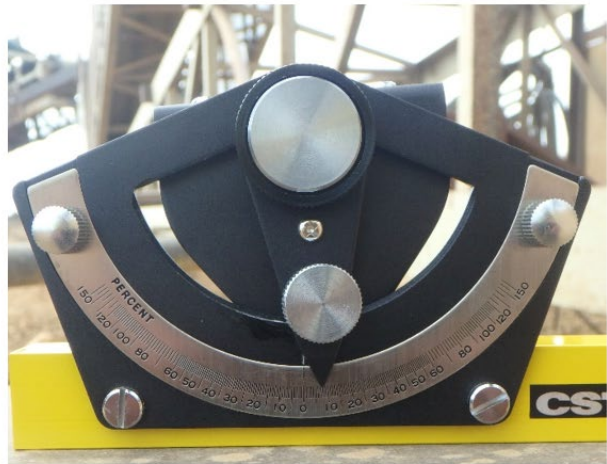
Horizontal frame of carriage at approximately 7.5% grade
