REPORT OF INVESTIGATION

Fatal Drowning Accident  
August 18, 2023

Mine No. 39  
Twin State Mining, Inc.  
Elbert, McDowell County, West Virginia  
ID No. 46-09261

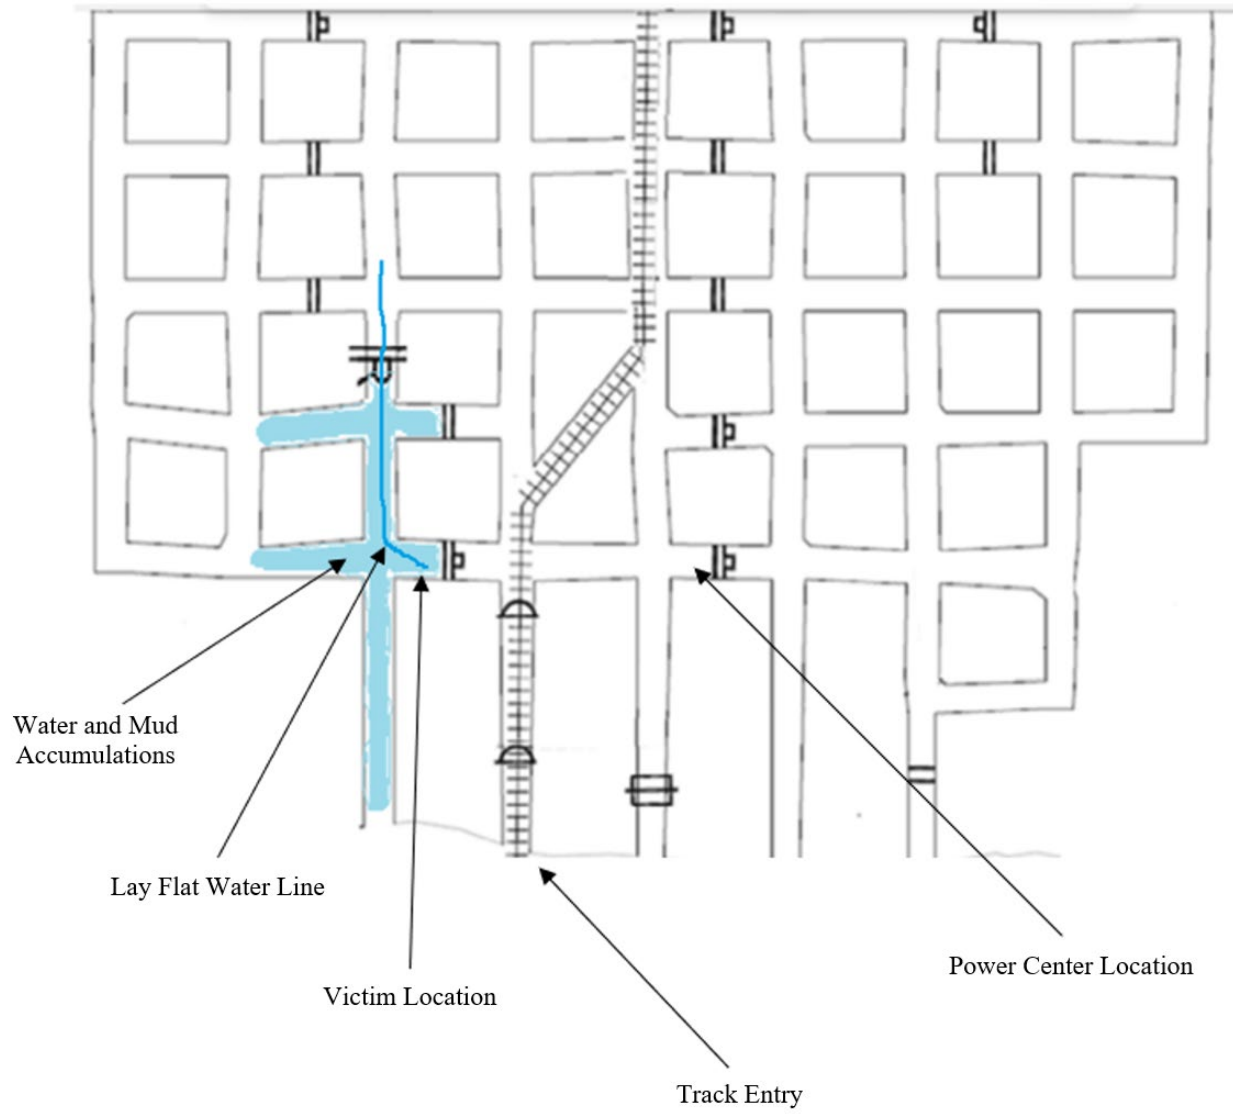
APPENDIX B – Mine Map

The accident occurred at the No. 1 crosscut between the No. 3 and No. 4 entries in the left return air course on the Punch Out portal side of the mine (see Appendix B).

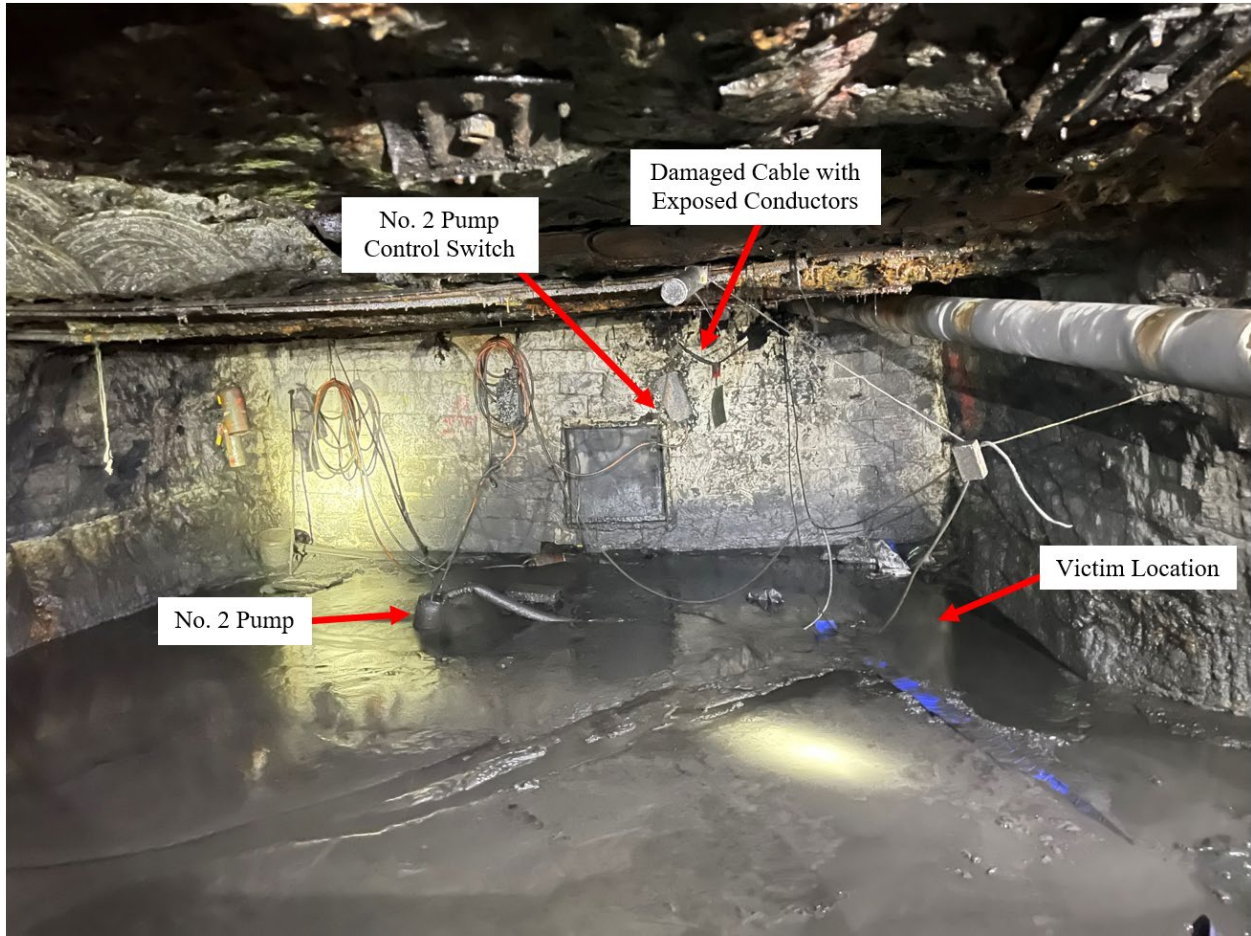
APPENDIX C – Photograph of the Accident Scene

The No. 2 pump is a single phase 240-volt AC, Stancor Model P-20CE submersible pump (see Appendix C). The pump circuit received power from a 240-volt receptacle in a power center located one crosscut in by the portal between the No. 5 and No. 6 entries. A 30-amp, Siemens Model BF230, ground fault circuit interrupter (GFCI) circuit breaker provided protection for the receptacle and connected loads.

Investigators determined that the mine operator did not comply with the approved ventilation plan. Page one, paragraph two states accumulation of water will be controlled primarily by natural drainage, supplemented by pumping, to prevent such accumulations from affecting the bleeder ventilation system and safe travel. Investigators measured water and mud up to 22 inches in depth within the accident area. The mud was extremely thick and created difficulty while walking through it.

Finley had started the pump just before the accident occurred. The pump was still pumping when investigators arrived. The depth of the water would have decreased by the time the investigators arrived at the accident scene. Statements received by investigators reported water being up to the victim's waist before the accident occurred. The mine floor was uneven and had irregularities which caused water and mud to be deeper in areas other than where the accident occurred. The depth of the water and mud also prevented observing tripping and stumbling hazards underneath that miners otherwise would have noticed. Investigators determined that all of these conditions: tripping and stumbling hazards, or depth of water and mud, or both, contributed to the accident.

Corrective Action: The water and mud in the affected area has been removed, gravel has been installed, and the tripping/stumbling hazards have been removed to create a safe travelway.

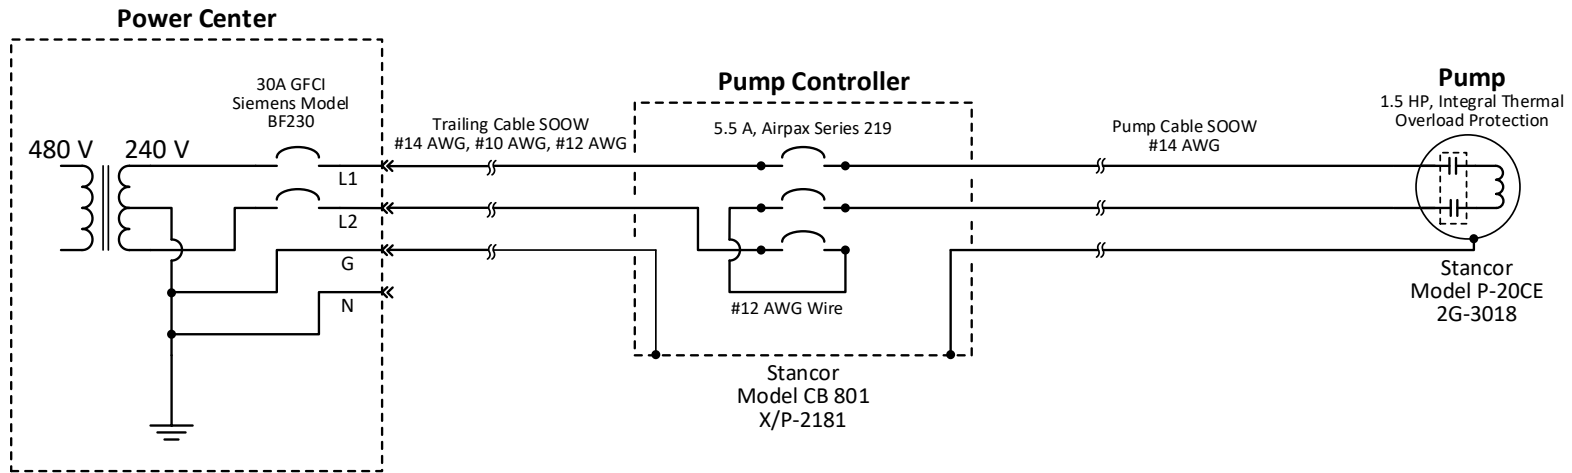
*Figure 1 - Submersible Pump Circuit*

During the onsite investigation, investigators observed several hazardous conditions while examining the No. 2 pump and circuitry (see Appendix D):

- 1) The GFCI test button would not open (trip) the 240-volt AC circuit breaker.
- 2) The power cable had a 1-inch opening in the outer jacket exposing the inner current carrying conductors. Moisture was also present inside the opening.
- 3) The handle on the control switch was stuck in the on (closed) position.

During the additional testing and examination at the MSHA Pikeville, KY office, investigators discovered other hazardous conditions:

- 1) The 240 VAC circuit breaker would not trip during ground fault condition.
- 2) Moisture was found inside all five splices.
- 3) Suitable connectors were not used in two of the splices. The conductors in these splices were only twisted together.

1. The pump circuit was energized at the time of the accident.
2. The pump circuit wiring contained a number of faulty splices capable of exposing the standing water or other wet surfaces to electrical energy.
3. Some of these faulty splices were in contact with standing water or surfaces rendered wet from the standing water.
4. The standing water was dirty and consisted of significant contaminants that typically increase the electrical conductivity of the water.
5. The circuit breaker would not trip during an electrical shock (ground fault condition).

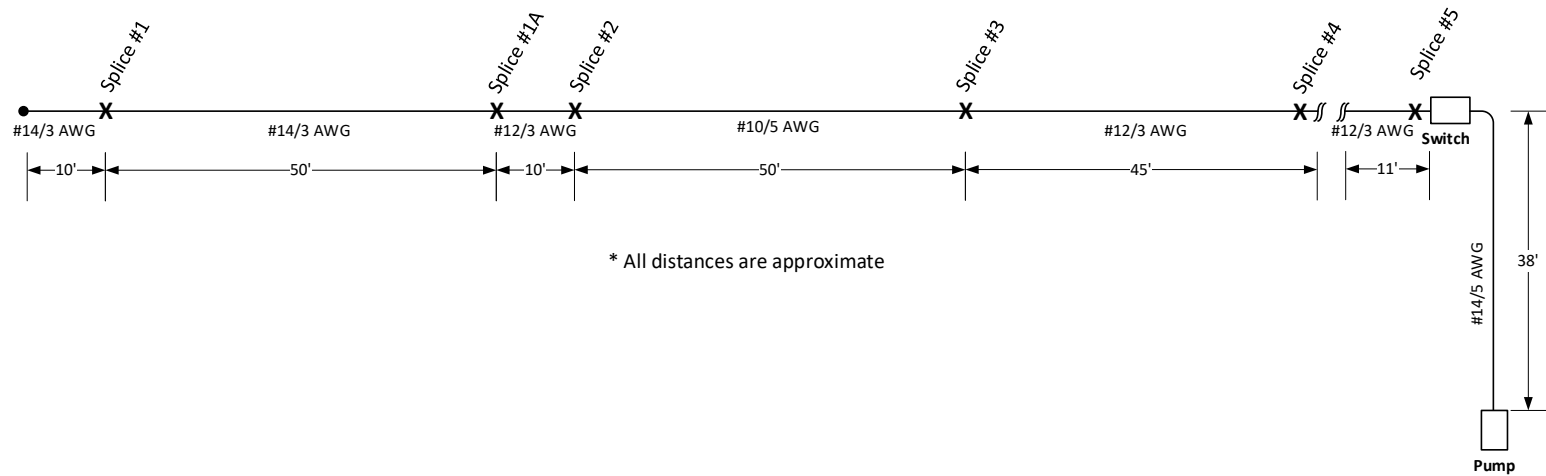
*Figure 2 - Cable Sections and Splices*

A power cable extended from the receptacle to a pump control switch (Stancor, Model CB801) in the return air course approximately 165 feet from the power center. The cable hung from the mine roof for the entire distance. The cable contained five splices and was composed of three different types of cable: No.14 AWG, three-conductor; No.12 AWG, three-conductor, and No.10 AWG, five-conductor.
