REPORT OF INVESTIGATION

Fatal Powered Haulage Accident
May 22, 2023

Huntington Plant CS01
Central Stone Company
Hannibal, Ralls County, Missouri
ID No. 23-00079

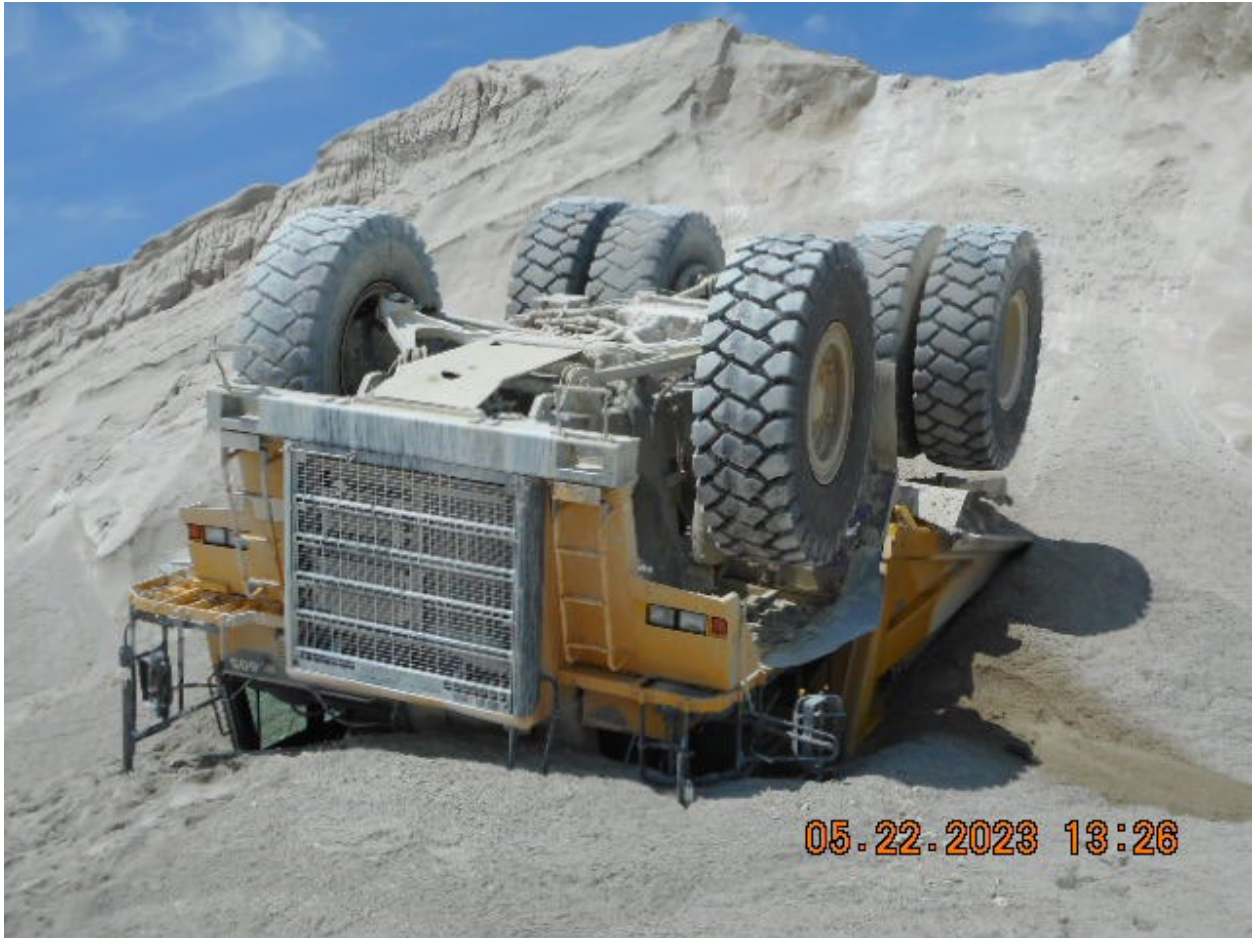
APPENDIX A – Accident Scene

On May 22, 2023, at approximately 11:10 a.m., Darrell Huff, a 70 year-old stockpile driver with over 49 years of experience, died when the ground under his haul truck collapsed, causing the haul truck to overturn backwards, coming to rest at the base of the manufactured sand stockpile.

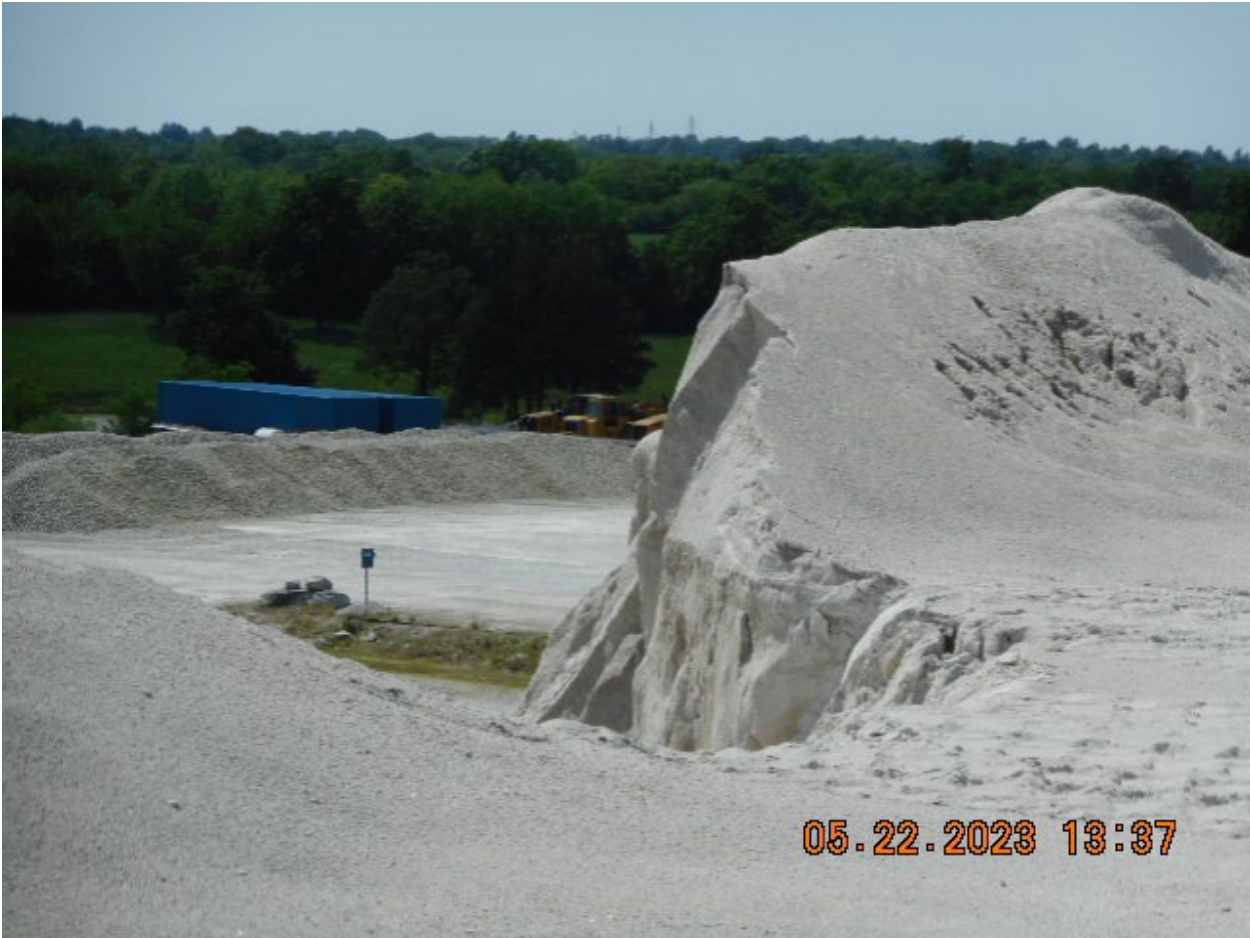
APPENDIX C – Edge of Manufactured Sand Stockpile at Location where Ground Collapsed

Haul trucks dumped new material on the top of the stockpile by driving up the access road built into the stockpile, backing up to the berm, and dumping the load near or over the edge. According to the mine operator, Huff trained haul truck drivers to dump their loads back and forth, or left to right, on top of the stockpile in a manner that allowed the bulldozer or front-end loader to push up the material after the area was full. However, this method was not being followed at the time of the accident. Instead of filling the area on top of the stockpile, Huff dumped over the edge.

There was berm material piled at the edge of the stockpile, averaging approximately 46 inches in height on the side facing the top of the stockpile (see Appendix C). The berm material shared an outside edge with the pile itself, which had become over-steepened. As a result, the berm material was too narrow at its base to restrain or impede a haul truck. This condition was created from the front-end loader operator loading customer trucks from the toe of the stockpile, causing loose unconsolidated material to slough away from the side and top of the stockpile (see Appendix D). According to interviews, the superintendent who had driven through the area earlier in the shift made no effort to mitigate the conditions. Investigators determined that the mine operator did not establish mining methods to ensure stability of the dump site and did not ensure miners dumped a safe distance back from the edge of the unstable area of the stockpile, which contributed to the accident.

Corrective Action: The mine operator has abandoned the manufactured sand stockpile from future stockpile dumping. It will only be used to loadout customer trucks from the bottom of the pile. The mine operator also developed and implemented a new written procedure to ensure stability of dump sites that includes constructing stockpiles on a solid base, and prohibiting dumping above areas where material is being removed to load customer trucks. The mine operator trained all miners on this procedure.

Corrective Action: The mine operator developed and implemented a new written procedure requiring miners to dump a safe distance back from the edge of stockpiles and the material to be pushed over the edge by a loader, bulldozer, or excavator. The mine operator trained all miners on the procedure.

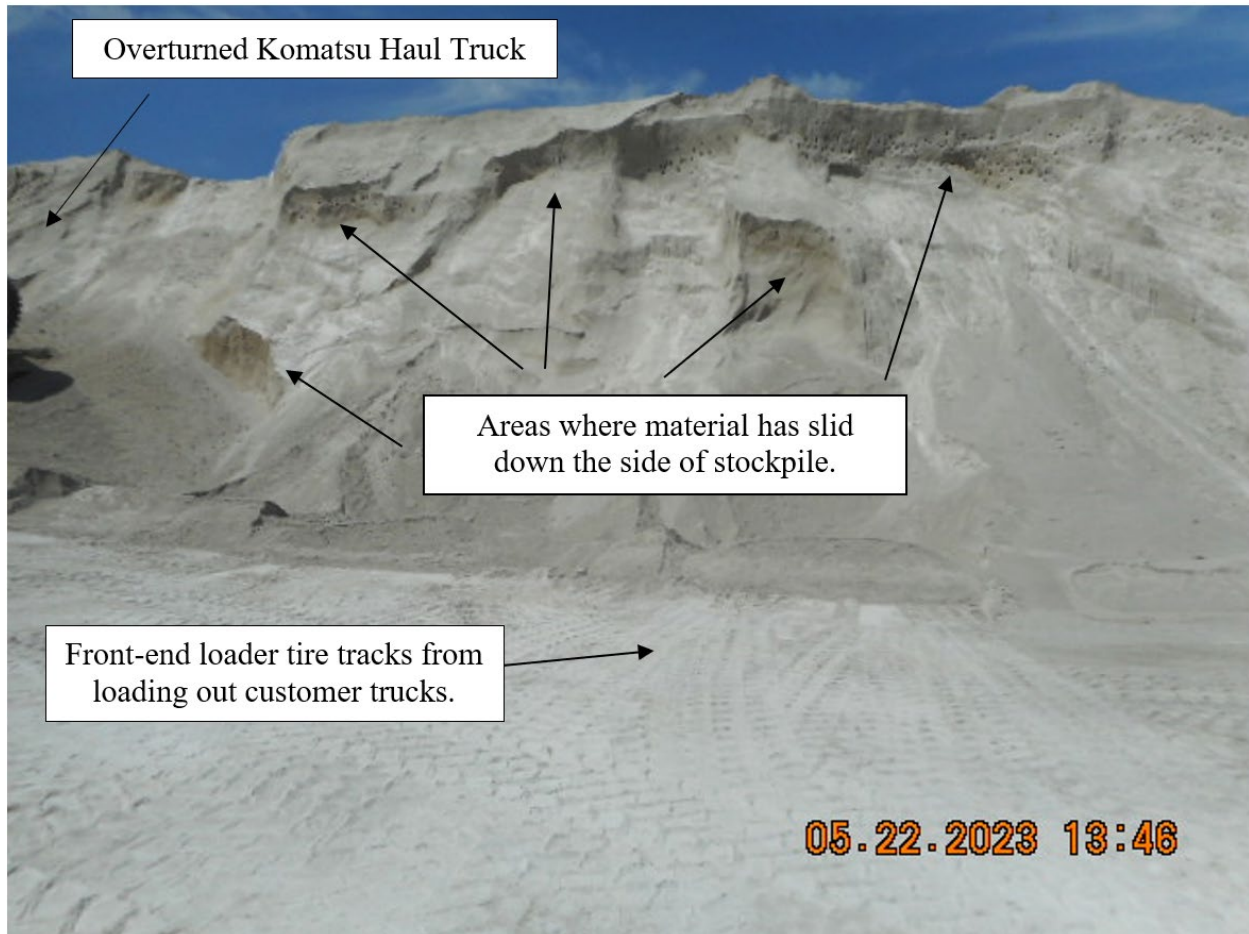
APPENDIX D – Base of the Manufactured Sand Stockpile

The accident occurred at the manufactured sand stockpile located approximately 1,200 feet southwest from the crushing plant. The stockpile was about 42 feet high at the location of the accident. At the base of the stockpile, a front-end loader loaded customer trucks.
