REPORT OF INVESTIGATION

Underground
(Platinum Group Ore)

Fatal Machinery Accident
November 13, 2023

Moran Mining USA Inc (4MC)
Nye, Montana

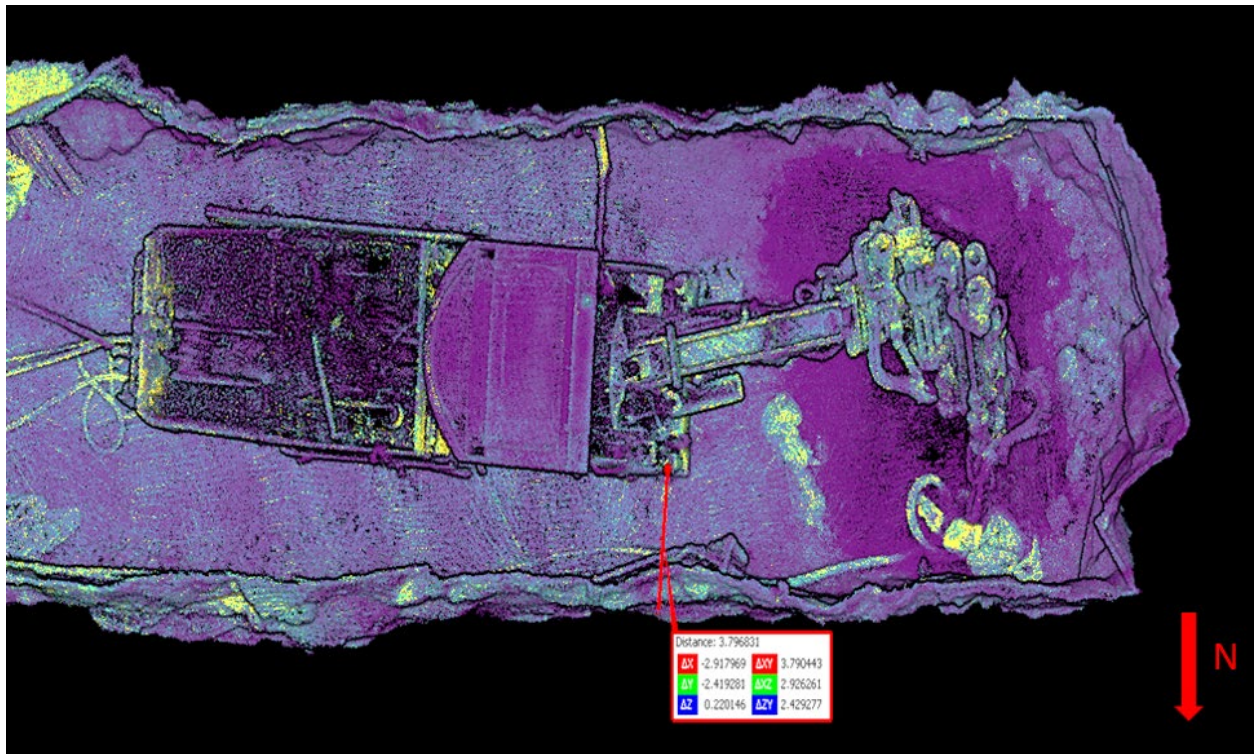
APPENDIX B – LiDAR Scan of 72W 11400 Decline

The accident occurred at the 72W 11400 decline, Muck Bay 2 (see Appendices B and C).

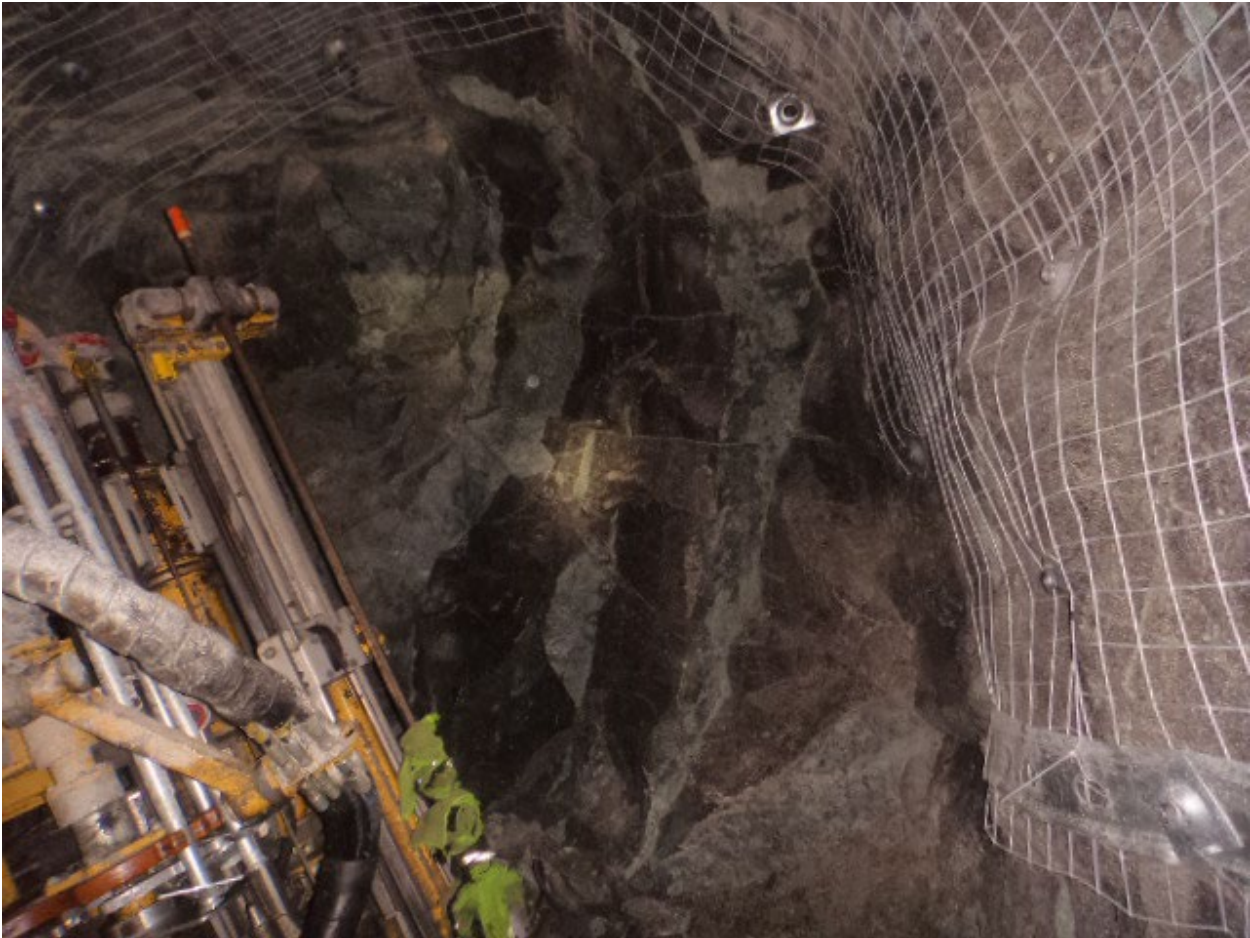
APPENDIX D – Roof Bolting Machine Head Position

The roof bolting machine involved in the accident was a 2022 Komatsu ZB21. The roof bolting machine is fitted with a bolt-driver, bolt carousel, and a rotating drill head. The bolting machine is operated from controls located in the cab, allowing the operator to drill holes and install bolts from the safety of the cab, away from the rotating drill steel and percussion bolt driver. Investigators conducted an examination of the bolting machine and found no defects that contributed to the accident.

Investigators determined that the roof bolter need only approach the bolt carousel and drill head when refilling bolts or when changing drill steels. Investigators found a broken bit in a previous hole and confirmed that a new drill steel had been installed. Investigators located the Komatsu ZB21 operator's manual, which contains warning statements indicating that no persons should be near the drill or bolt driver while the equipment is in operation. The manual also warns against persons working around the machine while wearing loose clothing. According to interviews, when S. Dinger approached the roof bolting machine to check on N. Dinger, he discovered that it was still operating and he immediately de-energized it. Investigators concluded that the manufacturer's warning statements were not followed during the accident.

1. Root Cause: The contractor did not ensure that the power was off, and that the equipment was blocked against hazardous motion.

Corrective Action: The contractor developed and implemented a new written procedure requiring two miners to operate the roof bolting machine, and signage located at the front jacks restricting access while the drill is energized. The mine operator is working with the equipment manufacturer to install electronic barriers that will de-energize the roof bolting machine automatically.
