Massive Pillar Collapses in U.S. Underground Limestone Mines: 2015–2021

Gregory M. Rumbaugh, Christopher Mark, and Todd Kostecki
Mine Safety and Health Administration

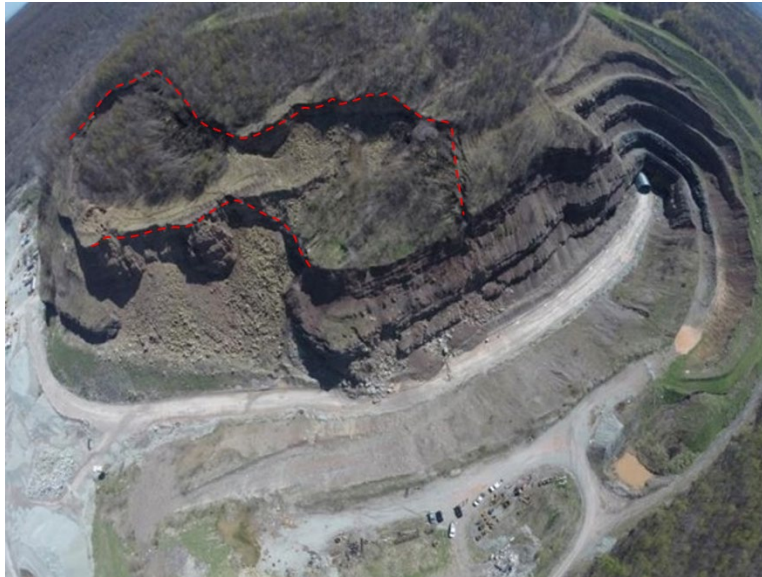
At approximately 5 AM, three underground miners were about to enter the portal to begin their shift when they heard what sounded like the firing of shots underground. An airblast then exited the portal with enough force to throw the miners and their equipment approximately 50 ft, injuring all three miners. Two of the miners were unconscious and required helicopter transport to the hospital. Significant subsidence occurred at the surface above the mine, displacing an area over seven acres (Figure 2). It was determined that these events were the result of a collapse of up to 35 pillars (Figure 3). Fortunately, no other miners were underground at the time of the pillar collapse and no other injuries occurred.

Figure 2. Aerial view of Mine A subsidence

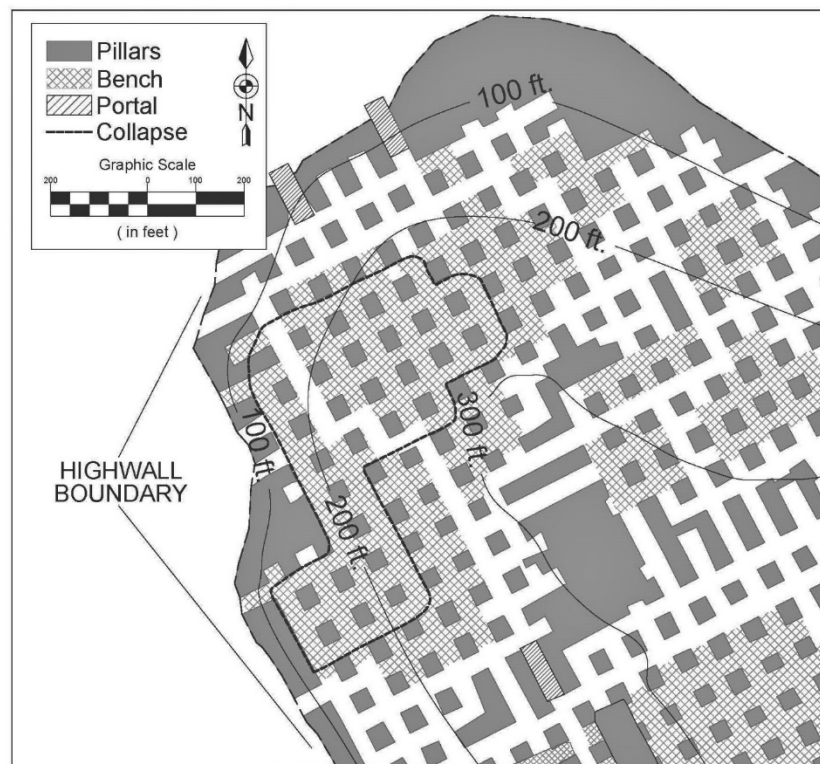
The operator's state mining permit defined the rooms and pillars as 35-ft square on 80-ft centers. The limestone averages 60 ft in thickness, with mining planned in two lifts (i.e., initial development and benching). The height of the initial development was 23 ft. Secondary bench mining removed an additional 30 ft from the floor, resulting in a total planned mining height of 53 ft. Observations at the perimeter of the pillar collapse showed the actual mining dimensions deviated from planned. The centers measured ≈ 80 ft, but the average pillar width was only 31 ft, resulting in an as-mined dimension $\approx 10\%$ less than planned. In addition, the mining height in the benched area measured 58 ft. It is estimated that the as-mined dimensions, reduced the w/h from 0.66 to 0.54 (Esterhuizen et al. 2019).

The standard deviation of the pillar widths around the perimeter of the fall was 4.5 ft (Esterhuizen et al. 2019). Therefore, a similar pillar dimension variability likely existed in the pillar collapse area. Using the S-Pillar software, the FOS of the pillar collapse was slightly above 1.0 (Esterhuizen and Murphy 2010). The size of the benched area was approximately seven acres, some of which had been backfilled with fine crusher waste (Esterhuizen et al. 2019). As shown in Figure 3, the mine operator benched most of the pillar collapse area, apart from the unbenched travelway bisecting the pillar collapse area.

A prominent joint set, 500 ft wide in plan view, exists through the eastern half of the pillar collapse. The joint spacing was from 10 to 16 ft and dipped from 60 to 80°. A low angle thrust fault along the southeast edge of the pillar collapse zone intersected the joint set. NIOSH conducted simulations after the pillar collapse and found that the large discontinuities coupled with the $w/h = 0.54$, resulted in a pillar strength lower than what could be predicted by established hard-rock pillar strength equations (Esterhuizen et al. 2019).

Figure 3. Pillar collapse periphery at Mine A

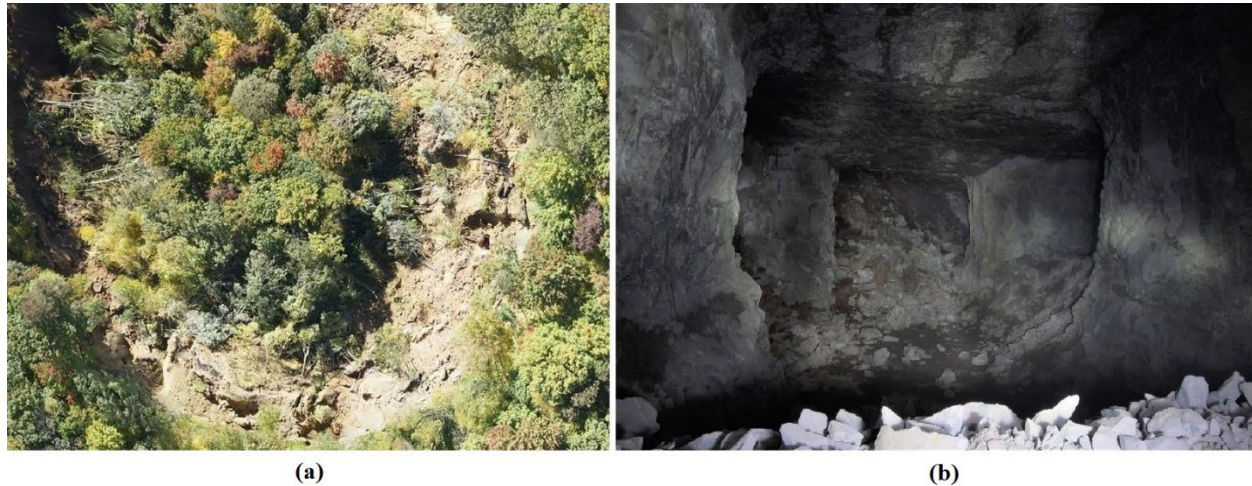
On October 6th, 2020, approximately 25 pillars collapsed at a southwestern Pennsylvania limestone mine. This pillar collapse registered as a 2.9 magnitude event on the U.S. Geological Survey’s seismic network. See Figure 4a for an image of the resulting subsidence and Figure 4b for an image of the pillar collapse perimeter.

Figure 4. (a) Subsidence from collapsed workings and (b) an underground perspective of the rubblized periphery

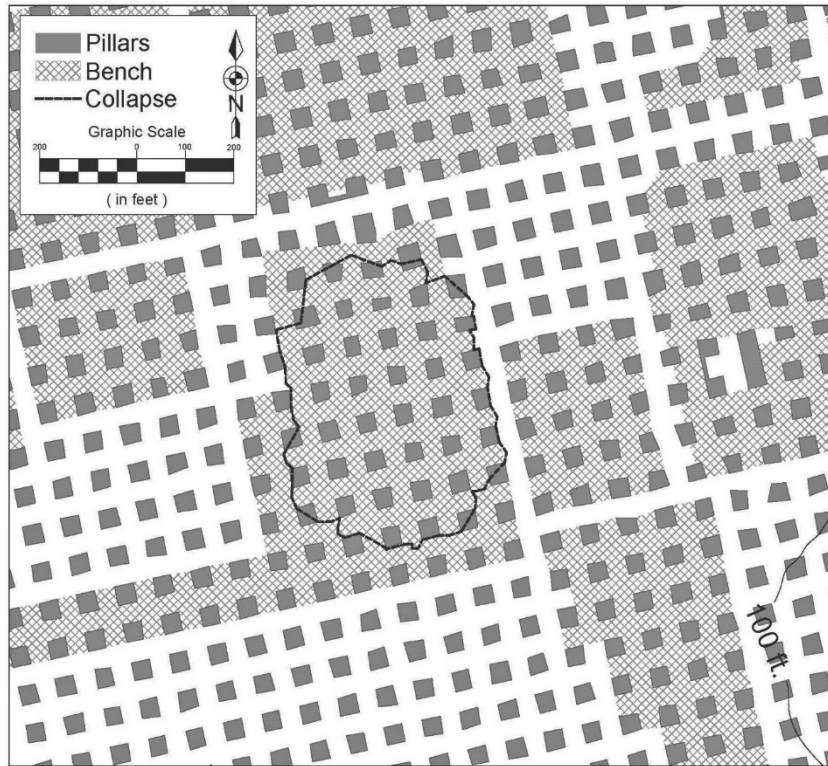
The pillar collapse occurred in a benched region of the underground room-and-pillar works, with a depth of overburden of ≈ 160 ft (Figure 5). Development mining occurred five to six years prior to the pillar collapse, at a mining height of 25 to 30 ft, or 50% of the total height of the Loyalhanna Limestone Bed in the area of the collapse. Bench mining of the lower portion of the Loyalhanna was ongoing and conducted just four days prior to the pillar collapse. It was not evident if bench mining began recently or had been on-going since development. The full bench height ranged from 45.9 to 48.0 ft. Mudstones, shales, and siltstones overlay the mining horizon and operations left 8 ft of limestone in the roof to provide a stable back; however reliable data via drilling logs were not available to attest to the main and immediate roof thickness and composition in the vicinity of the collapse. It should be noted that while the immediate and main roof can be a contributing factor to pillar instability, the focus of these case studies was primarily on the generalized pillar geometry.

A contributing factor to the pillar collapse was the as-mined pillar widths being smaller than the planned pillar widths of 40 ft, which created unacceptable w/h values. Field measurements ($n = 32$) around the border of the pillar collapse indicated that $\approx 90\%$ of the measured pillars were less than 40 ft and $\approx 13\%$ were less than 30 ft. Along the periphery of the pillar collapse area, the average width was ≈ 35 ft with some as low as 25 ft, resulting in w/h of 0.53 (25.3 ft/48.0 ft). The mine plan showed the smallest width of a pillar inside the pillar collapse area as 20.6 ft, resulting in an even lower (estimated) $w/h = 0.43$. At the boundary of the pillar collapse area, where the pillar run ceased, and using a conservative pillar height of 45.9 ft, $\approx 44\%$ of periphery pillars were below a w/h of 0.76.

Figure 5. Pillar collapse periphery at Mine B

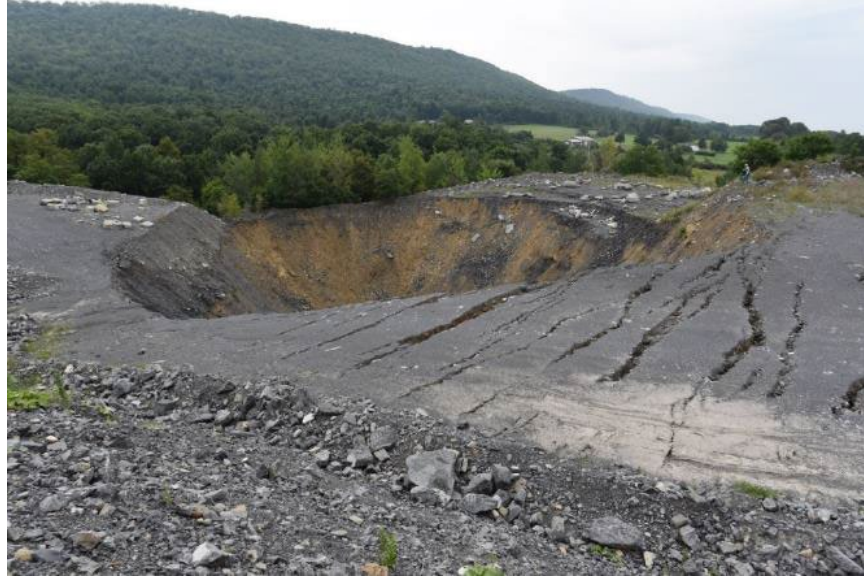
During the pre-dawn hours in November 2020, a surface miner returned to his worksite on a spoil pile where he had parked a brand-new excavator, with only 10 machine-hours on it, at the conclusion of his last shift. Surprised by not seeing the excavator, the miner stopped and exited his truck. Instead of finding the excavator, he realized that he was standing near the edge of the surface depression shown in Figure 6, and narrowly avoided driving into the sinkhole. The excavator is engulfed in the sinkhole and has not been found.

The sinkhole overlays room-and-pillar workings in the Valentine Limestone, which are part of an active mine owned and operated by a different company than the surface operation. The underground workings experienced a pillar collapse during the previous night. What occurred that morning would be the first of many sinkholes that would appear in the spoil pile area and adjacent properties. The cause of these sinkholes was the collapse of approximately 12 pillars, comprising six acres. In July 2021, a second pillar collapse occurred in the same panel, resulting in more subsidence and an airblast that caused damage to mine-infrastructure, including communication beacons, ventilation brattices, escapeway signage, haulage mirrors, and barricades.

Figure 6. A 260 ft diameter by 100 ft deep sinkhole associated with the pillar collapse at Mine C

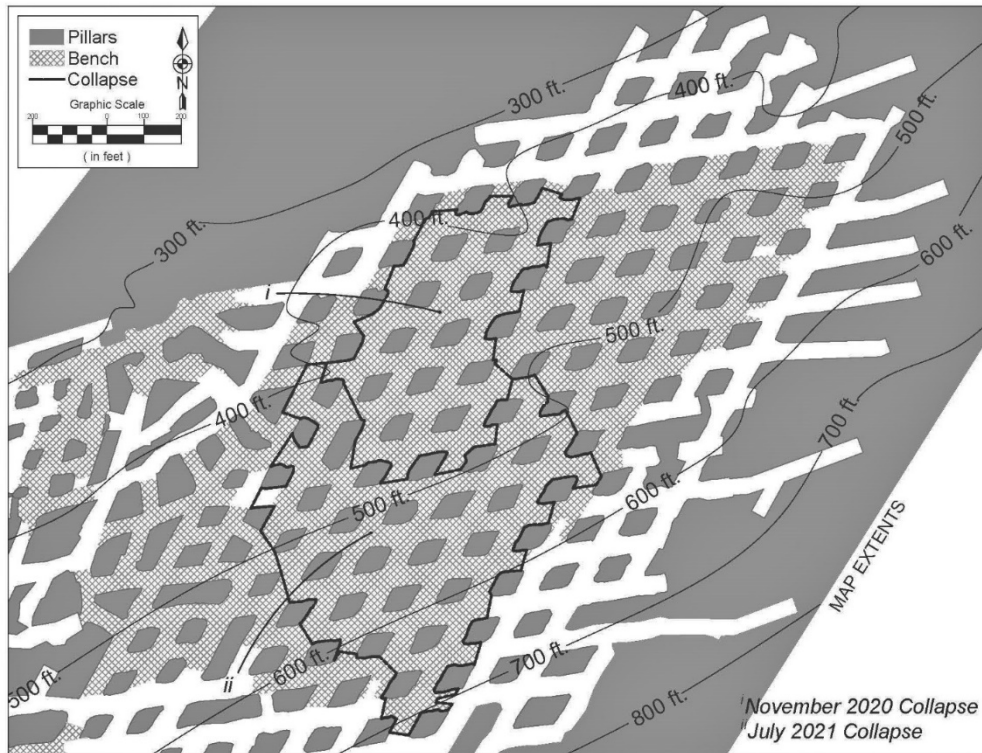
The July 2021 pillar collapse registered as two distinct seismic events on the regional Pennsylvania State Seismic Network of 1.4 magnitude at 3:45 AM and 2.6 magnitude at 4:00 AM local time. Nearly half of the 36 acres of benched area collapsed during these two events (Figure 7) and were the first failure of its kind since the mine began operations around 1950.

Figure 7. Pillar collapse regions at Mine C

The operator initially developed the panel that collapsed between 1998 and 2001, at a height of ≈ 30 ft. Benching occurred from 2002 to 2006, which increased the total mining height to 72 ft. The pillars were diamond-shaped, with north-south oriented headings developed 53° from the east-west headings. The seam dips from 10 to 15° to the southeast and center-to-center spacing between headings was 115 ft. The planned pillar widths were 65 ft. According to the mine operator, blasting during benching and spalling of the pillars over time may have reduced the pillar width to 55 ft. The depth of cover ranged from 350 to 650 ft.

The w/h of the pillars was ≈ 0.76 and analysis showed a FOS of ≈ 1.4 for the collapsed panel; both values were less than those that S-Pillar suggests (Esterhuizen and Murphy 2010). The w/h was calculated using the minimum width of the pillar. Moreover, there are several unaccounted factors in the software's calculations, particularly those associated with the dip of the seam, impact of adjacent face development, adjacent surface mine, overlying spoil pile, complex geology, and the angled headings and crosscuts. Most notable is that the seam dips from 10 to 15° and the S-Pillar database only includes flat-lying formations. A steeply dipping seam, such as this one, would further reduce stability of the pillars; therefore, the actual FOS is likely less than the S-Pillar calculated value of 1.4.

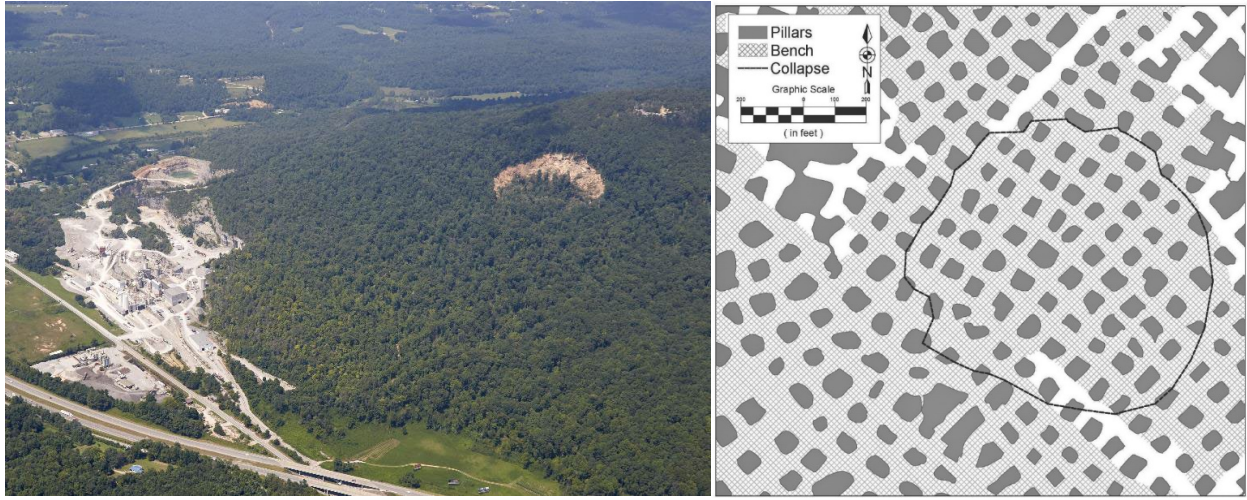
The miners tagged out and gathered at the mine office, near the portals of the mine. Suddenly a pillar collapse occurred. The miners reported feeling a pressure pulse or wave, heard rumbling from the portals, then watched an airblast with a velocity between 120 and 180 mph exit the portals. The airblast damaged nearby infrastructure and buildings and resulted in a sinkhole that encompassed an area of approximately nine acres as shown in Figure 8. Fortunately, no injuries occurred. The pillar collapse registered as a 3.1 magnitude seismic event. The pillar spalling and the resulting rock that miners noticed on the roadway on the day before the pillar collapse was an indication of the changing stability conditions. Miners cleaned up the material and scaled the pillar but observed fresh fallen material on the morning of the pillar collapse. During the months following the

Figure 8. Sinkhole associated with the pillar collapse at Mine D and the associated underground plan view

The exploration program indicated that approximately 40 pillars, developed 70 years prior, collapsed across an area of 14 acres. Extracted over the next 35 years were two floor benches making the total mining height between 80 and 90 ft. The depth of cover was approximately 400 ft. The pillar widths were 36 ft minimum and averaged 53 ft. These widths suggest that the minimum w/h ranged from 0.40 to 0.45 for the pillar collapse area.

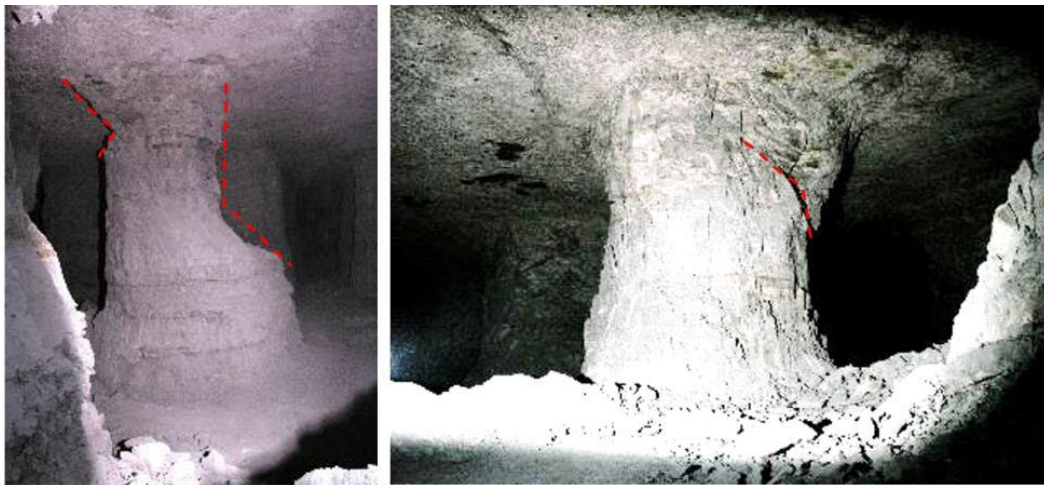
The collapsed pillars had been the subject of a pillar stability study in 2005 which included field measurements and photographs as shown in Figure 9. As were the circumstances in two of the other cases, nearby development mining had recently taken place. Since 2012, development headings had extracted a large barrier of intact limestone directly north of the area that collapsed. The presence of through-going joints in the pillars and karst features may have also been factors in the pillar collapse.

Figure 9. Pillars involved in the massive pillar collapse of Mine D (Photo credit: Dr. G.S. Esterhuizen)
