REPORT OF INVESTIGATION

Fatal Powered Haulage Accident  
June 9, 2021

Stillwater Mine  
Stillwater Mining Company  
Nye, Stillwater County, Montana  
ID No. 24-01490

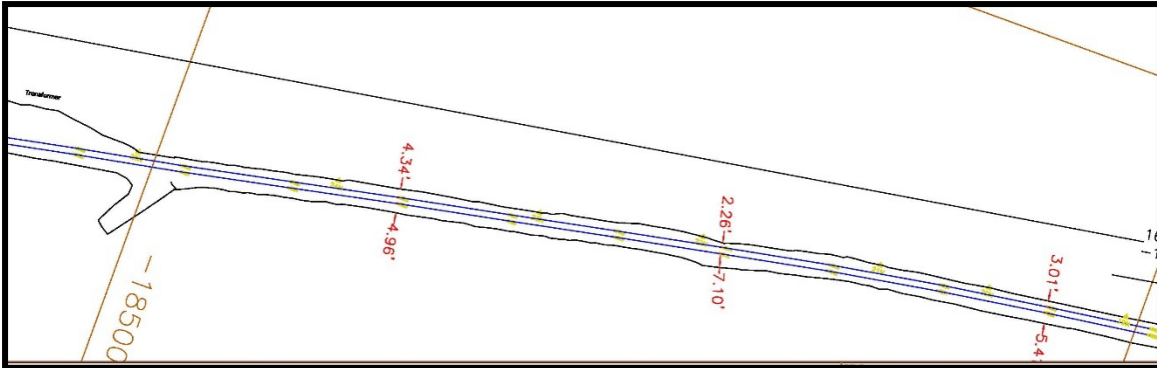
Illustration No. 1: Plan View of 18500 Area to 18000 Area

From radio recordings, Knight and Rodenberger left the 19600 loading chutes of 35W, traveling eastward, and started down the rail haulageway to the 18300 section of 35W when they observed

the approaching lights of the Kubota. Rodenberger called out on the radio to clear the rail haulageway, as Knight attempted to stop the train. The momentum of the train propelled Knight and Rodenberger down the tracks, and the locomotive struck the Kubota, with Ketola and Ashlock inside. The locomotive derailed and pinned the Kubota against the rib just east of the 17350 transformer bay area of 35W.

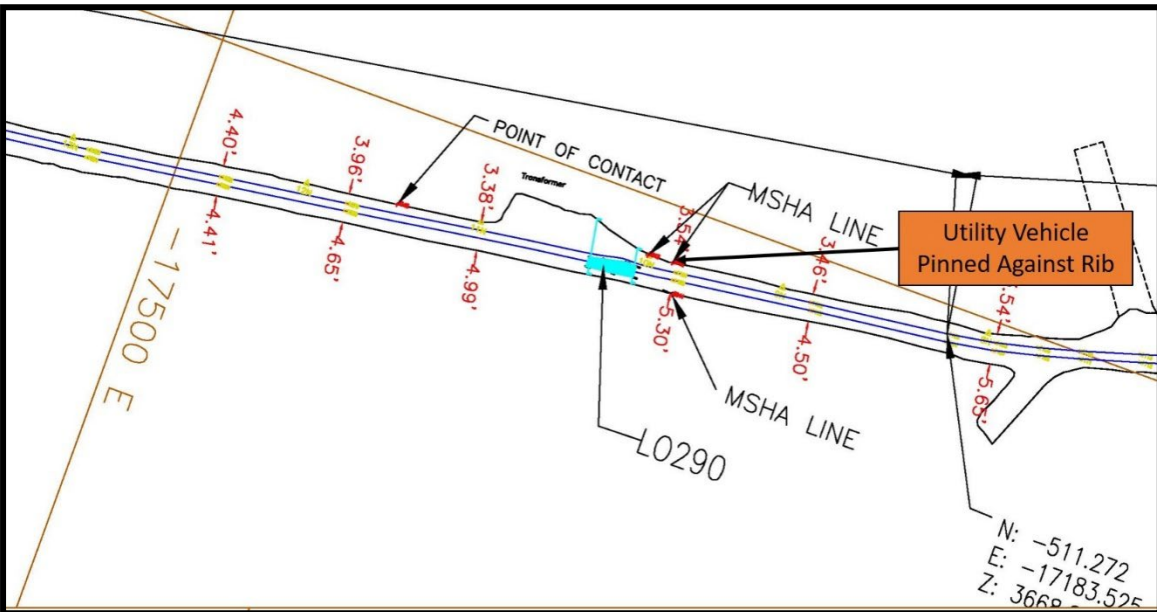
Illustration No. 3: Plan View of Immediate Accident Area

The accident occurred on the 35 level of the underground mine on the section of the rail haulageway referred to as the 17350 transformer bay area of 35W.

A fatal accident occurred June 9, 2021, when two miners traveling westward in the 35W rail section of the mine in a Kubota personnel carrier, were struck by a 20-ton locomotive traveling eastward. The locomotive pushed the Kubota backwards into the north rib at the 17350 transformer bay. The momentum of the locomotive caused it to derail, pinning and crushing the Kubota against the rib. The mine operator did not assure that traffic rules governing communication, right of way, and direction of movement were followed for rail haulageways. This is an unwarrantable failure constituting more than ordinary negligence.

Corrective Action: The mine operator revised the 35 Rail SOP and incorporated it into a new written policy for all rail haulageways, which prohibits the use of rubber-tired equipment and foot traffic when locomotives are operating. The new policy also establishes and designates a rail haulageway controller, which is not the locomotive operator, and a communication protocol. The mine operator trained all miners on this new policy.

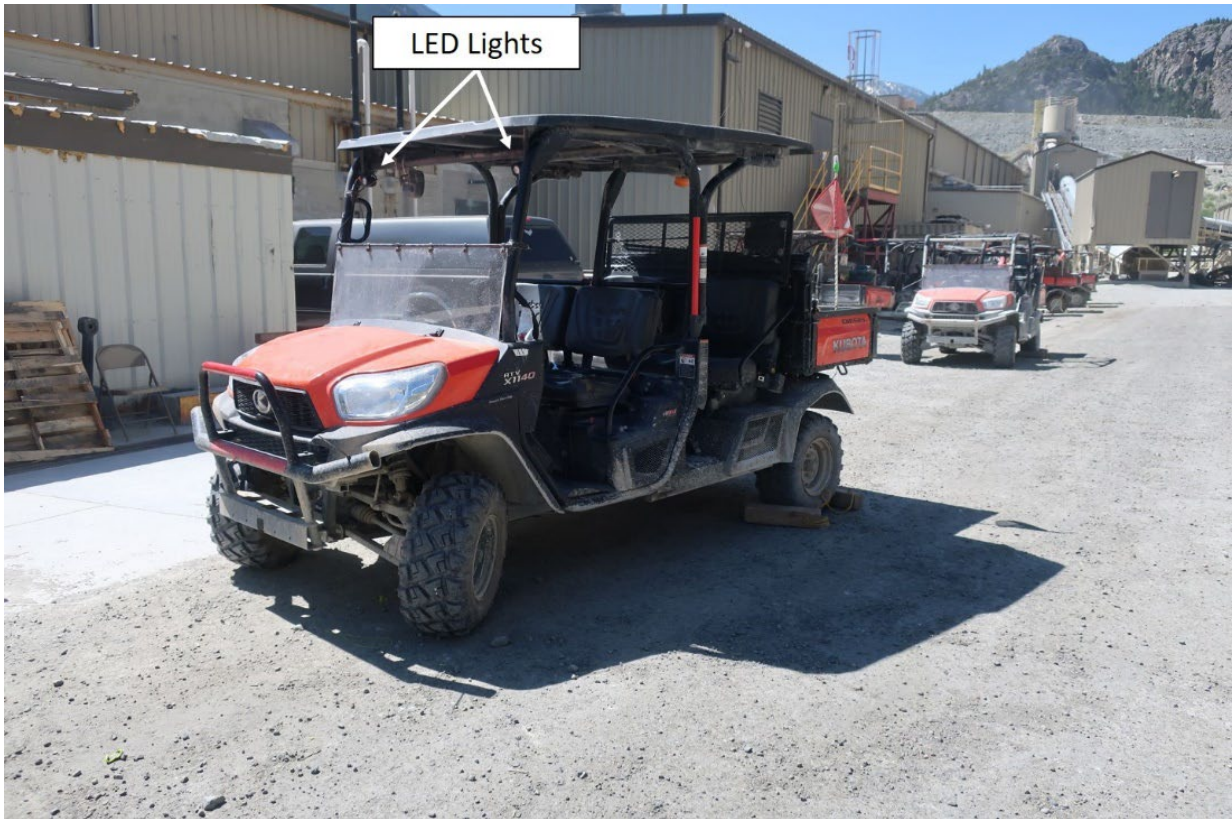
APPENDIX C – Kubota Utility Vehicle Similar to One Involved in Accident

The equipment involved in the accident were: (1) a Kubota Utility Vehicle Model RTV-X1140 four-passenger personnel carrier (see Appendix C), (2) a leading Brookville 20-ton locomotive Model 20T200D-FR (see Appendix D), (3) 16 fully loaded 15-ton rail cars, and (4) a trailing Brookville 20-ton locomotive Model 20T200D-FR. The two locomotives operate together through a Control Chief radio remote control linking system. This system allows the locomotive

MSHA could not conduct an inspection of the Kubota personnel carrier due to the physical damage sustained in the accident.

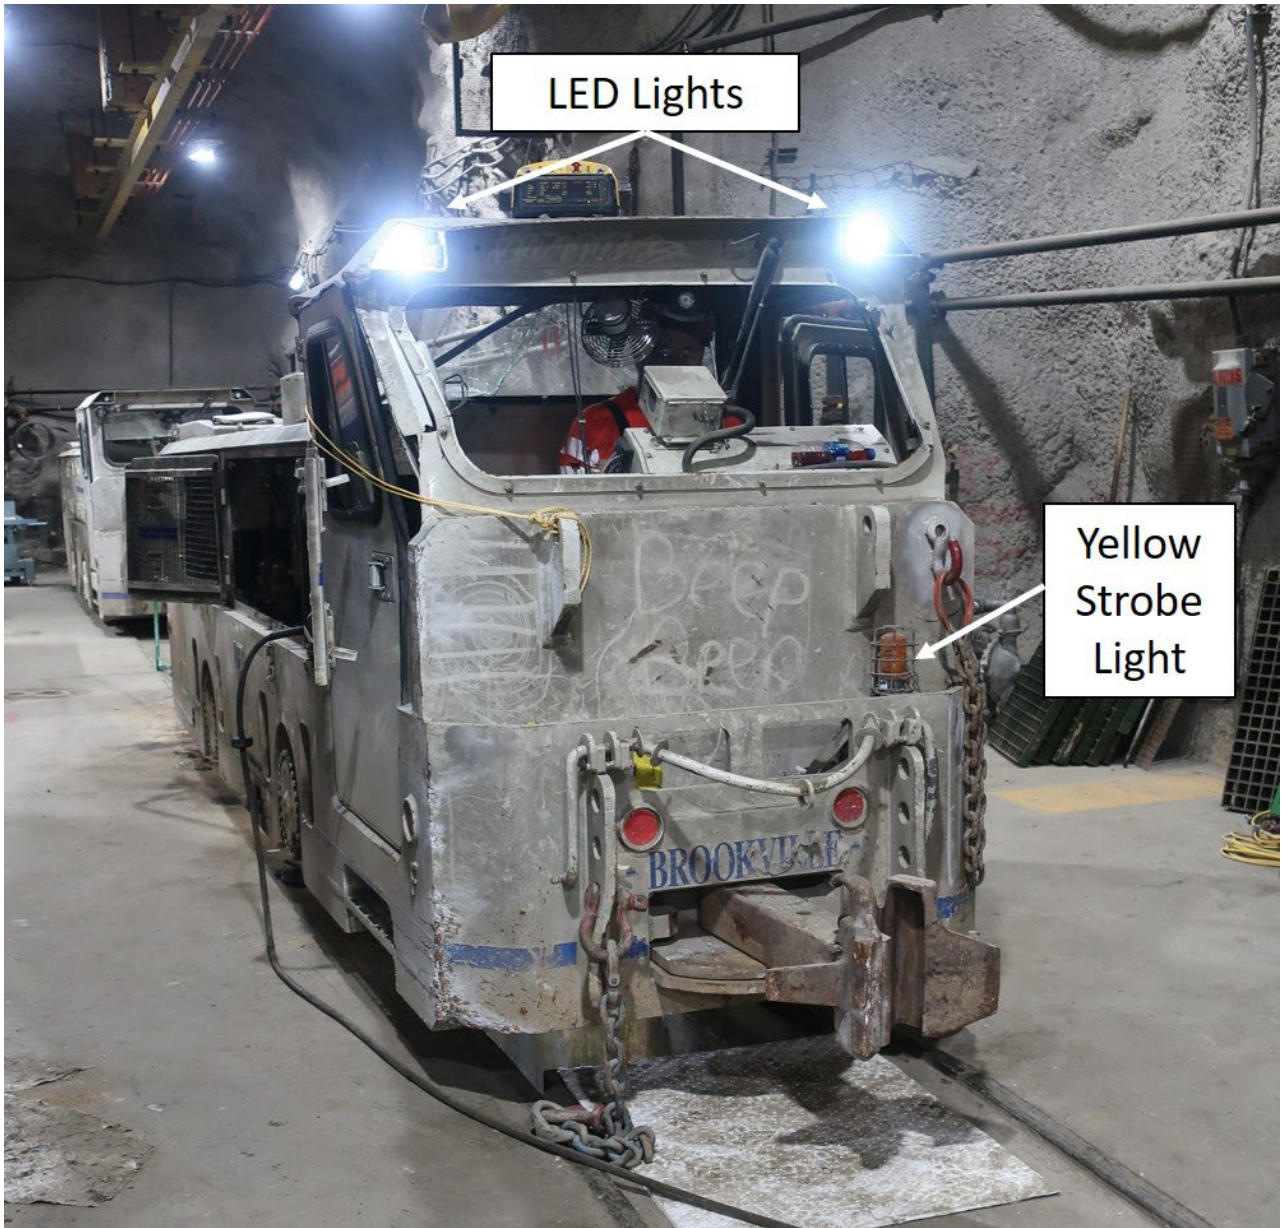
APPENDIX D – Brookville 20-ton Locomotive

Operational and mechanical checks of the two locomotives revealed the equipment was within manufacturer's specifications.
