REPORT OF INVESTIGATION

Underground
(Silver Ore)

Fatal Fall of Roof Accident
April 11, 2023

Galena
U.S. Silver-Idaho, Inc.
Wallace, Shoshone County, Idaho
ID No. 10-00082

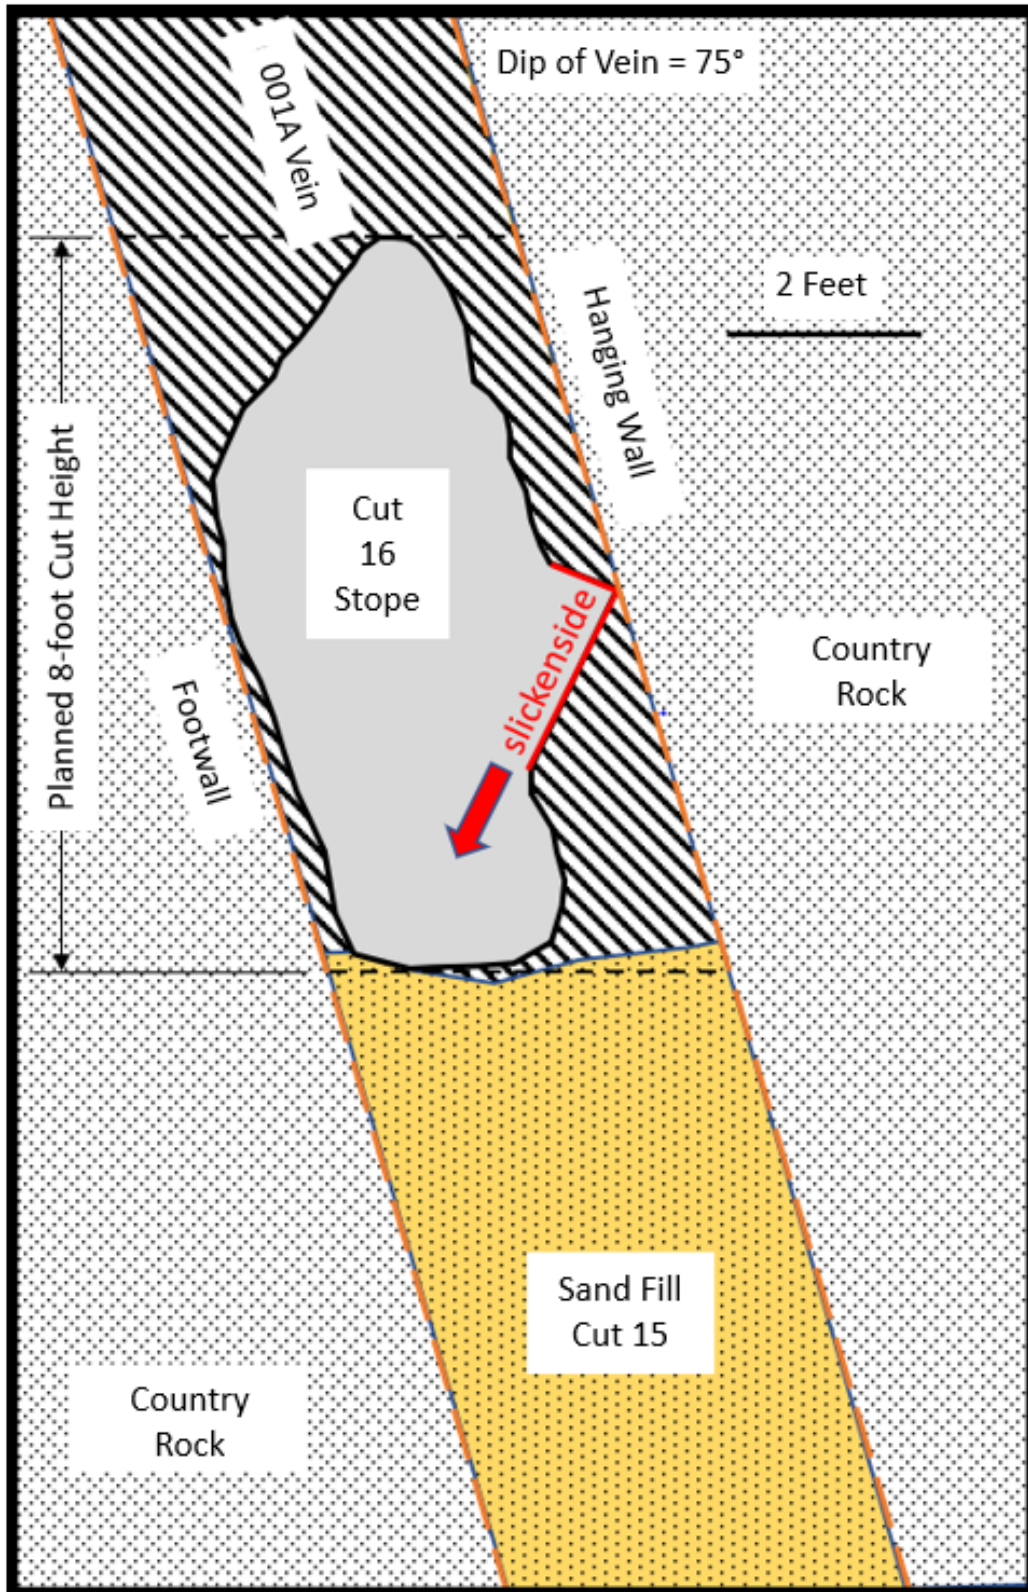
APPENDIX A – Sketch of 3200-033 Stope Profile and Failure Geometry

The accident occurred in the 001A Vein at the 3200-033 stope, which used a conventional overhand cut-and-fill method of mining (see Appendix A). The stope was approximately four to eight feet wide, eight feet high, and 100 feet long. The accident occurred approximately 16 feet from the end of the stope, this area was approximately four and half feet wide.

Appendix A shows how the 001A Vein at the 3200-033 stope was mined. The vein dips at a 75-degree angle, which creates a hanging wall above the vein and a footwall below the vein. The hanging wall and footwall are composed of metamorphic rock. Below Cut 16, Cut 15 was backfilled with sand. The 001A Vein in Cut 16 had a slickenside (smoothly polished surface caused by frictional movement between rocks along a fault) on the hanging wall side.

The Galena mine's Ground Control Plan (GCP) specified the use of bolting in a three-foot pattern where stope widths exceeded five feet. In stopes with narrower widths, the GCP states to use bolts, wire, wire mesh, and stulls (sideways wood bracing) when necessary, but does not specify when support should be used, how often, or include design criteria for the stulls. For overhand cut-and-fill stopes, the GCP states "the back will be supported with 4-foot bolts and holy boards or monster mats," and that "generally, bolt spacing of at most three quarters the bolt length should be adequate" with reference to a cross sectional diagram for stopes less than 5 feet wide showing a single bolt installed in the crown and a single wood support member wedged between the hanging wall and footwall. The reference to spacing based on three quarters the length of a 4-foot bolt suggests bolts should be installed on 3-foot centers. Jurado had the authority to direct the application of ground support but was not aware of the ground control plan or its provisions. In the area where the accident occurred, Nutting had installed two bolts. He installed one bolt in the rock that fell and another bolt near the same rock. Nutting was preparing to install a third bolt in or near the same rock when the fall occurred.

Investigators performed an extensive visual examination of the area and tested the ground competency using sound and vibration. Investigators noted considerable loose material, open apertures of joints, and "drummy" conditions, indicating an unstable rock mass. Investigators determined that 14 bolts and one stull were installed in the approximately 100 foot-long stope, during the mining cycle. One of those bolts had been installed in the rock wedge that fell prior to failure but had insufficient anchorage to control the rock. The bolts installed in the crown (roof) were obviously more than three feet apart. According to interviews, the stull was installed during a shift prior to the accident. Investigators determined an additional stull was installed by the mine rescue team.

The stulls, which were three inches by eight-inch wood boards cut to the width of the stope at their installed locations, were not hitched in the footwall. The stulls had been installed on an individual basis, rather than as part of a regular support system with a defined spacing. Proper installation and adequate support density, or spacing, are both elements of a support system that has been designed to control the ground.

Investigators determined that the ground control plan was not adequately designed for narrow stopes. The necessary ground support systems were not adequately designed or installed to control the ground where the miner was working. Investigators determined that inadequate ground support contributed to the accident.

Corrective Action: The mine operator updated the ground control plan to include ground support in narrow stope mining. The revised ground control plan contains additional information about proper installation, spacing, and maintenance of ground support bolts and stulls. The mine operator revised their training plan and trained miners on these changes.
