REPORT OF INVESTIGATION

Surface
(Crushed and Broken Stone)

Fatal Machinery Accident
December 14, 2023

Staker & Parson Companies
Beck Street
Salt Lake City, Salt Lake County, Utah
ID No. 42-01452

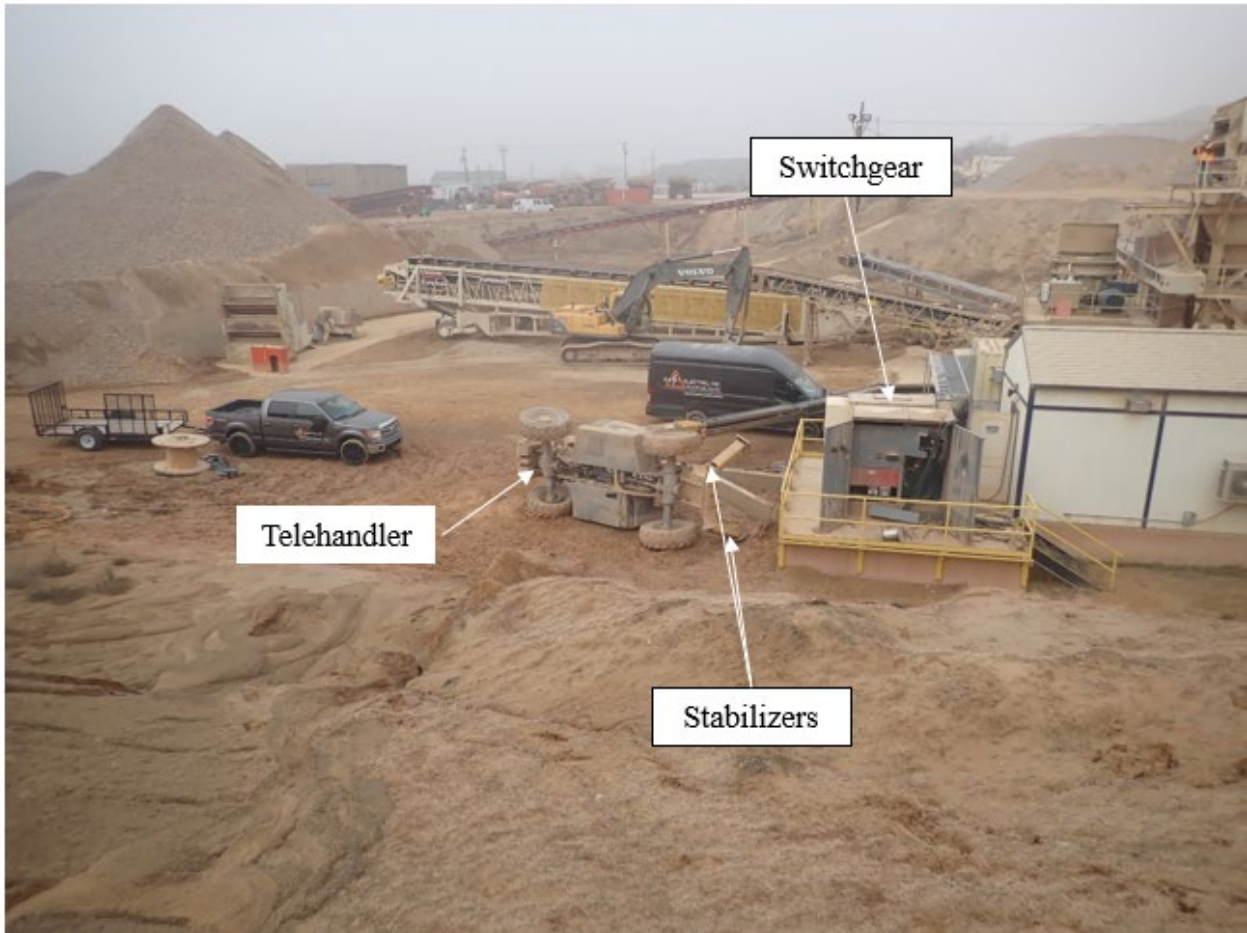
APPENDIX B- MCC Switchgear where cables were being pulled.

The accident occurred at the MCC switchgear of the primary crusher (see Appendix B). There was a hill to the right of the telehandler with the toe of the pile just a couple of feet away from the right front tire. The ground was damp and uneven.

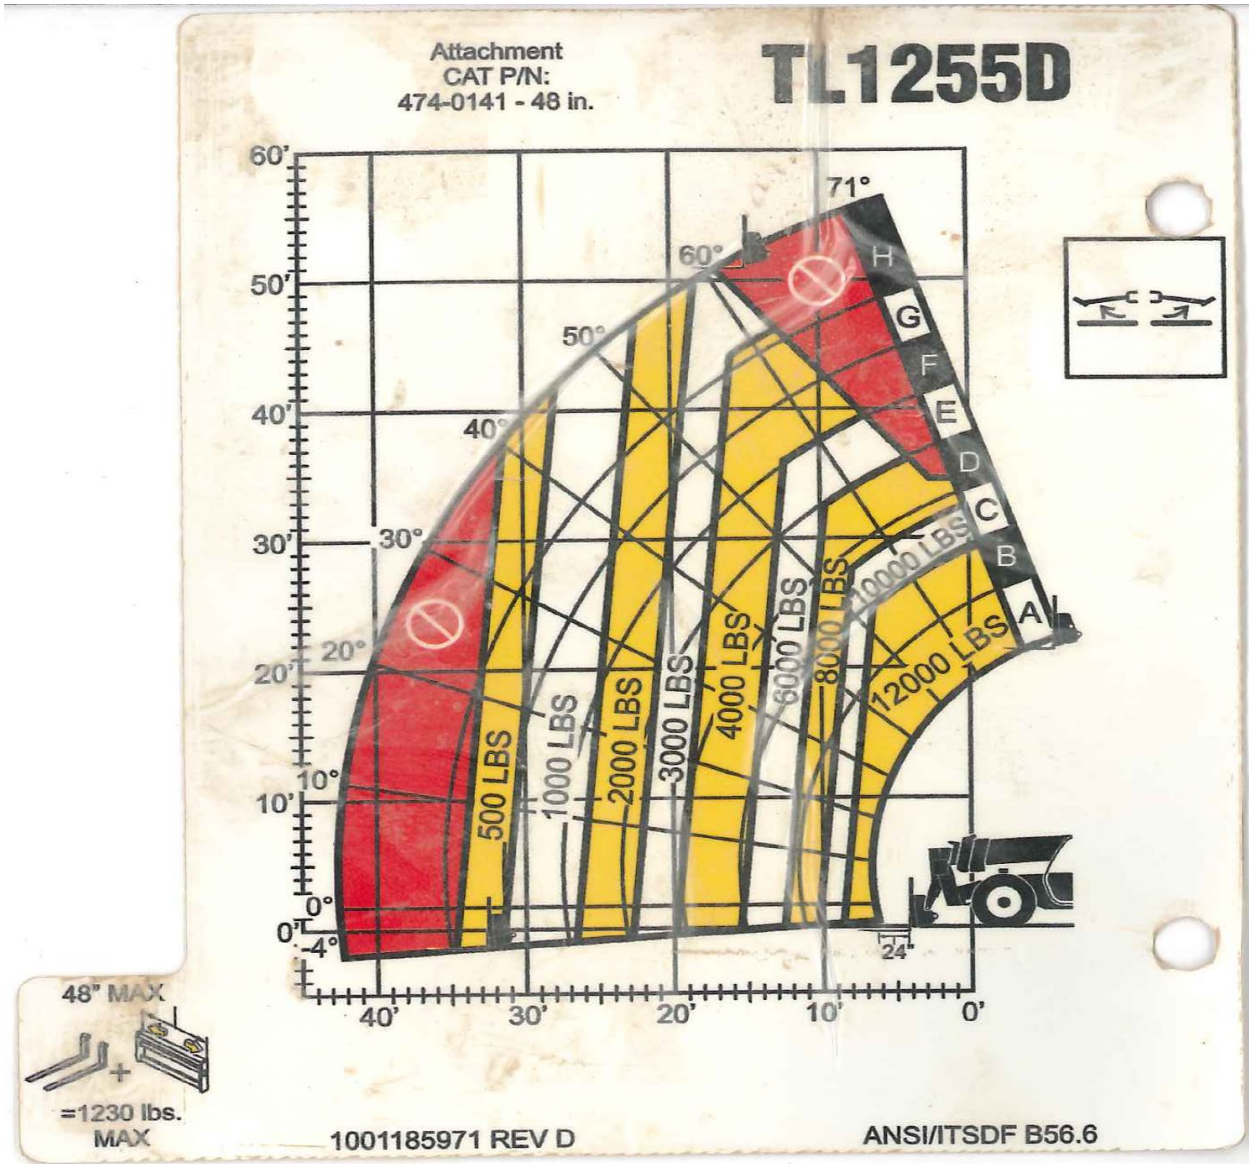
APPENDIX C - Capacity chart obtained from the telehandler.

deliver material at elevated heights. It is equipped with front stabilizers which are lowered to the ground to stabilize the telehandler while the boom is raised in the air. Investigators determined T. Manning was operating the telehandler outside the design capacity intended by the manufacturer. The telehandler was moved with the boom extended to its full length, at a 67-degree angle, with the stabilizers raised while under a load from the cables being pulled. Investigators observed warning stickers inside the cab as well as the manufacturer's manual and capacity chart that listed these as hazards and warned not to operate the telehandler in the condition in which it was found (see Appendix C). Investigators determined from the manufacturer's load charts that regardless of the attachment on the telehandler, there was no acceptable load with the boom fully extended, at a 67-degree angle with the stabilizers raised. Investigators determined these factors contributed to the accident.

This caused the telehandler to tip to the left and fall onto its left side. The capacity charts in the cab state the equipment is not to be moved with the boom raised in this position with a load. The B.E.S.T. Electric contractor engaged in aggravated conduct constituting more than ordinary negligence in that their foreman operated the telehandler beyond the manufacturer's design capacity. This violation is an unwarrantable failure to comply with a mandatory standard.

Corrective Action: The contractor has implemented an SOP and trained their employees on the importance of following the manufacturer's design capacities. This includes operators of equipment being fully trained in the operation and safe use of the equipment according to the manufacturer manuals.
