REPORT OF INVESTIGATION

Fatal Electrical Accident
February 6, 2023

Greenbrier Quarry
Rogers Group Inc
Greenbrier, Faulkner County, Arkansas
ID No. 03-00855

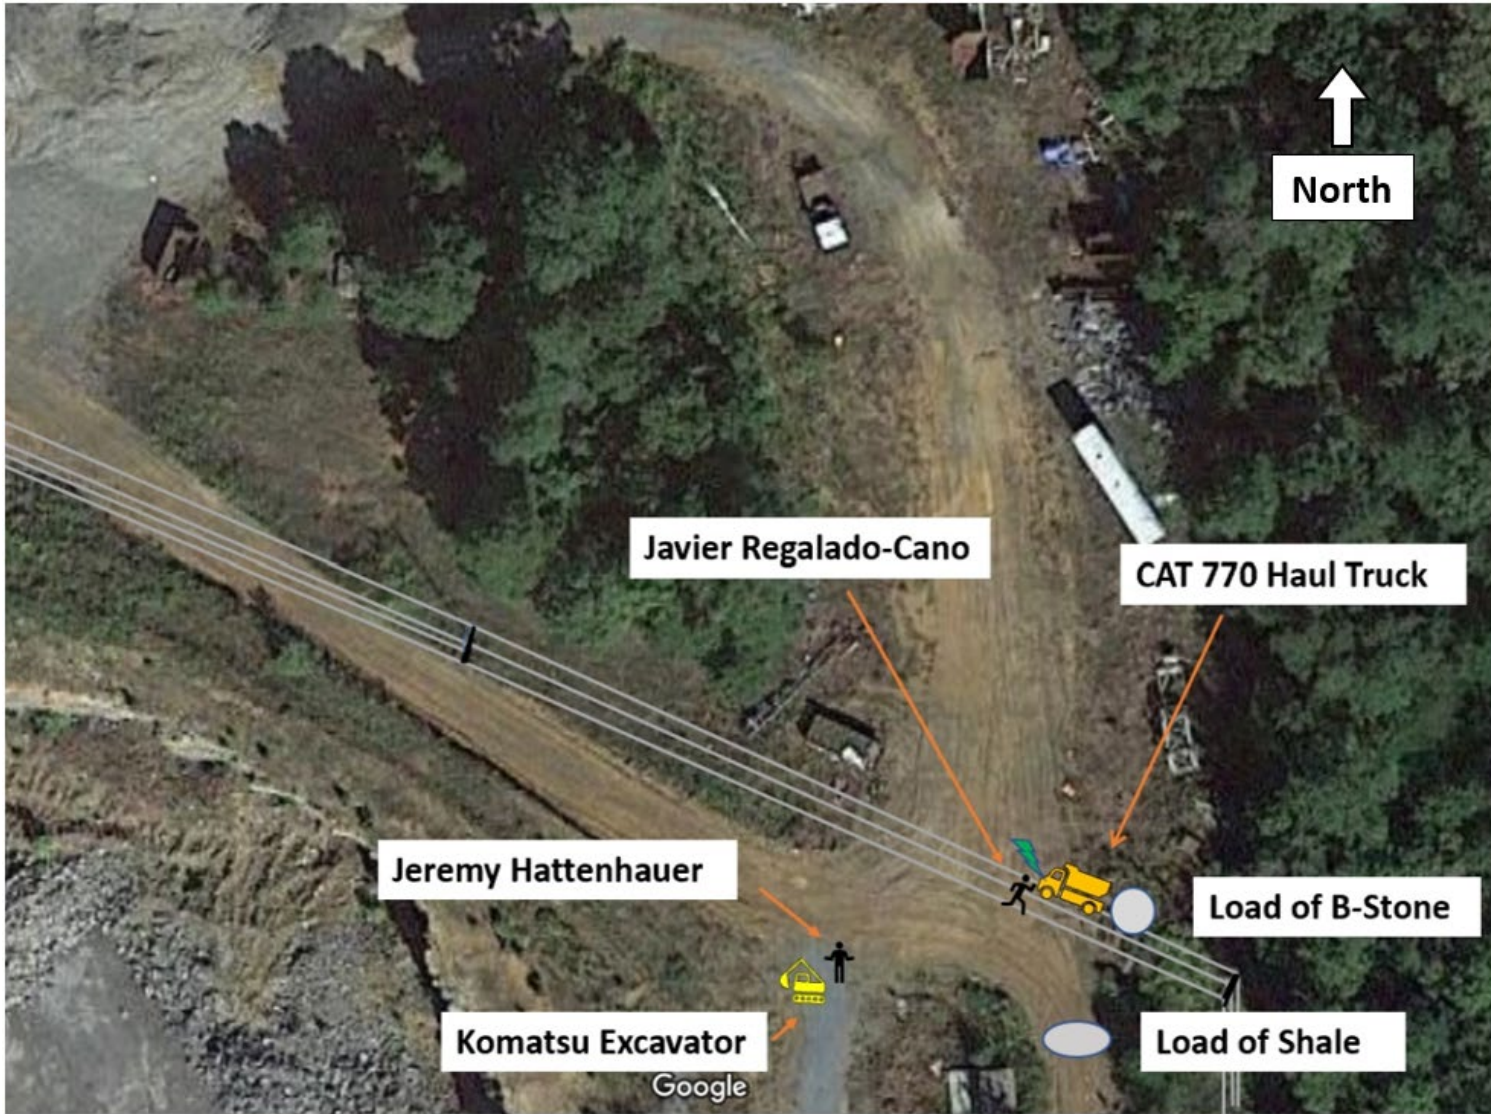
APPENDIX A – Aerial View of the Accident Scene

Regalado told Hattenhuaer that he would lower the bed and move his haul truck in order to examine the tires. Hattenhuaer walked towards his hydraulic excavator when he heard Regalado yell at him. When he turned around, Regalado was pointing up at his haul truck’s bed where it was touching the power lines. Hattenhuaer yelled “no” as Regalado touched the energized handrail of the haul truck and fell to the ground.

Entergy Power Co. owns the power lines and has a right of way to cross the mine's property. The 13,800 phase-to-phase power lines cross over the Stripping Road near the gate. At the location of the accident, the lowest two lines were energized 13,800-volt power lines at 26.5 feet above the ground. When raised, the truck bed height was over 27 feet and within reach of the energized power lines. Members of mine management travel this road daily. The power lines are obvious and low hanging in relation to the size of the equipment operated in the area.

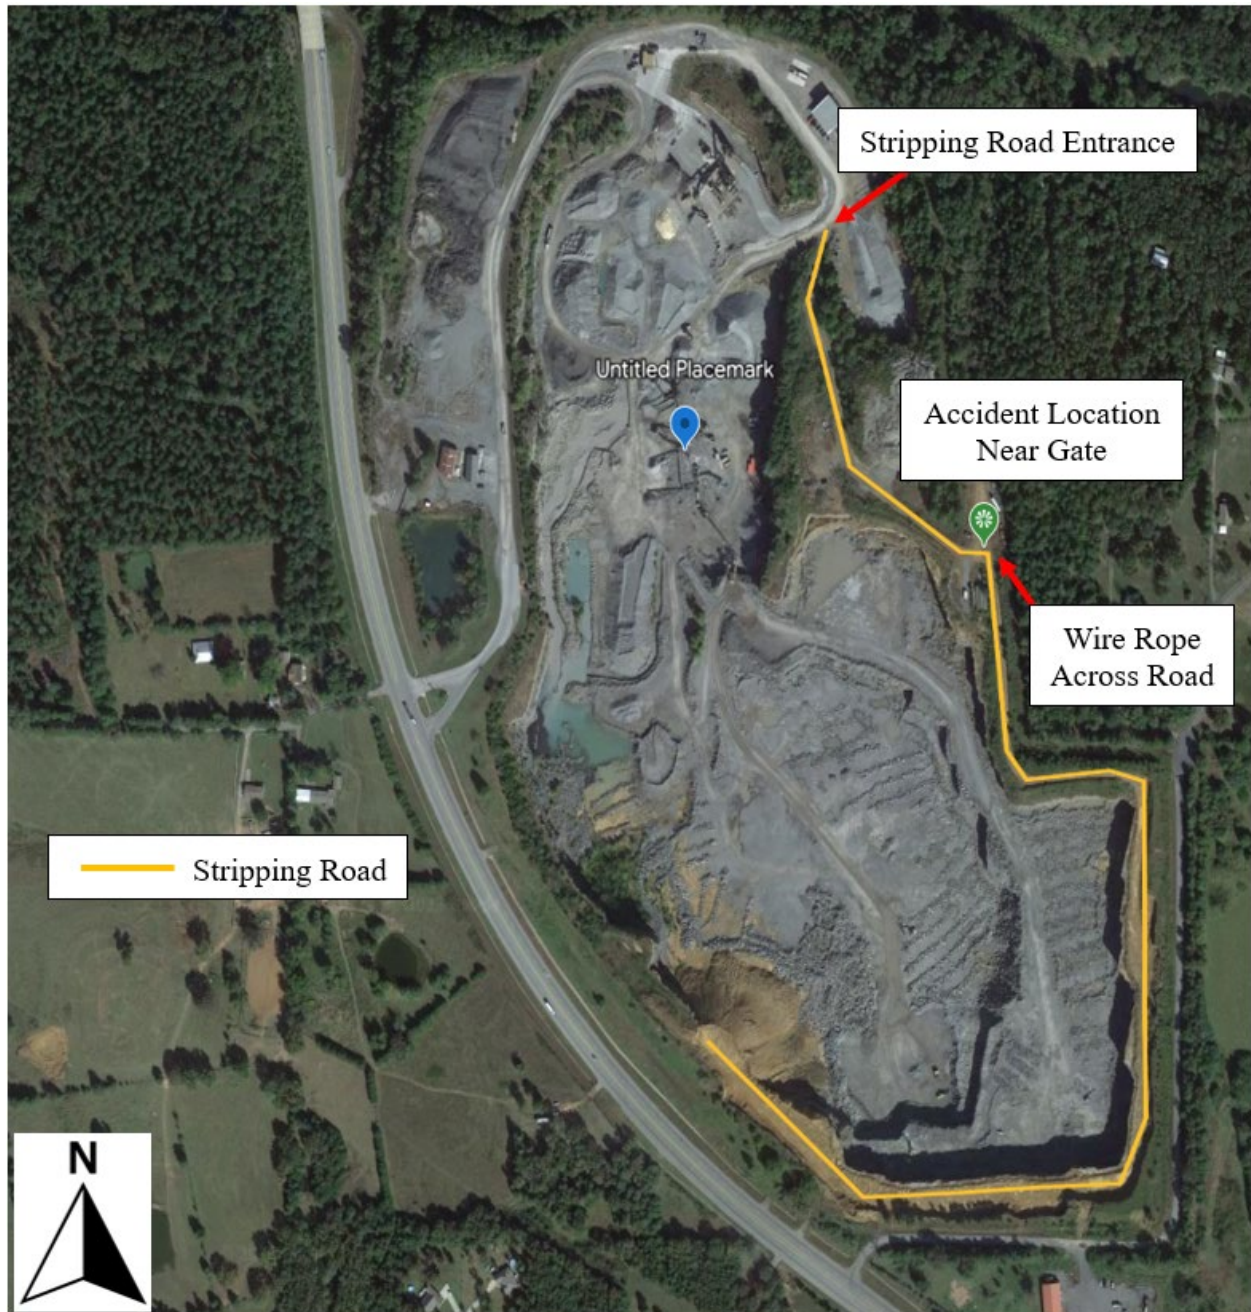
APPENDIX C – Aerial View of Greenbrier Quarry & Stripping Road

The accident occurred at the gate on the Stripping Road (see Appendix C).

There was a warning sign for power lines at the entrance onto the Stripping Road. The entrance to the Stripping Road is approximately 1,151 feet from the accident location and the warning sign at the entrance cannot be seen from the accident location. There are three places along the Stripping Road where equipment can cross under the power lines. The first crossing is at the scrap metal yard, 621 feet from the warning sign. The second crossing begins 635 feet from the

danger sign and continues under the power lines for approximately 175 feet. The third crossing is over 100 feet wide and located at the intersection of the boneyard access and the Stripping Road, 1,111 feet from the warning sign. All three crossings are out of sight of the danger sign posted at the entrance to the Stripping Road. Investigators found another warning sign hidden in the grass some distance from the road. The second sign faced away from the road and was not visible from the road. The mine operator did not install warning devices conspicuously marking the overhead high-voltage power that were directly above the area where Regalado raised the bed of his haul truck. Investigators determined that this contributed to the accident.

Corrective Action: The mine operator submitted a written plan to install suitable danger signs visible from all approaches for all the major high-voltage overhead power lines at the Greenbrier Quarry.

Corrective Action: The mine operator submitted a written plan to lower the road and install markers on the power lines.
