REPORT OF INVESTIGATION

Surface  
(Construction Sand and Gravel)

Fatal Machinery Accident  
June 1, 2023

Hockley Plant  
Alleyton Resource Company, LLC.  
Hockley, Harris County, Texas  
ID No. 41-03491

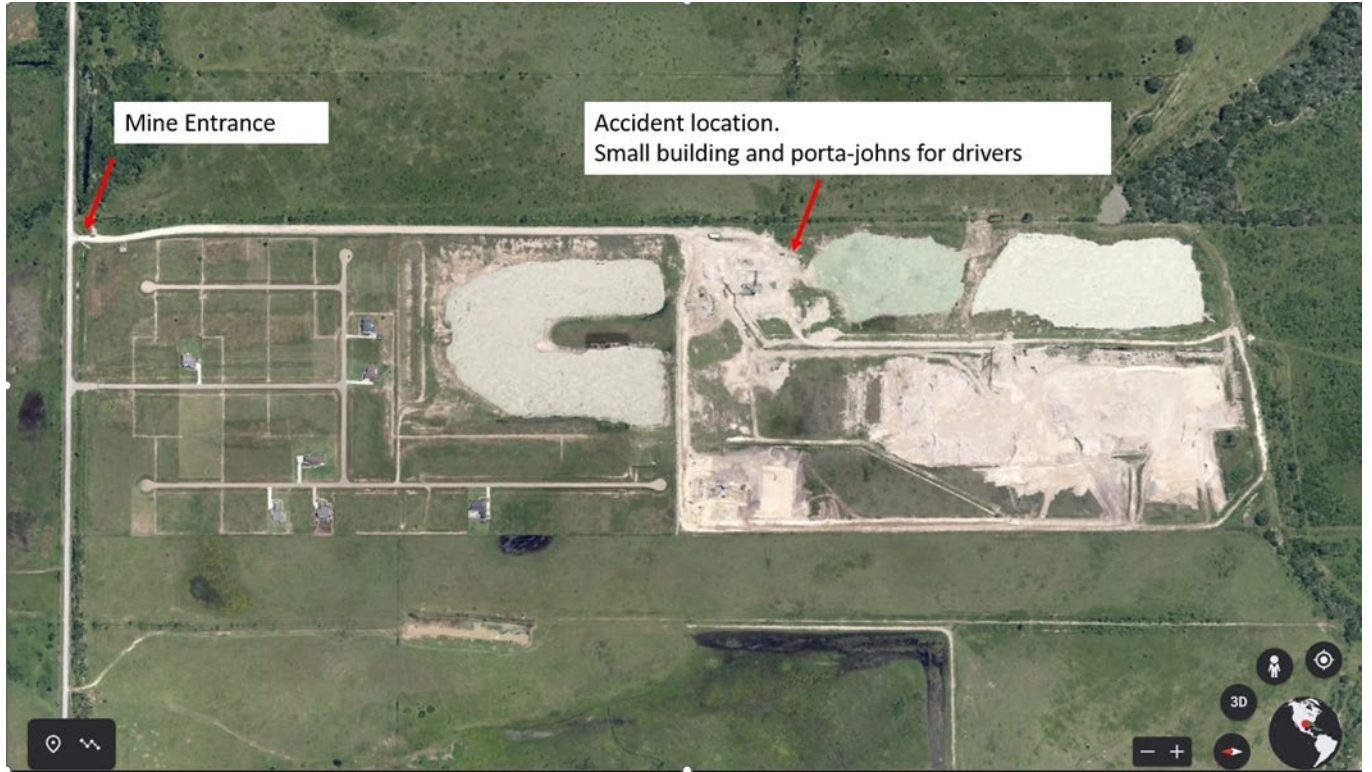
APPENDIX B – Location of the Accident

The accident occurred at the customer staging area and outside of the breakroom located in the mine site (see Appendix B).

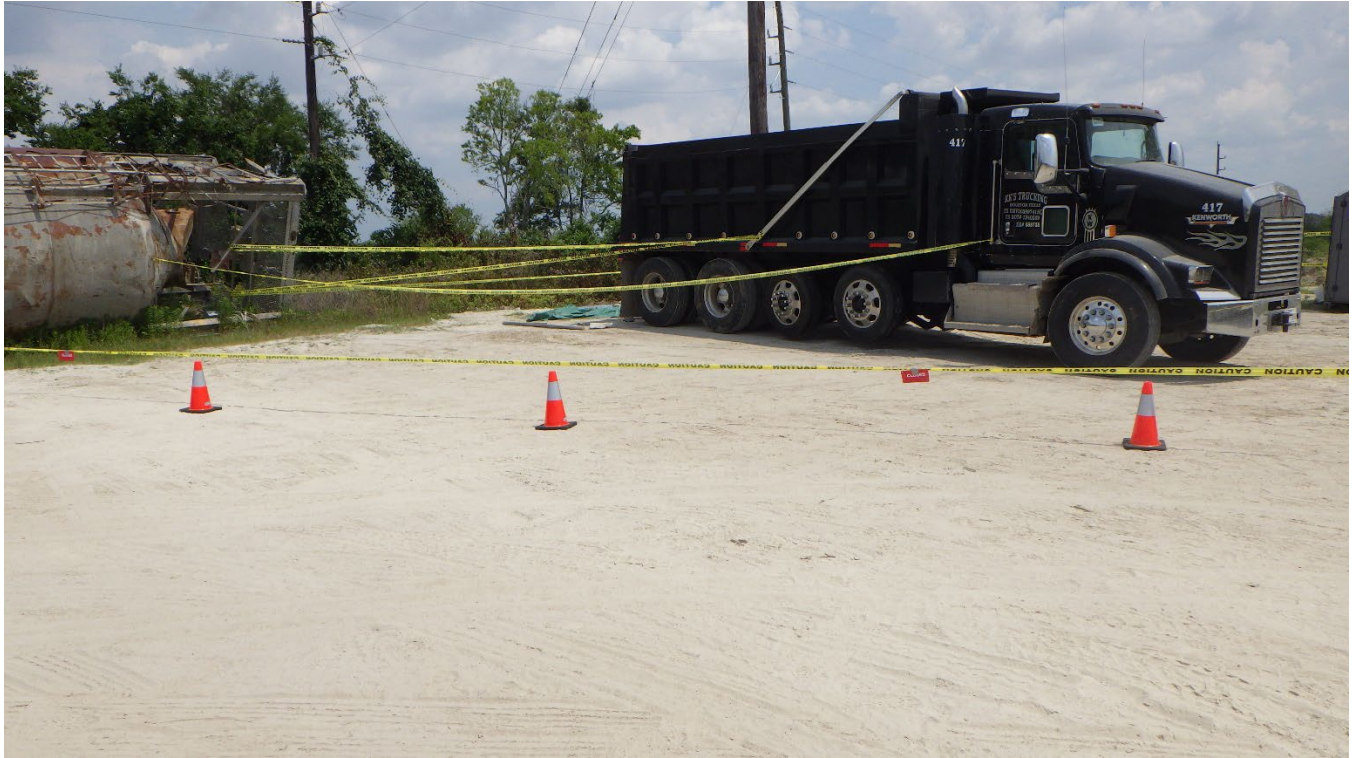
APPENDIX C – Kenworth T880 Quad Axle Dump Truck

The over-the-road haul truck involved in the accident was a 2013 Kenworth T880 quad axle dump truck (see Appendix C). Investigators discovered the right rear passenger side suspension assembly had a missing mounting bolt that was never found after the accident. Investigators believe this bolt was improperly installed and became dislodged during travel at some point off the mine site. The mine operator did not ensure the machinery was blocked against hazardous motion before Martinez began repair work, which contributed to the accident. Investigators examined the rest of the truck and did not find any other mechanical deficiencies or defects that would have contributed to the accident.

Corrective Action: The mine operator established a new procedure preventing anyone that is not an employee or a designated contractor of Hockley Plant from performing maintenance or repairs while on their property. The mine operator has trained, and will continue to train, all customer truck drivers on their new procedure.
