REPORT OF INVESTIGATION

Surface  
(Crushed and Broken Stone)

Fatal Slip or Fall of Person Accident  
June 8, 2023

N Attleboro Plant  
Boro Sand & Stone Corp  
North Attleboro, Bristol County, Massachusetts  
ID No. 19-00290

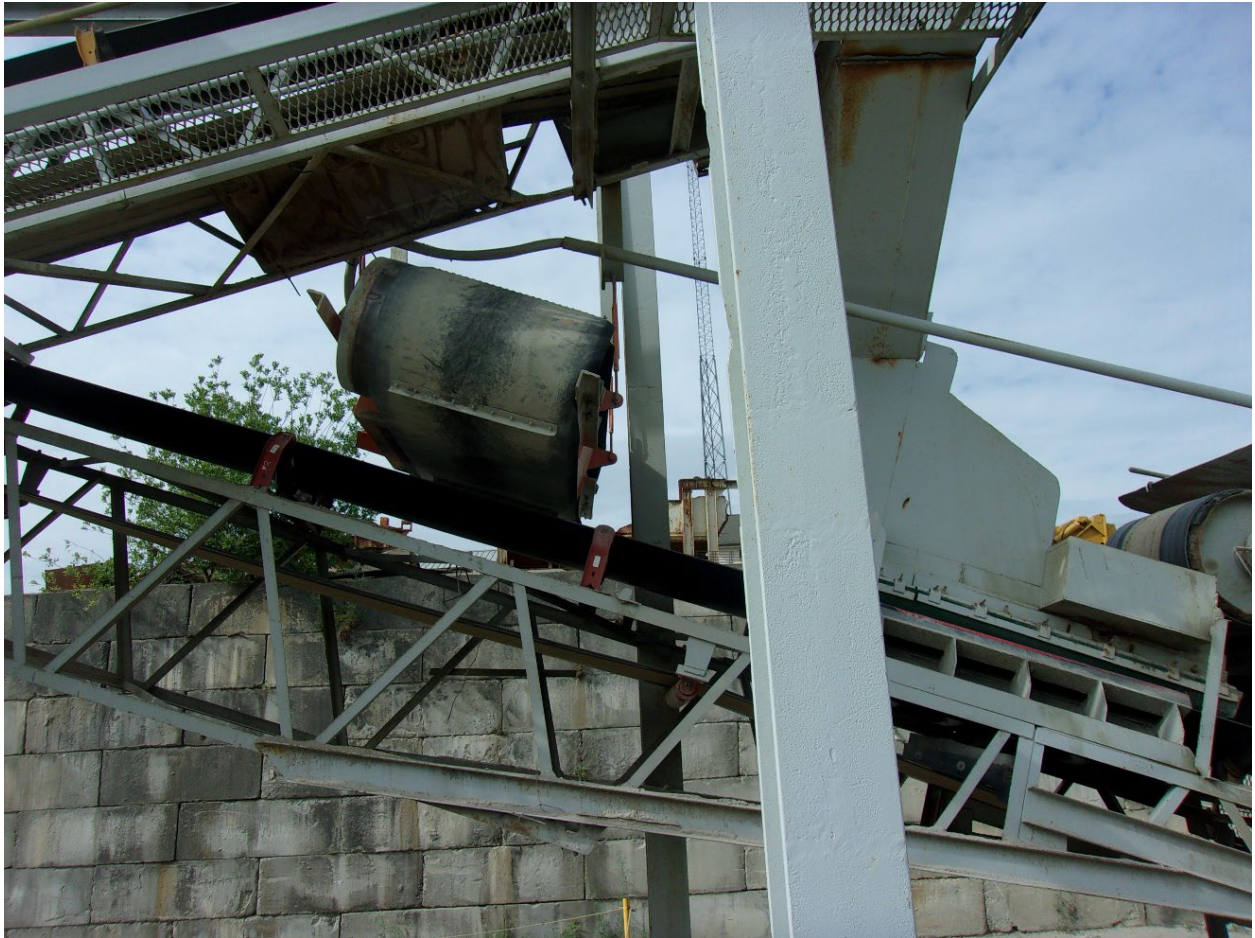
APPENDIX B – Eriez Magnet Belt Conveyor

The accident occurred at the Eriez Magnet Belt Conveyor (see Appendix B).

The belt conveyor involved in the accident was an Eriez Magnet Belt Conveyor Model Number SE323 that was installed over 20 years prior to the accident. This conveyor is used to remove ferrous metal from the material feed during processing. The 30-inch-wide belt conveyor was approximately 16 feet above ground level and installed with a 15-degree horizontal slope to match the inclination of the No. 2 Belt Conveyor located directly beneath it. The Eriez Magnet Belt Conveyor was controlled by a timer and cycled on automatically at preset intervals of ten minutes, without warning, to transfer ferrous metals to the collection area below.

The mine operator did not provide a safe means of access for the Eriez Magnet Belt Conveyor for the miners to perform maintenance, repairs, and adjustments. There was no written procedure for performing maintenance and repairs on the Eriez Magnet Belt Conveyor. Mine management stated miners could access the magnet belt using a ladder and fall protection tied off to a cable on an I-beam. However, investigators did not find a cable on the I-beam for miners to tie off to. There was a personnel lift available; however, the personnel lift was not usable to access the Eriez Magnet Belt Conveyor according to management. Investigators determined this contributed to the accident.

On June 8, 2023, a fatal accident occurred at this mine when a miner fell approximately 16 feet from the Eriez Magnet Belt Conveyor. The miner accessed the Eriez Magnet Belt Conveyor by climbing over and onto two other belt conveyors to perform maintenance. While the miner was standing on the top of the Eriez Magnet Belt Conveyor, the conveyor cycled on, throwing the miner off the belt to the ground below. The mine operator did not provide safe access to the Eriez Magnet Belt Conveyor.

Corrective Action: The mine operator developed and implemented a new written procedure to provide safe access for performing maintenance, repairs, and adjustments to the Eriez Magnet Belt Conveyor. The mine operator installed new work platforms and provided ladders to access the areas while performing maintenance and repairs. The mine operator trained miners on the use of this safe access.

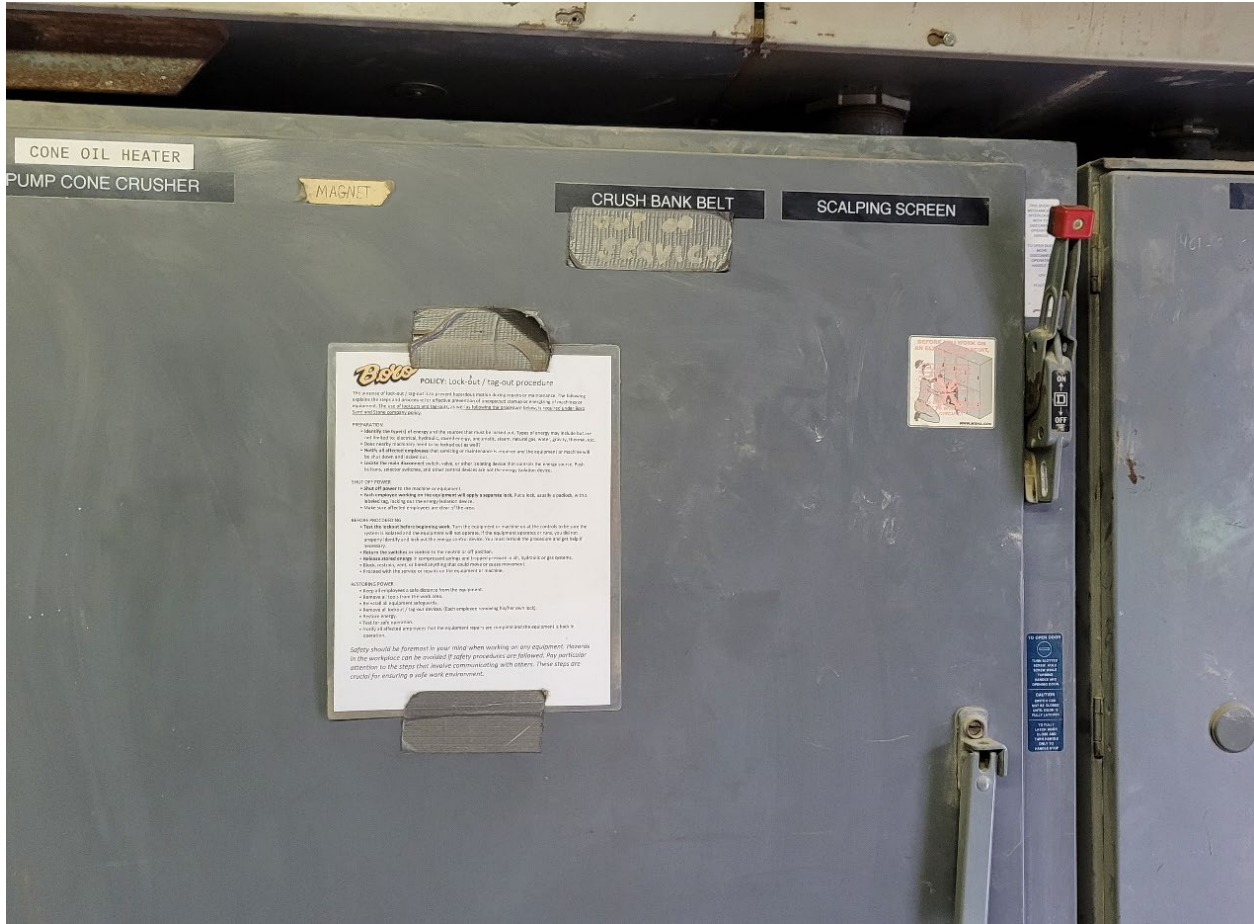
# APPENDIX C – Power Supply for the Eriez Magnet Belt Conveyor

The disconnect panel for the Eriez Magnet Belt Conveyor, located in the electrical room, had the mine's lock-out, tag-out procedure posted on it (see Appendices C and D), and a lock and tag was available for use. Investigators determined that Ayick shut down the Return Belt Conveyor and the No. 2 Belt Conveyor but did not shut down the Eriez Magnet Belt Conveyor and did not lock-out and tag-out the disconnect. The mine operator did not ensure the belt conveyor was de-energized and blocked against hazardous motion before Ayick performed maintenance, which contributed to the accident.

On June 8, 2023, a fatal accident occurred at this mine when a miner fell approximately 16 feet from the Eriez Magnet Belt Conveyor. The miner accessed the Eriez Magnet Belt Conveyor to perform maintenance without de-energizing, locking out, and tagging out the conveyor, which was the only effective means to block the conveyor against motion while conducting maintenance. When the miner accessed the top of the Eriez Magnet Belt Conveyor, the conveyor cycled on, throwing the miner off the belt to the ground below. The mine operator did not ensure the Eriez Magnet Belt Conveyor was de-energized and blocked against hazardous motion prior to the miner performing maintenance.

Corrective Action: The mine operator retrained all miners in 1) blocking machinery and tools against hazardous motion during maintenance and repairs, and 2) lock-out tag-out procedures.
