REPORT OF INVESTIGATION

Powered Haulage Accident
September 12, 2023

Cape Sandy #1
Mulzer Crushed Stone Inc
Leavenworth, Crawford County, Indiana
ID No. 12-00084

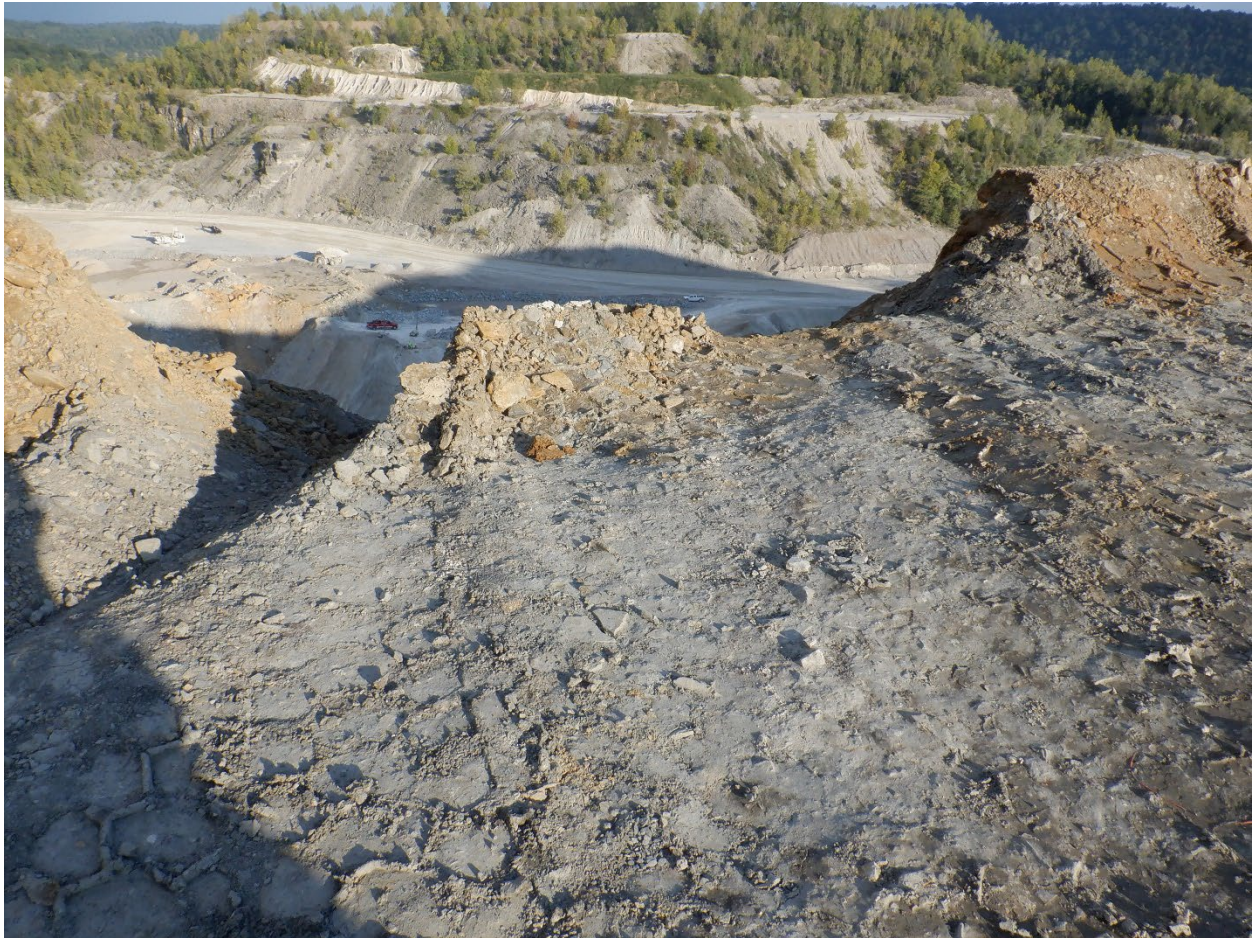
APPENDIX C – Broken Berm Post Accident

The haul truck operators were dumping material over the edge of the Exit Road Spoil Pile at the time of the accident. The haul truck had a mid-axle height of 52 inches. Measurements of the berm taken after the accident on the Exit Road Dump Site revealed heights ranging from 21 inches to 38 inches (see Appendix C). Investigators determined that the berms were unsubstantial. The mine operator built the berms with unconsolidated material (dirt and rock) that came to a narrow, tapered point at the top. At the time of the investigation, the dump site was relatively dry.

Tire tracks on the berm revealed that haul truck operators were backing up to and contacting the berm when dumping. Interviews indicated this was a common practice. Information gathered from the mine operator's survey shows that from the dump point to the water was approximately 250 feet vertically. The haul truck flipped down the 71 percent slope of unconsolidated material, coming to rest in the water approximately 350 feet East of the dump site. Investigators determined that the mine operator did not ensure the berm at a dump site impeded the haul truck from overtravel, which contributed to the accident.

On September 12, 2023, a fatal accident occurred at this mine when a laborer operating a haul truck traveled through a berm on the Exit Road Spoil Pile dump site and came to rest submerged in a pond. The mine operator did not ensure that the berm was substantial enough to impede overtravel. The berm was narrow at the top and ranged in height from 21 inches to 38 inches while the haul truck involved in the accident had a mid-axle height of 52 inches. The mine operator engaged in aggravated conduct constituting more than ordinary negligence by not constructing berms sufficient to act as dump site restraints. This violation is an unwarrantable failure to comply with a mandatory standard.

Corrective Action: The mine operator retrained all miners on berm construction for dumping locations to impede overtravel.

for adequate inspection, and any deficiencies or unsafe conditions will be noted and remedied. All berms shall be constructed of substantial and primarily non-dirt material, at a minimum mid-axle height of the largest vehicle traveling in the area and shall be maintained to prevent overtravel of berms.
