Refuge Alternative Examinations, Approvals, and Refits

Stakeholder Meeting-MSHA HQ
June 27, 2012

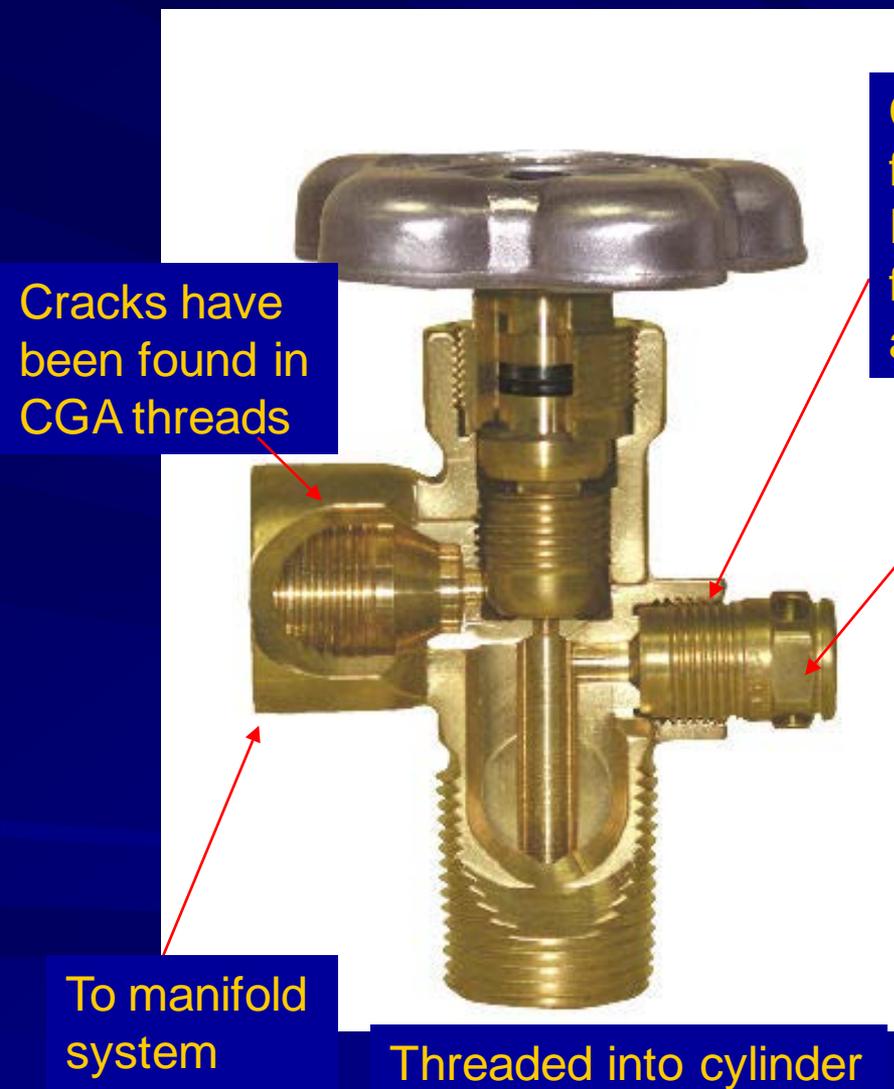
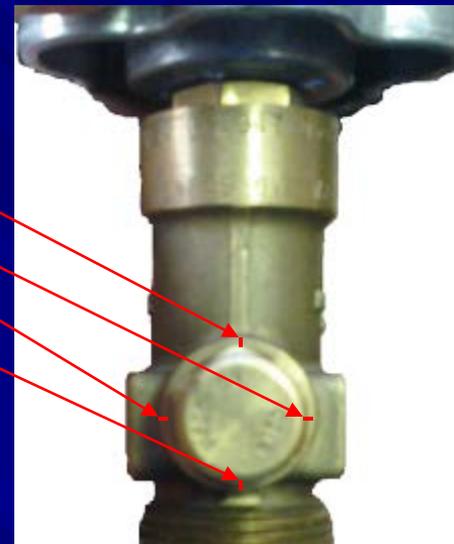
Common Valve Section Indicating Crack Locations

Cracks have been found around PRD boss on forging part line and at 90°

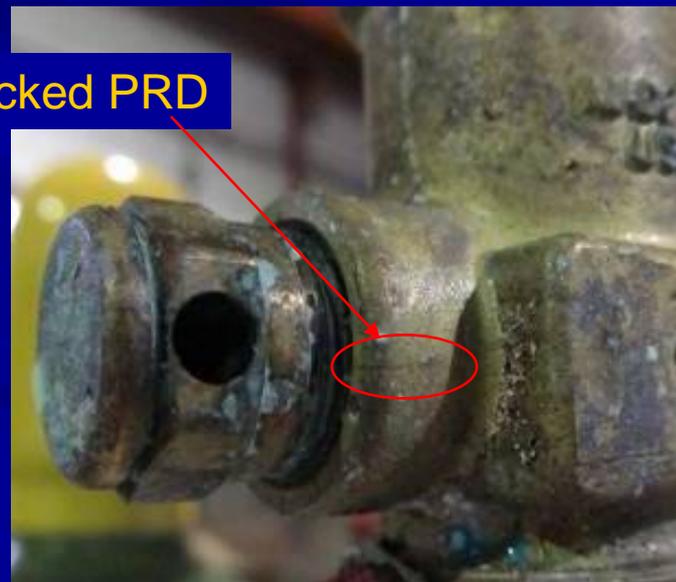
Cracked PRD

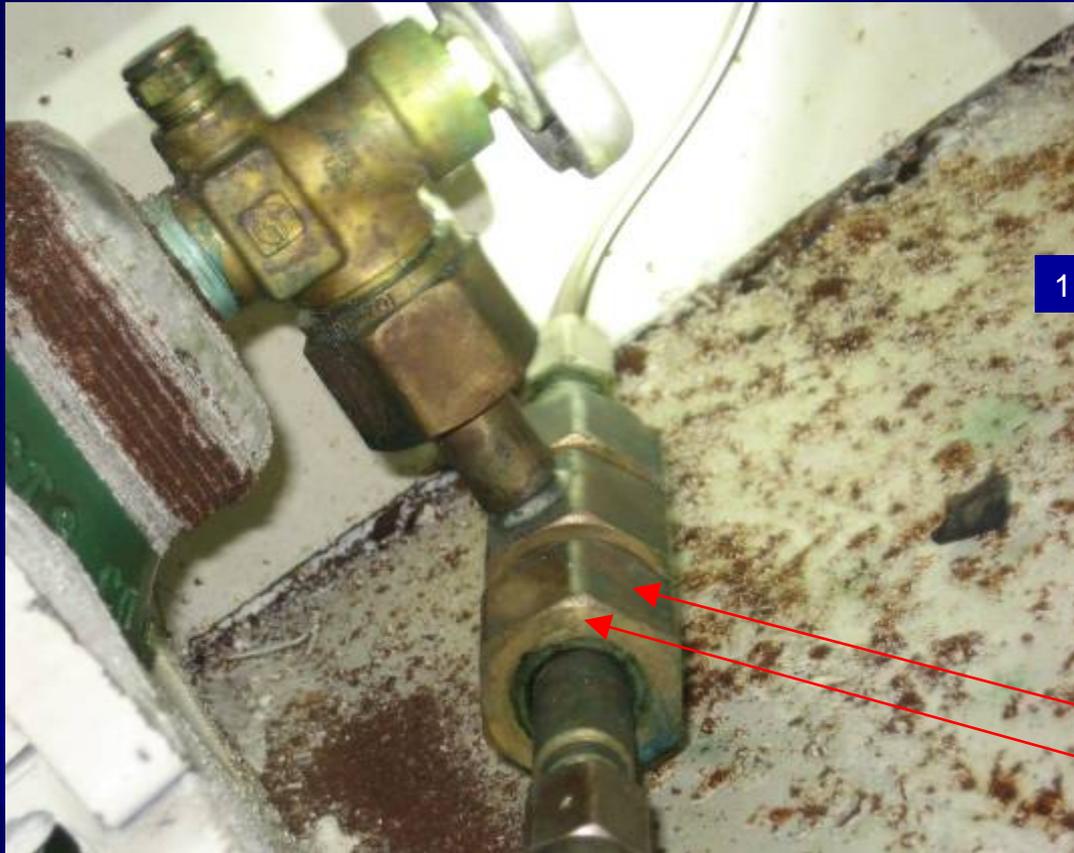
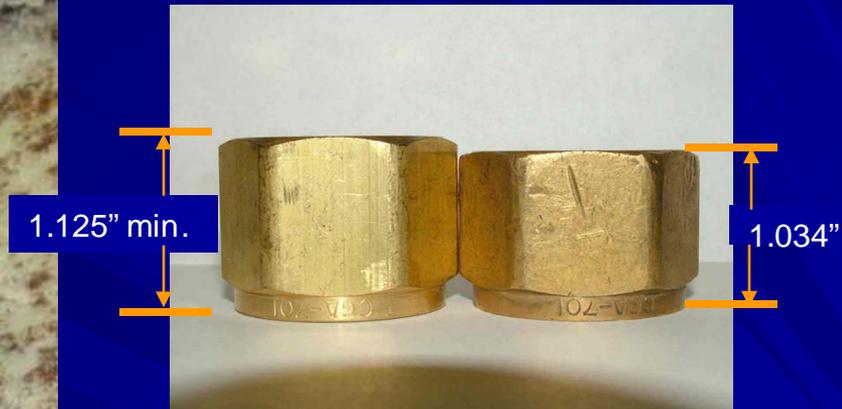
Fitting Dimensions and Crack Locations

CGA 701 Fittings have been found with incorrect dimensions

Cracks have been found on rear face and hex flats

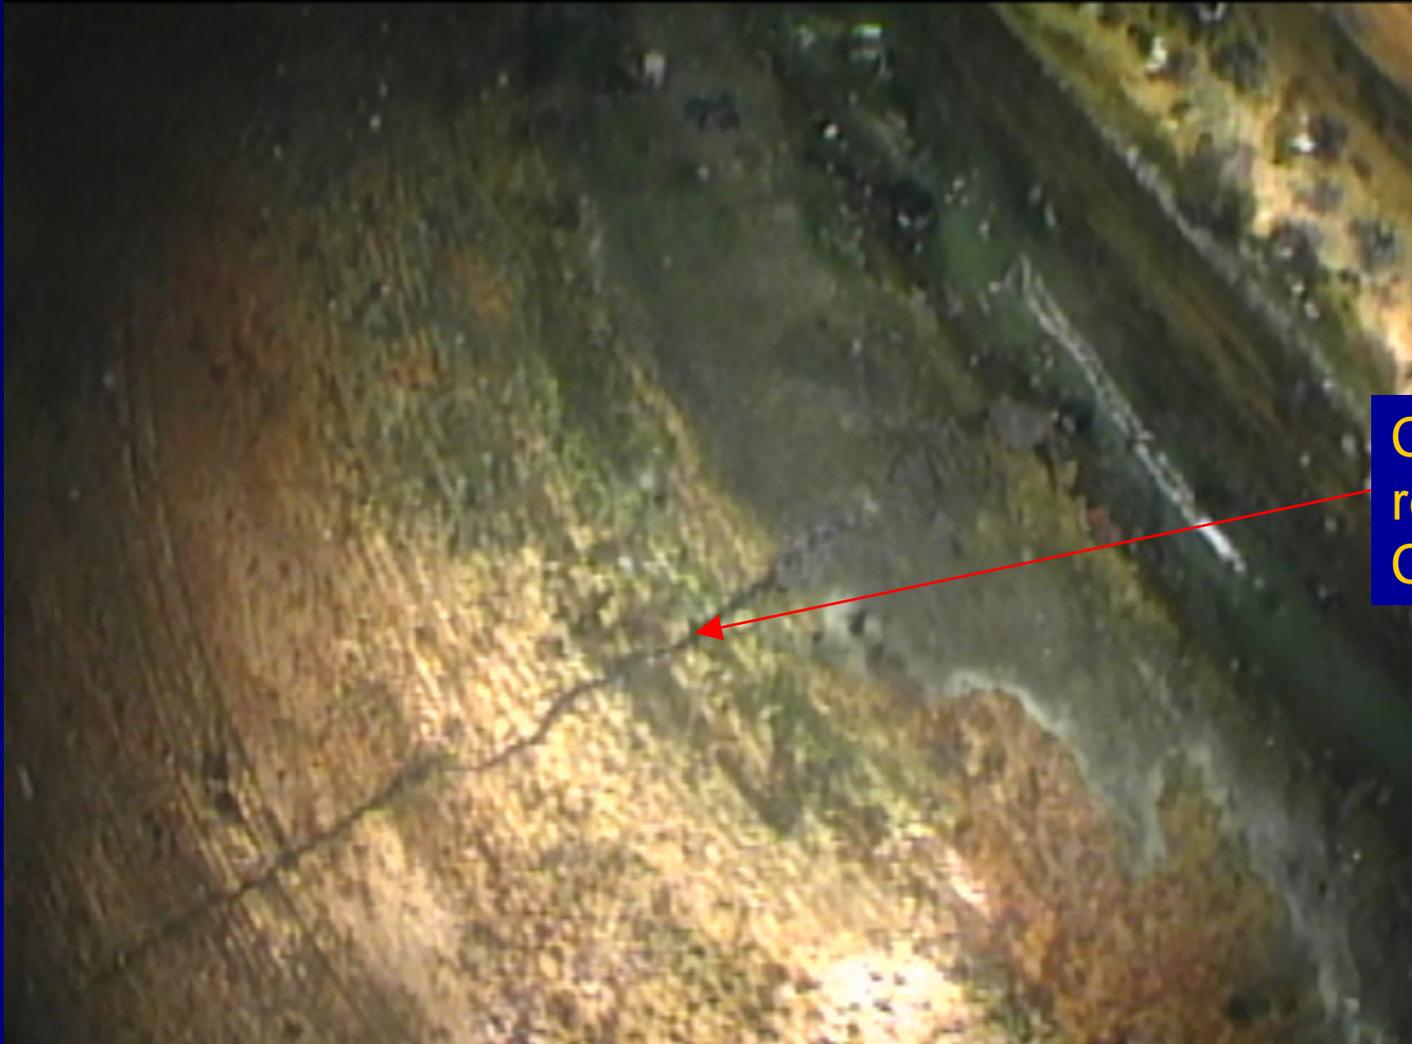
Example of cracks found during follow-up evaluations

Crack found on rear face of CGA 701 fitting

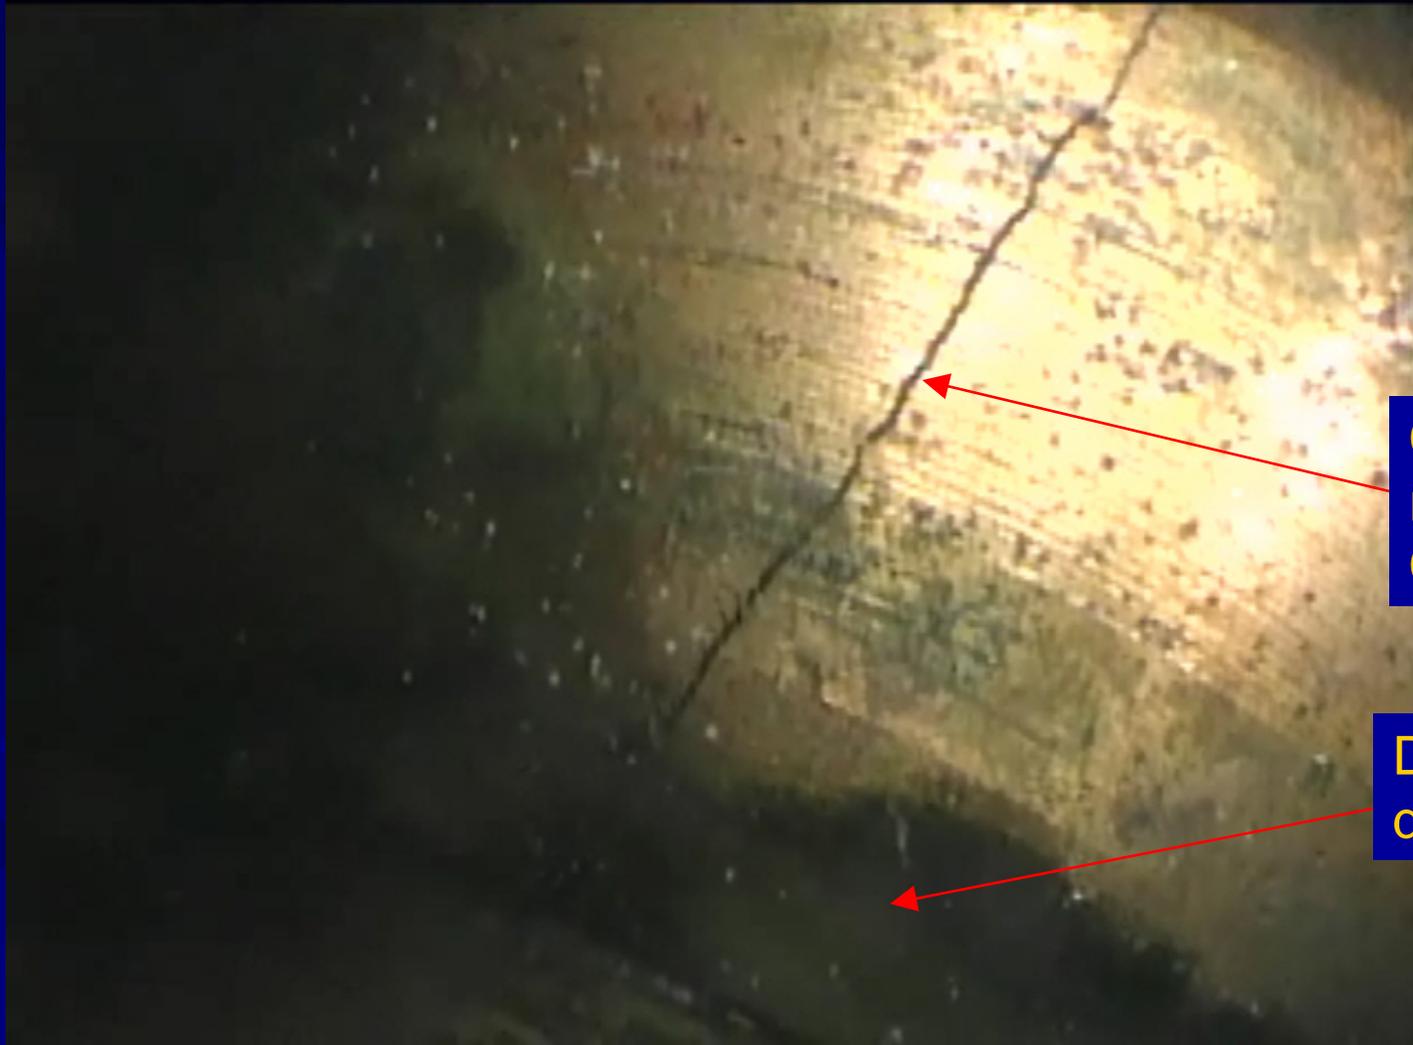
Example of cracks found during follow-up evaluations

Crack found on rear face of CGA 701 fitting

Dried leak detection fluid

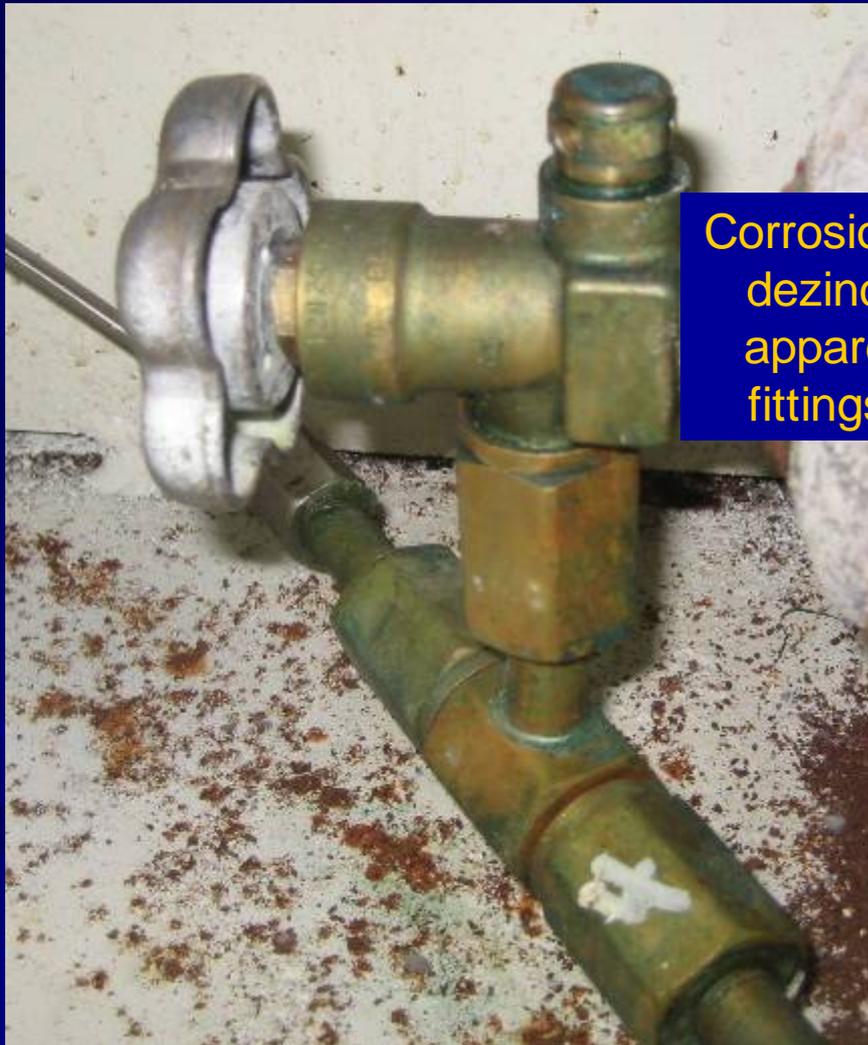
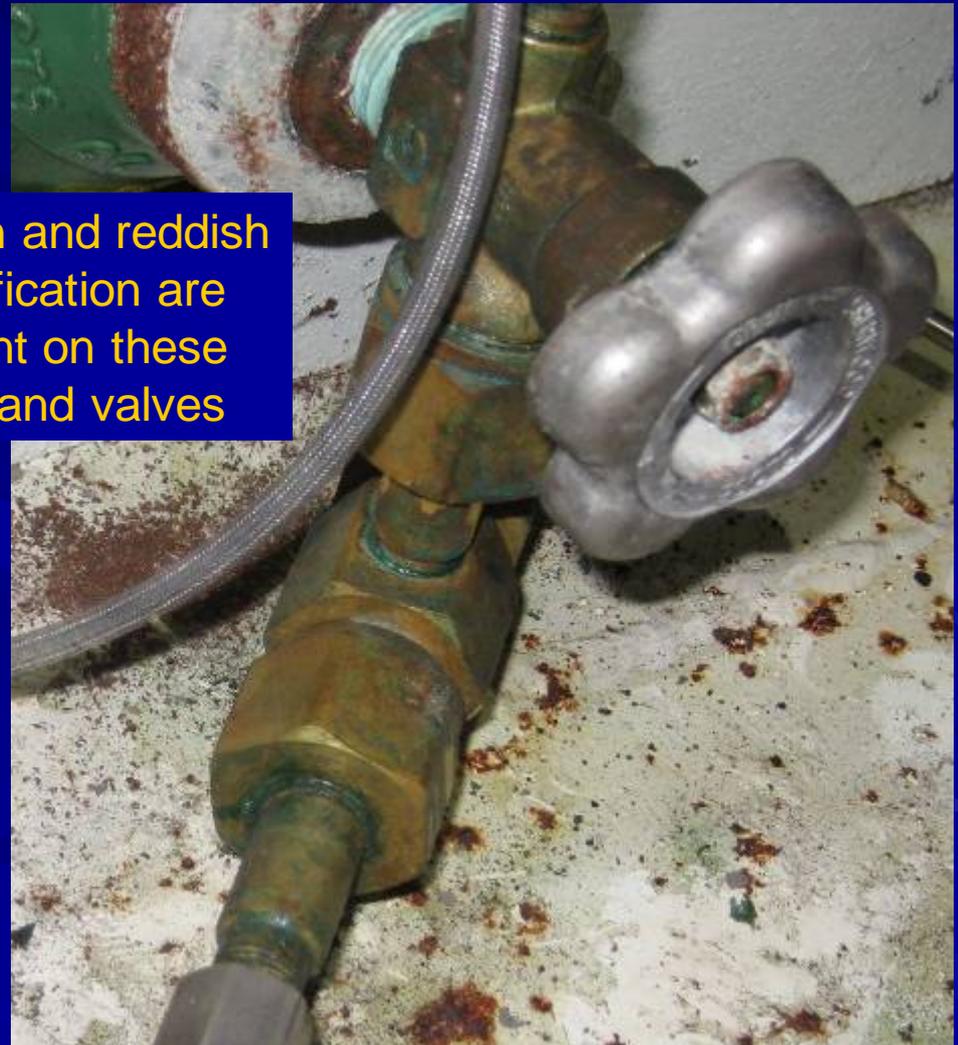
Example of corrosion found during follow-up evaluations

Corrosion and reddish dezincification are apparent on these fittings and valves

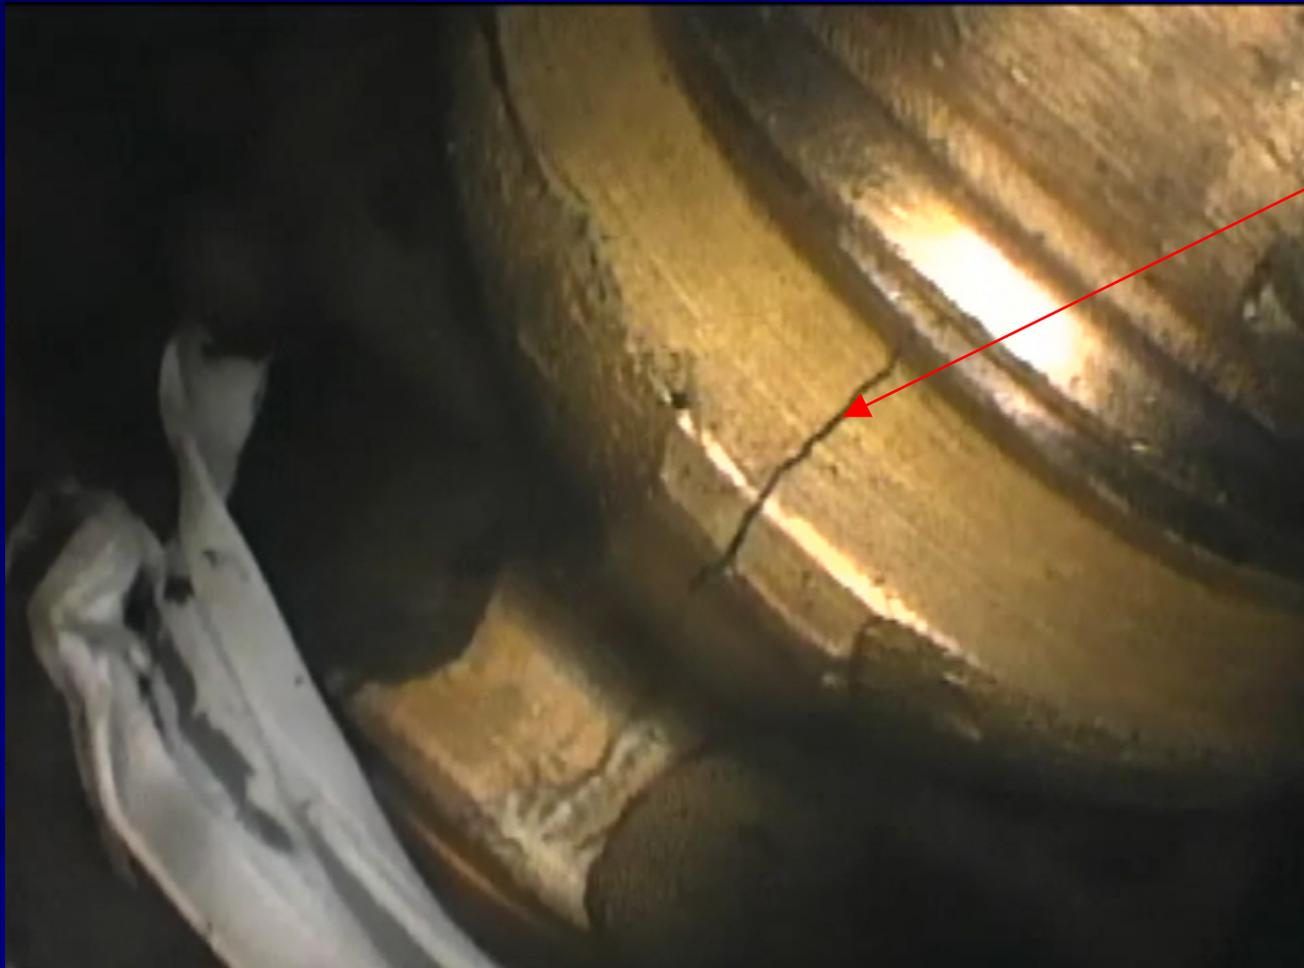
Example of cracks found during follow-up evaluations

Crack around
PRD boss
(view looking down
onto PRD)

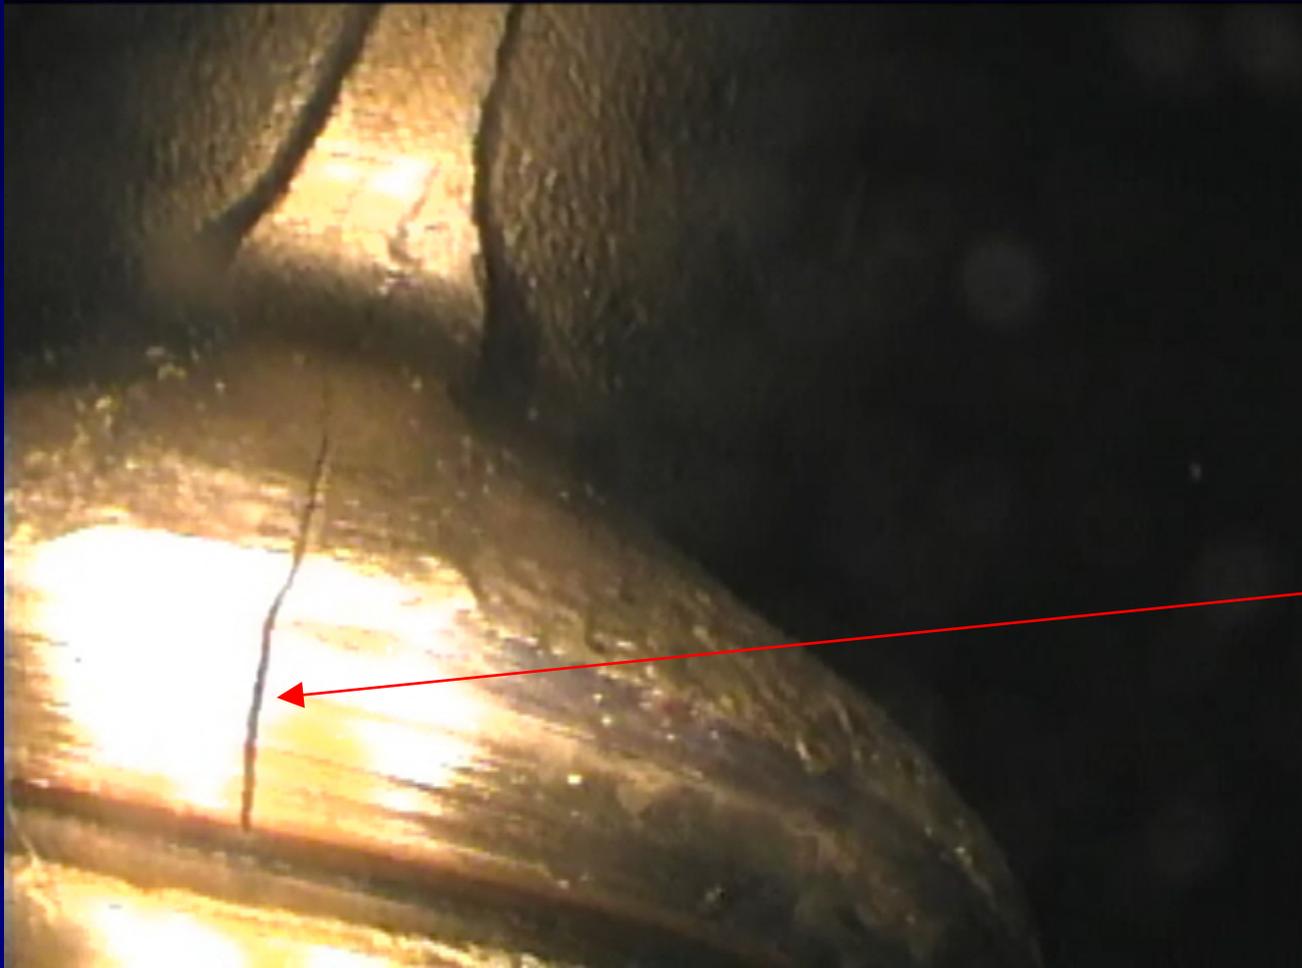
Example of cracks found during follow-up evaluations

Crack around
PRD boss
(view looking down
onto PRD)

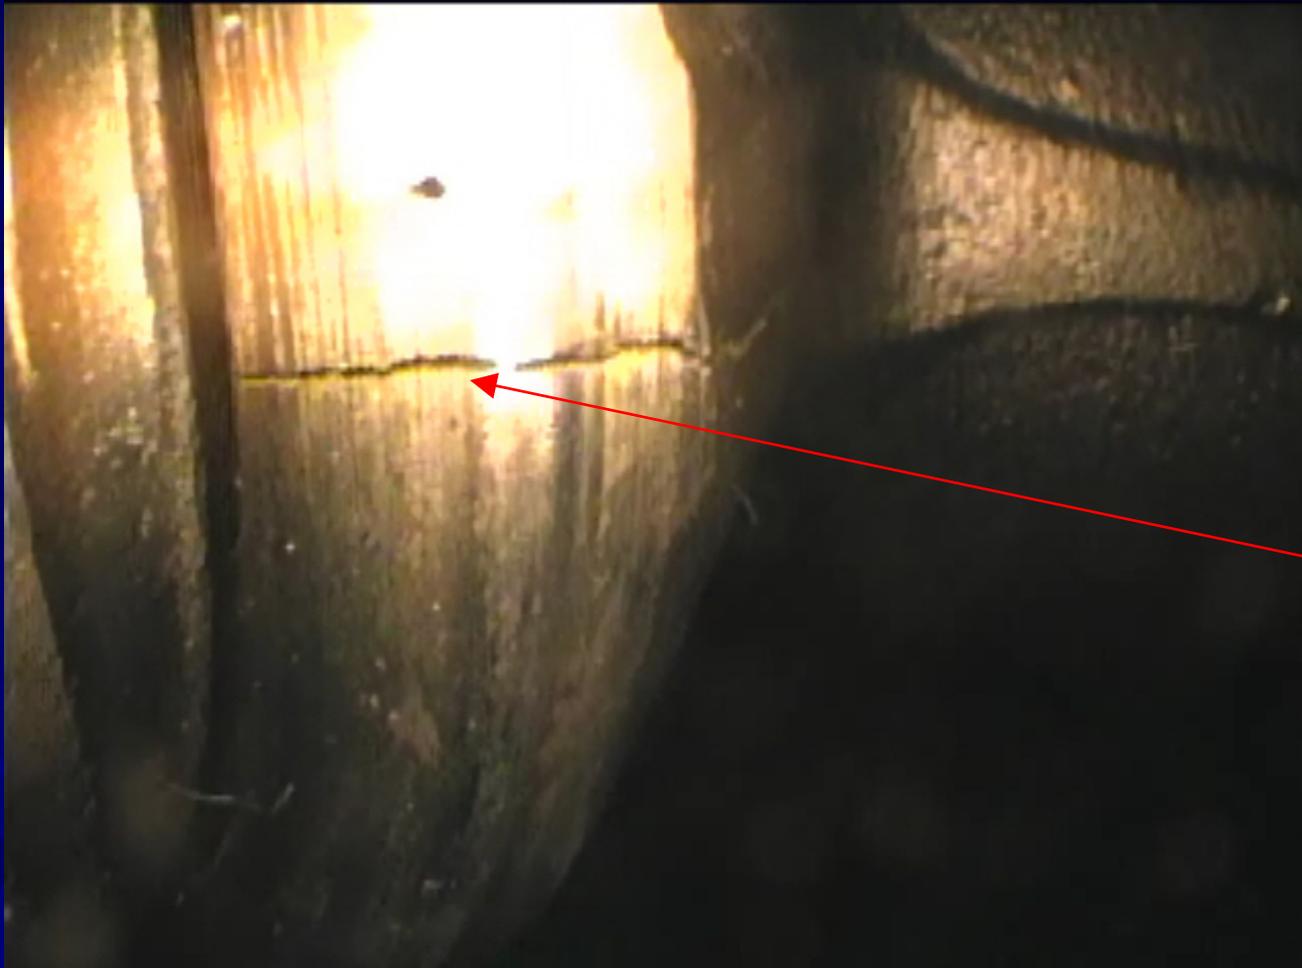
Example of cracks found during follow-up evaluations

Crack around
PRD boss
(view looking down
onto PRD)

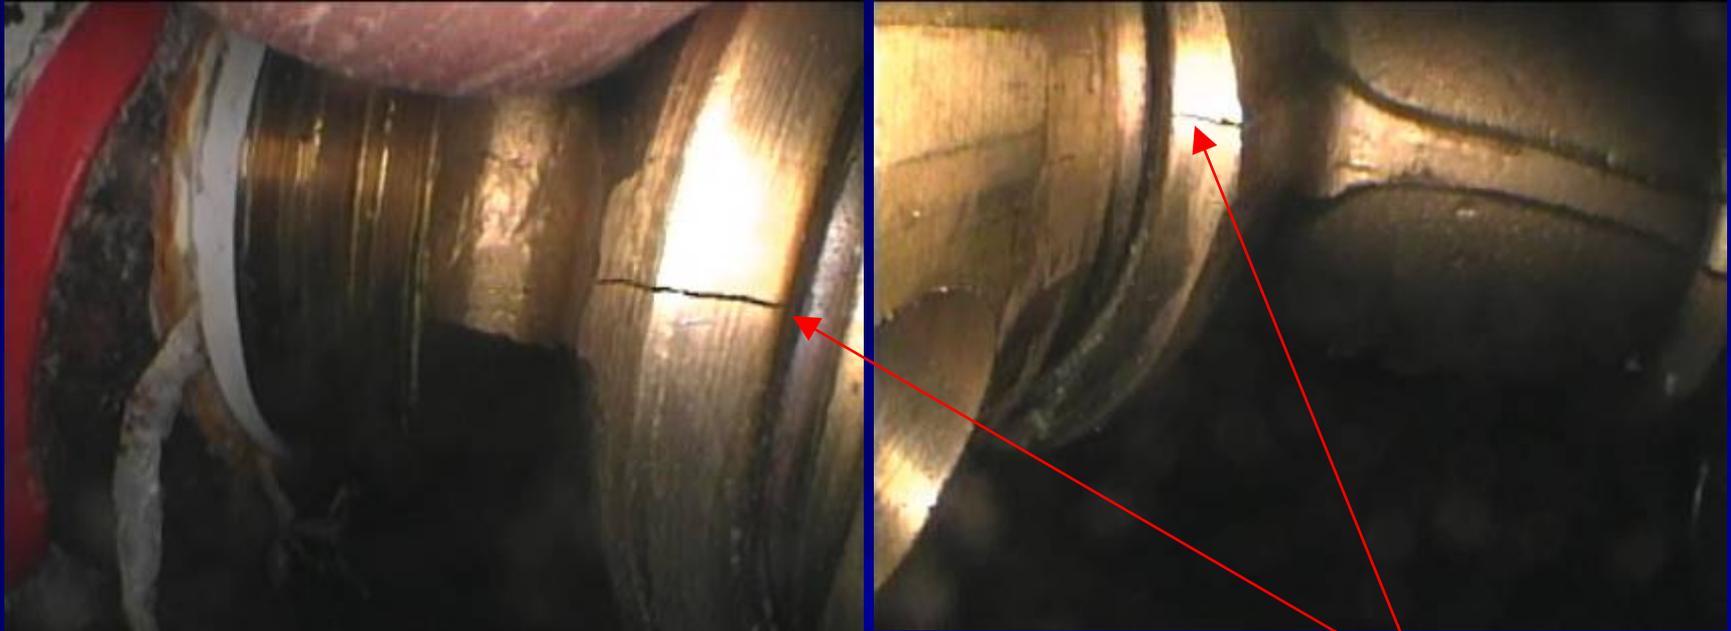
Example of cracks found during follow-up evaluations

Two cracks were found on this cylinder valve

Crack around
PRD boss
(view looking down
onto PRD)

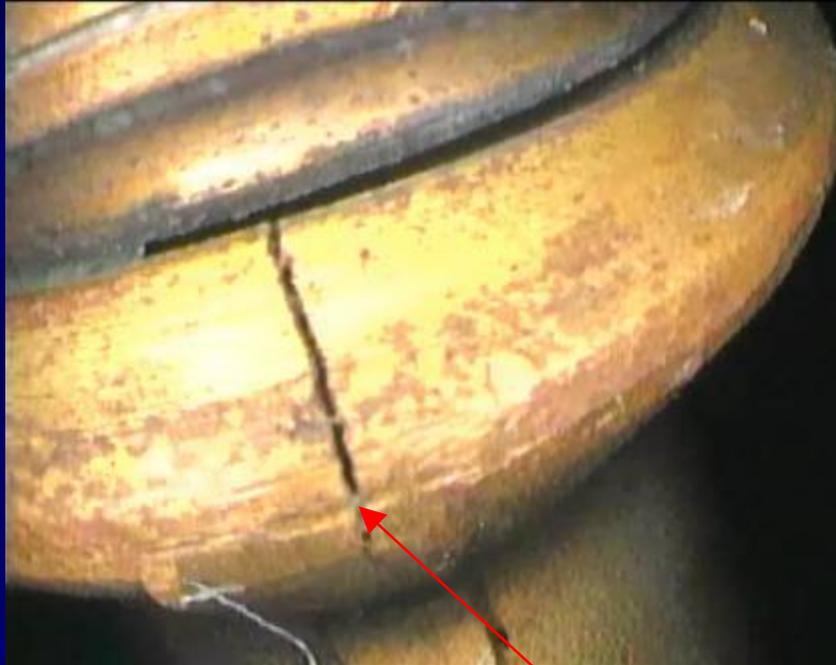
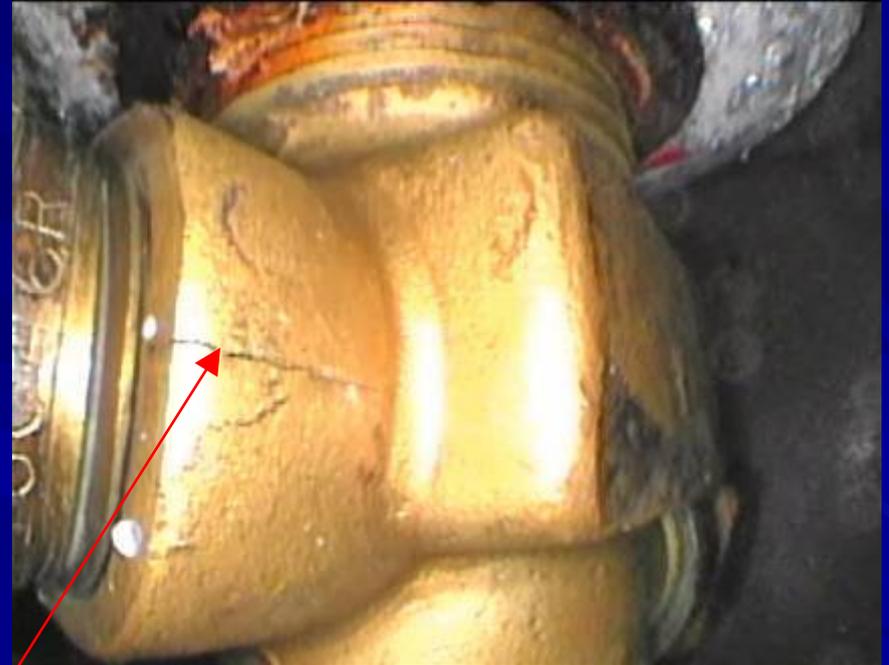
Example of cracks found during follow-up evaluations

Cracks around
PRD boss

Two cracks were found on this cylinder valve

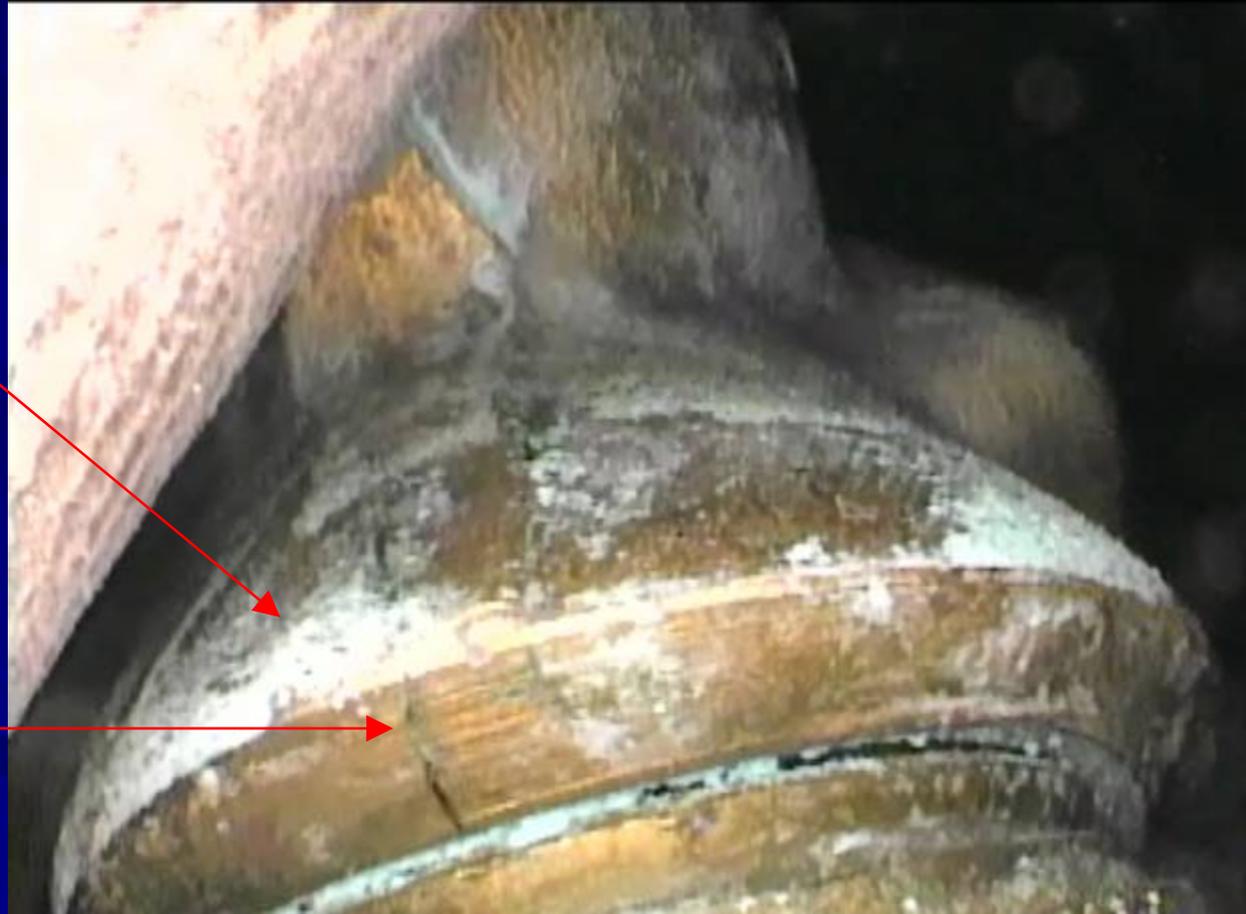
Example of crack and corrosion found during follow-up evaluations

Note white corrosion that was not indicated on examination report

Crack around PRD boss (view looking down onto PRD)

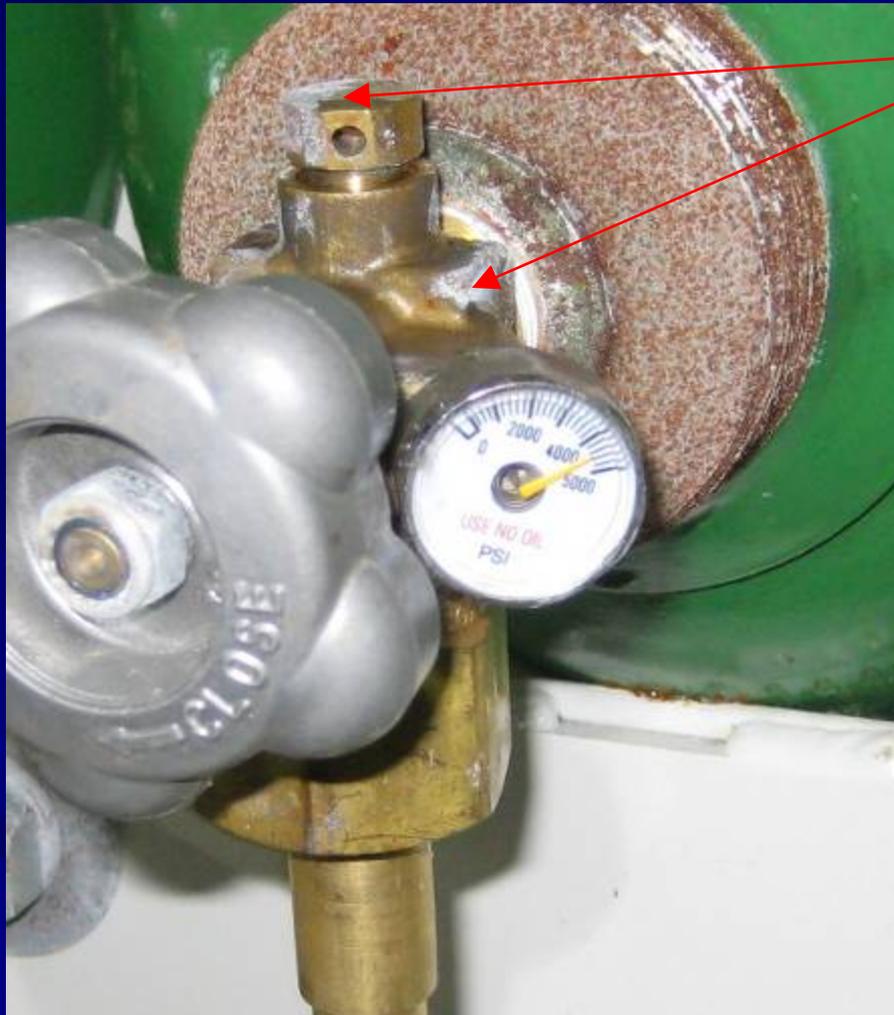
Example of corrosion found during follow-up evaluations

White corrosion is readily visible. This type of corrosion indicates the presence of zinc oxide, which means that the zinc is coming out of the brass matrix, a condition called dezincification.

This condition may lead to stress corrosion cracking.

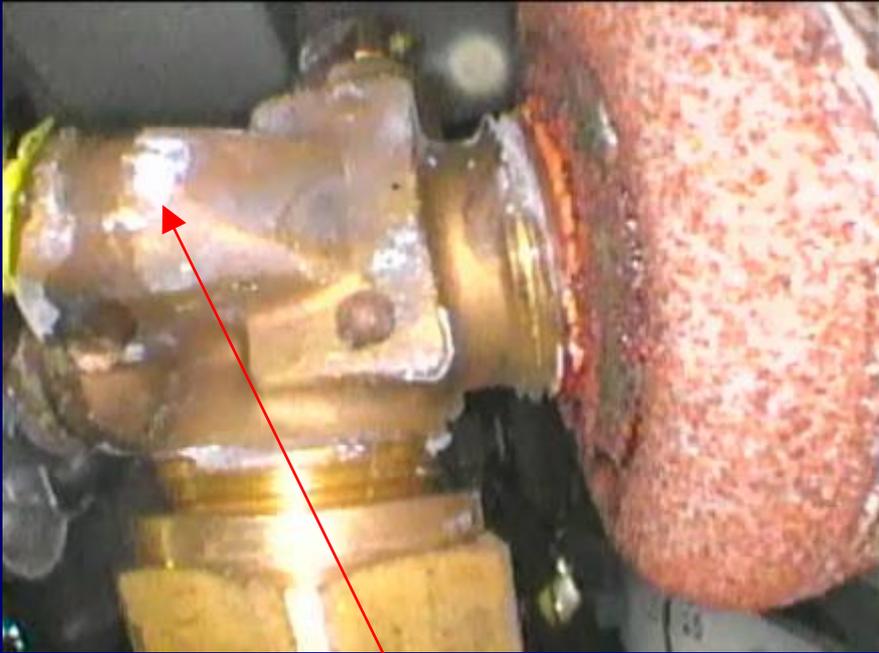
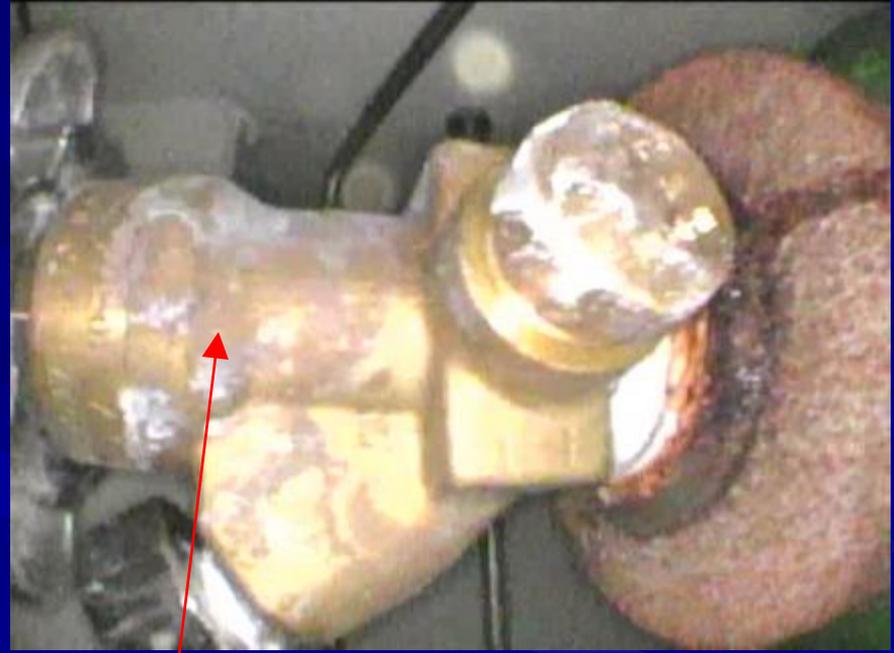
Example of corrosion found during follow-up evaluations

White corrosion is visible along with red discoloration indicating dezincification

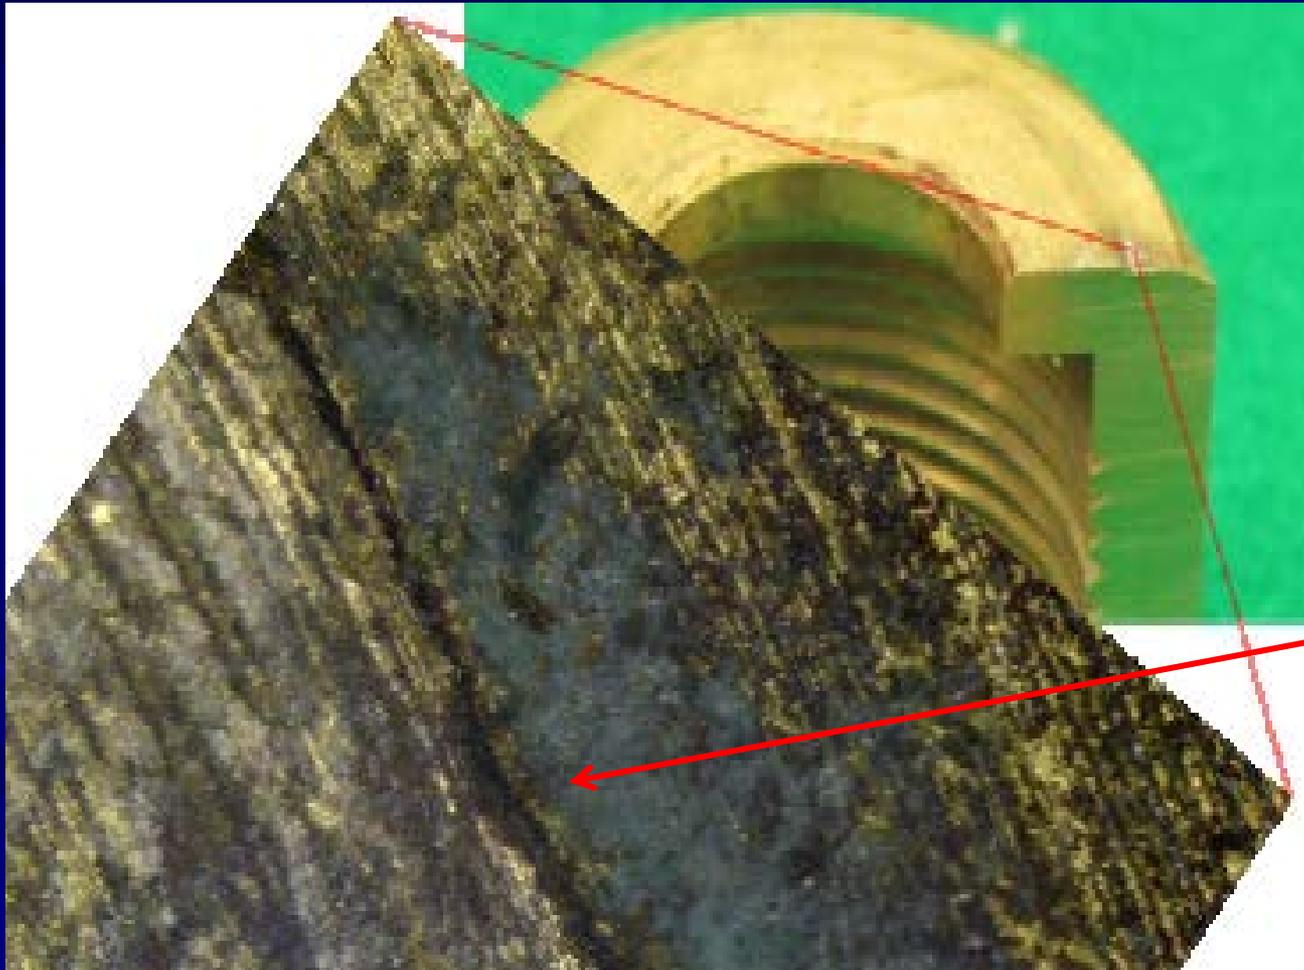
Example of SCC found during initial evaluation

Corrosion formed on surface

Note that on magnification cracks are forming

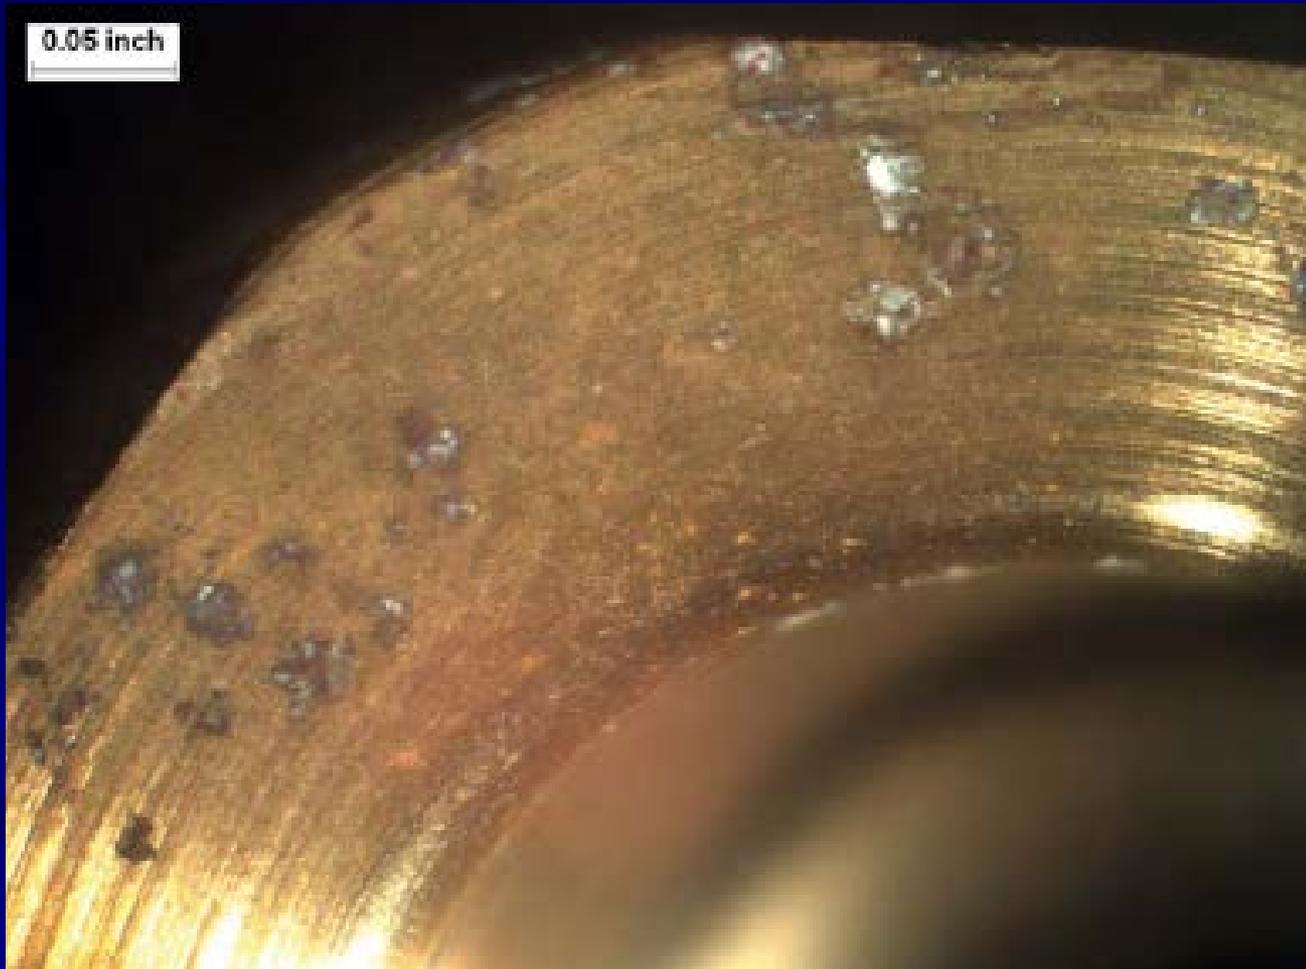
Example of SCC found during initial evaluation

Corrosion forming
on surface of
otherwise shiny
brass

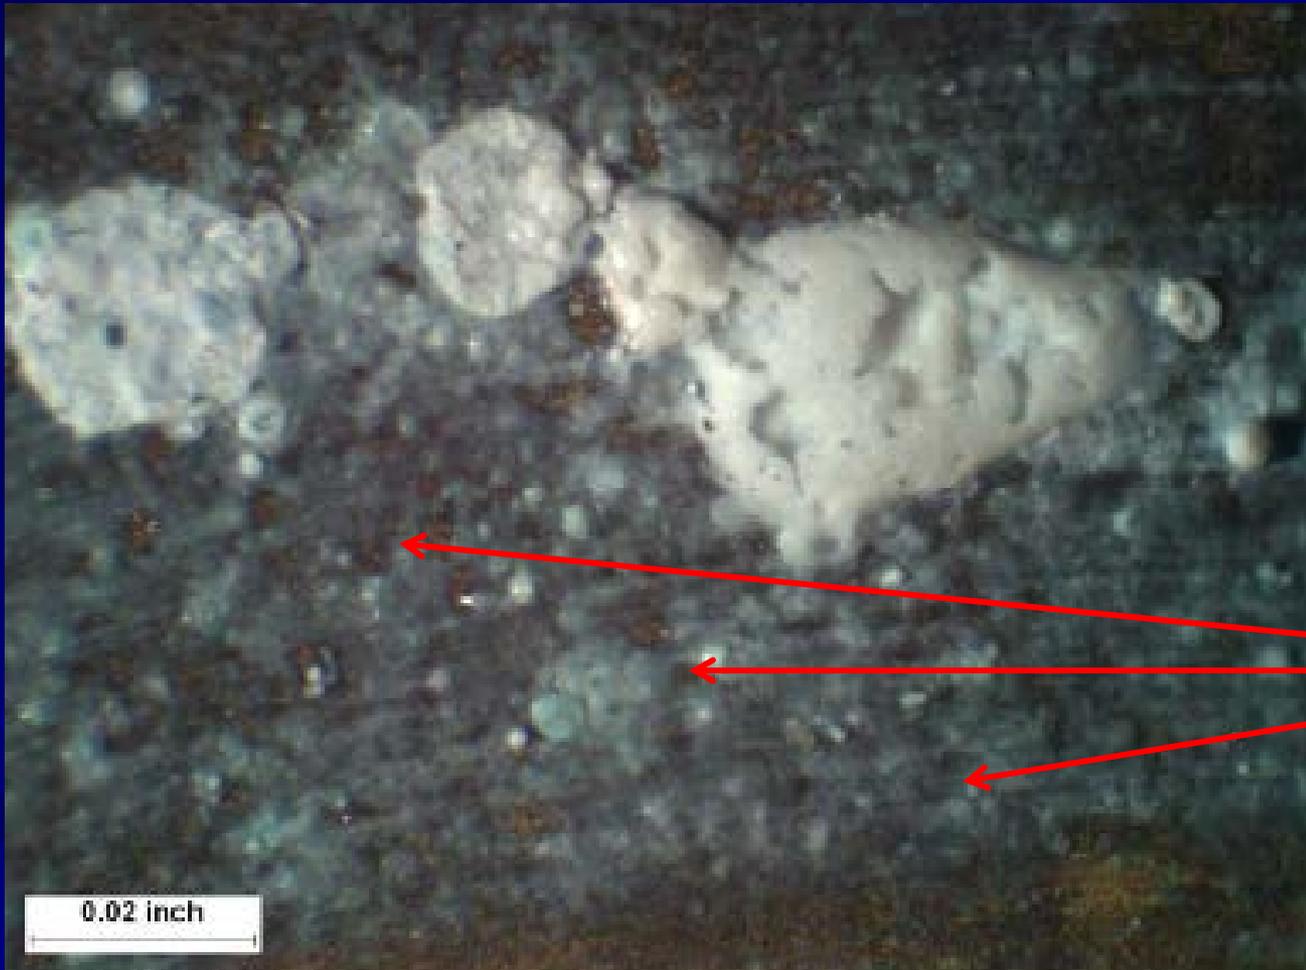
Example of SCC found during initial evaluation

Corrosion formed on surface

note the pitting

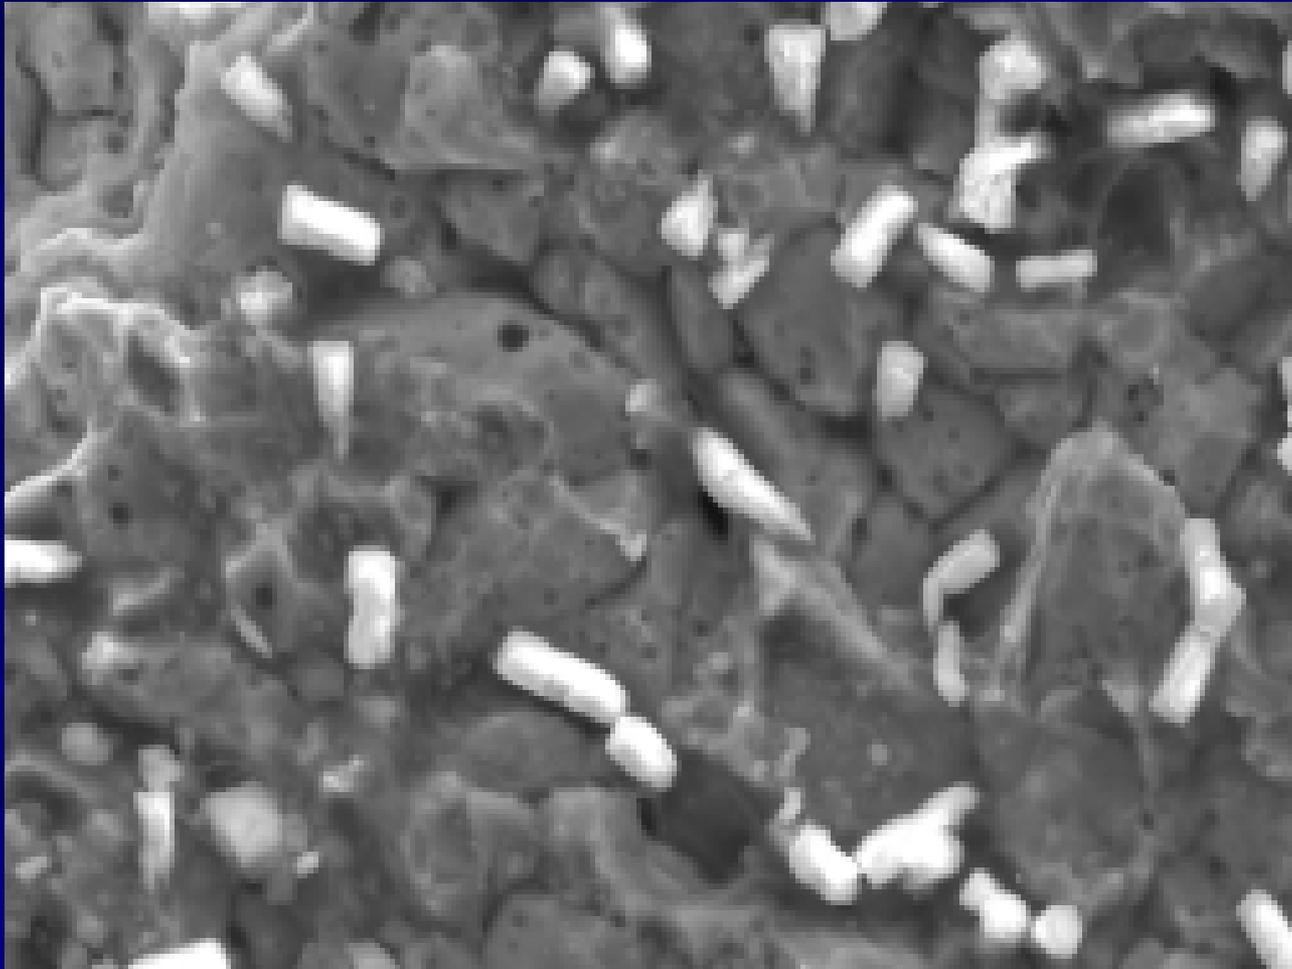
Example of zinc oxide found during initial evaluation

Zinc oxide formed on brass leaving spongy copper metal
