Refuge Alternative Examinations, Approvals, and Refits

Stakeholder Meeting-MSHA HQ
June 27, 2012

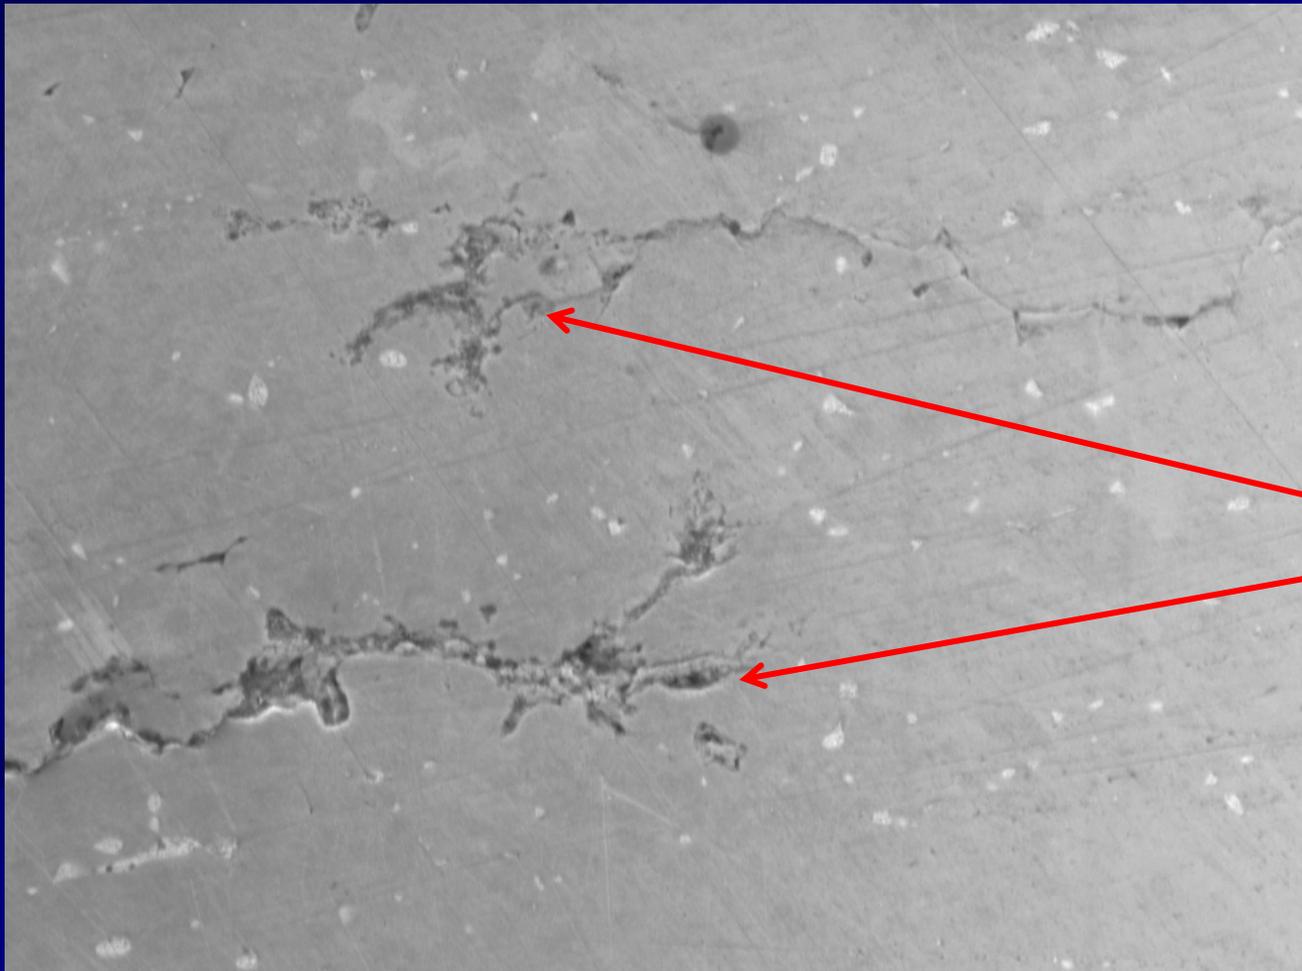
Example of SCC found during initial evaluation

Corrosion
Forming within the
metal

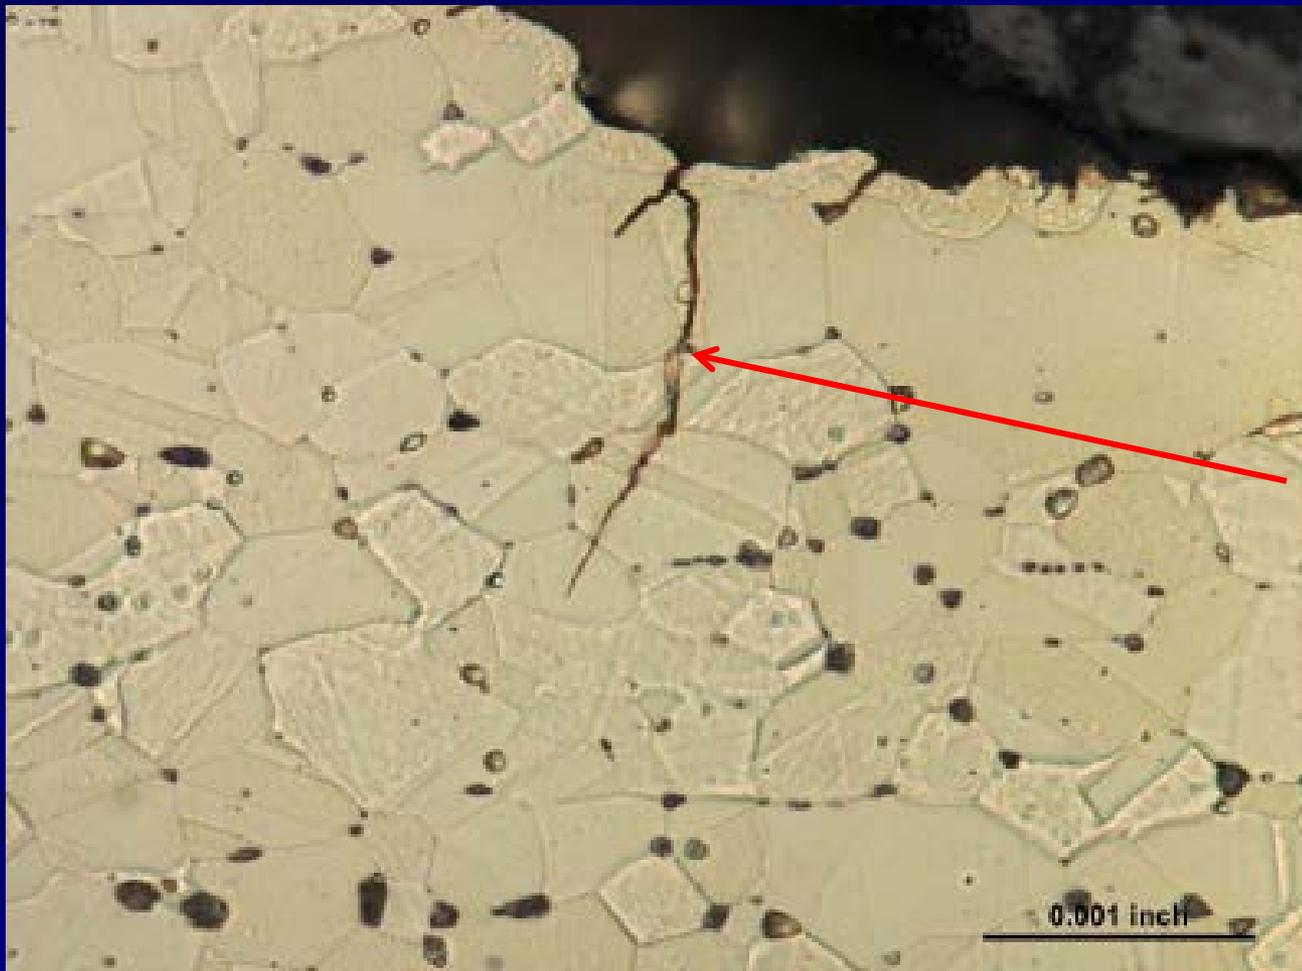
Example of SCC found during initial evaluation

Corrosion pit with
crack forming

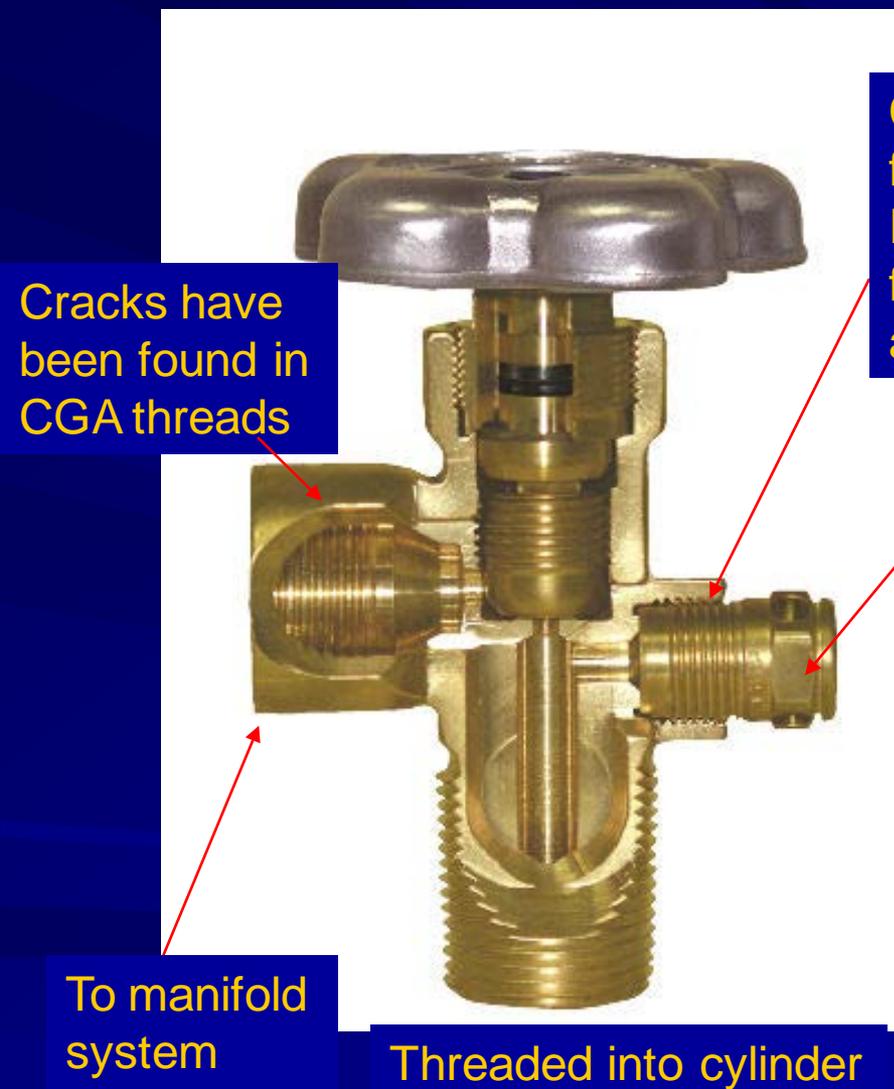
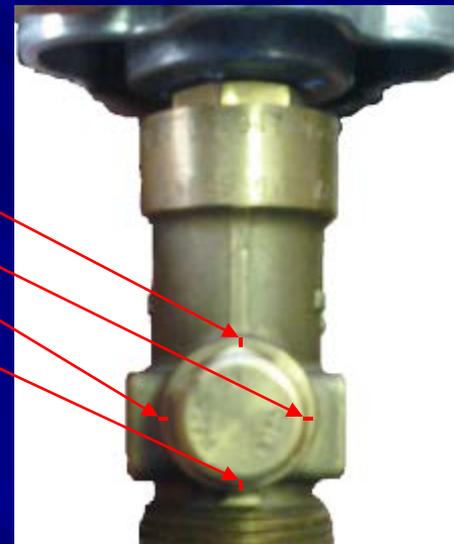
Common Valve Section Indicating Crack Locations

Cracks have been found around PRD boss on forging part line and at 90°

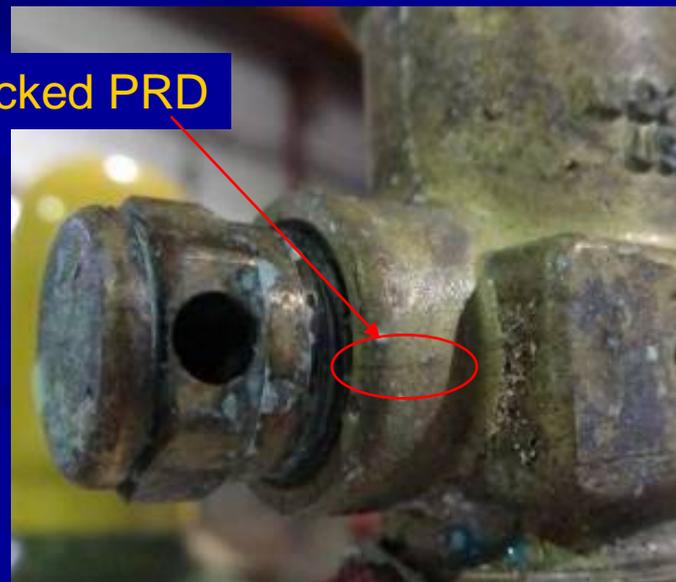
Cracked PRD

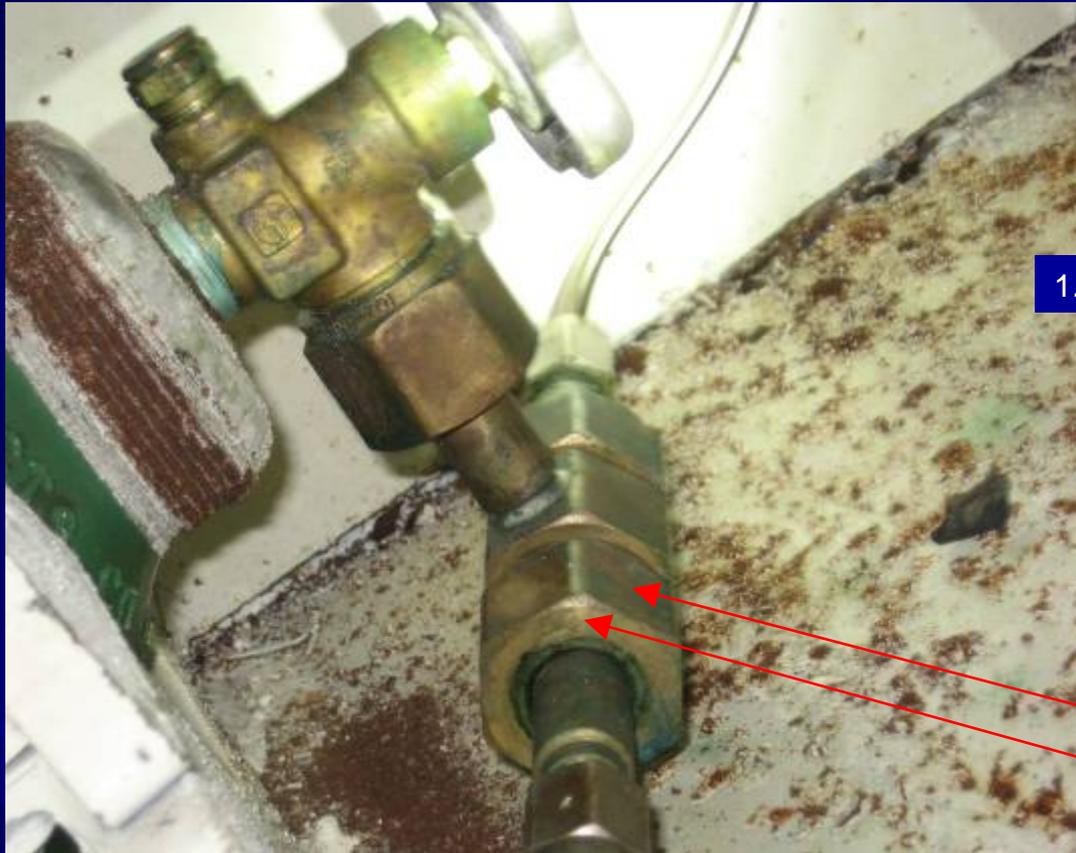
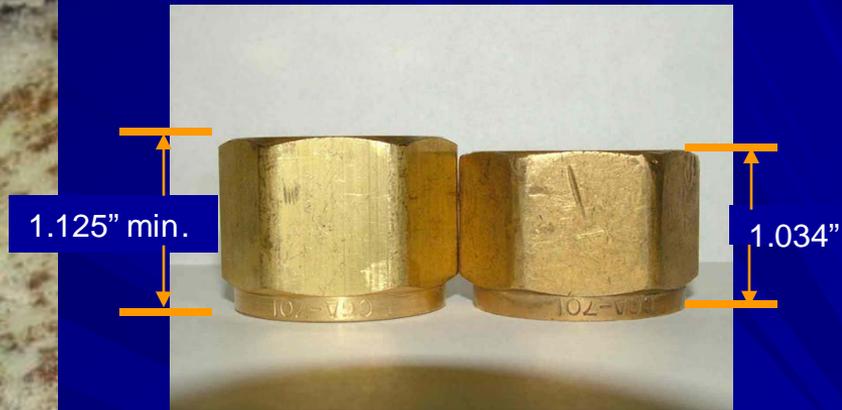
Fitting Dimensions and Crack Locations

CGA 701 Fittings have been found with incorrect dimensions

Cracks have been found on rear face and hex flats

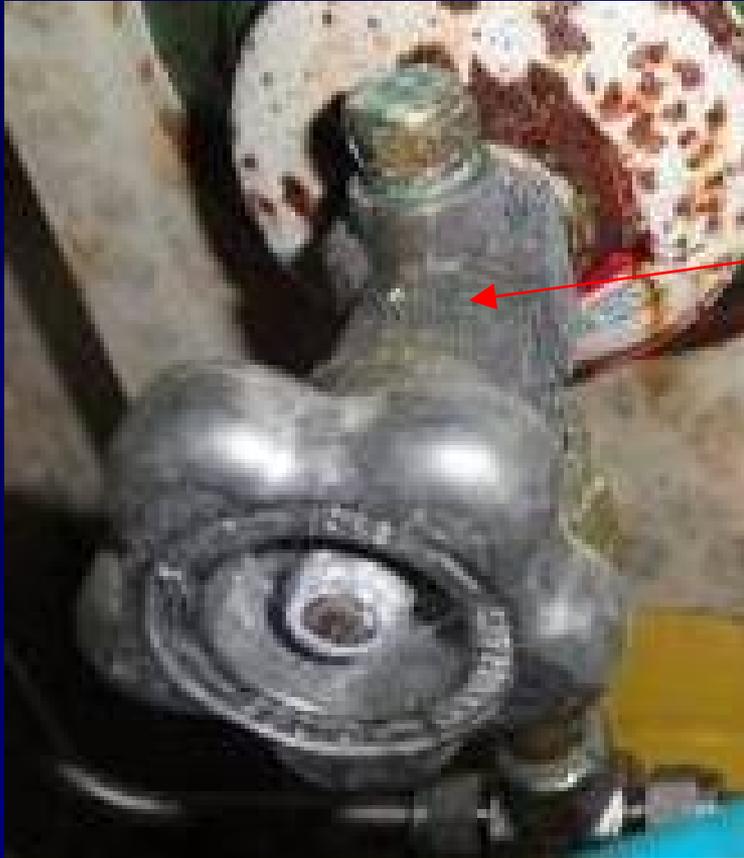
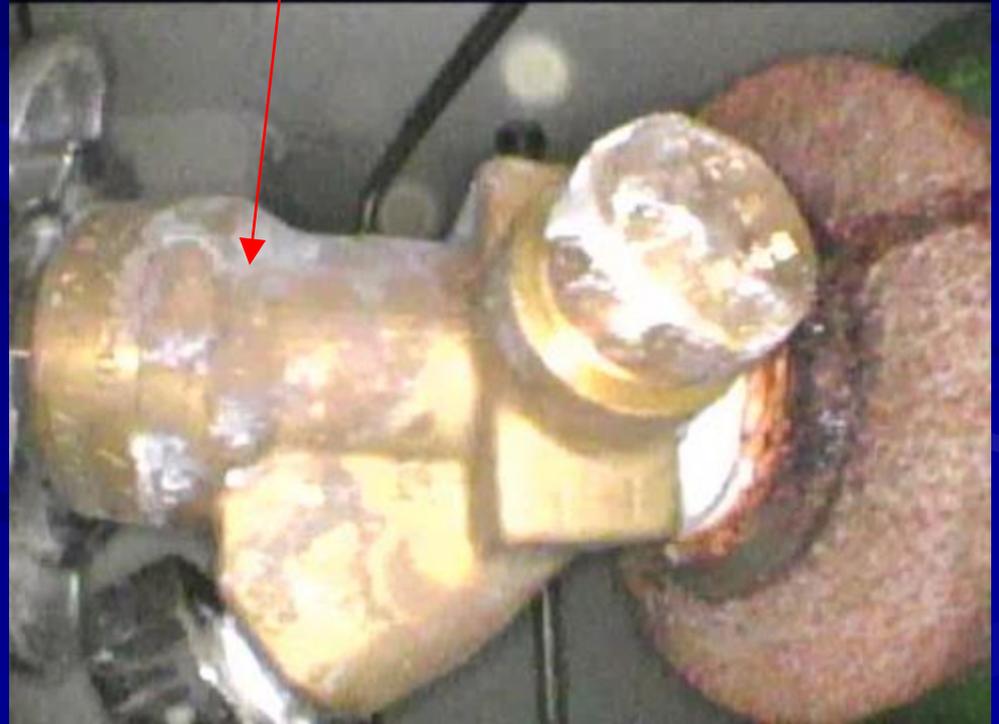
These cylinder valves
have developed
significant corrosion

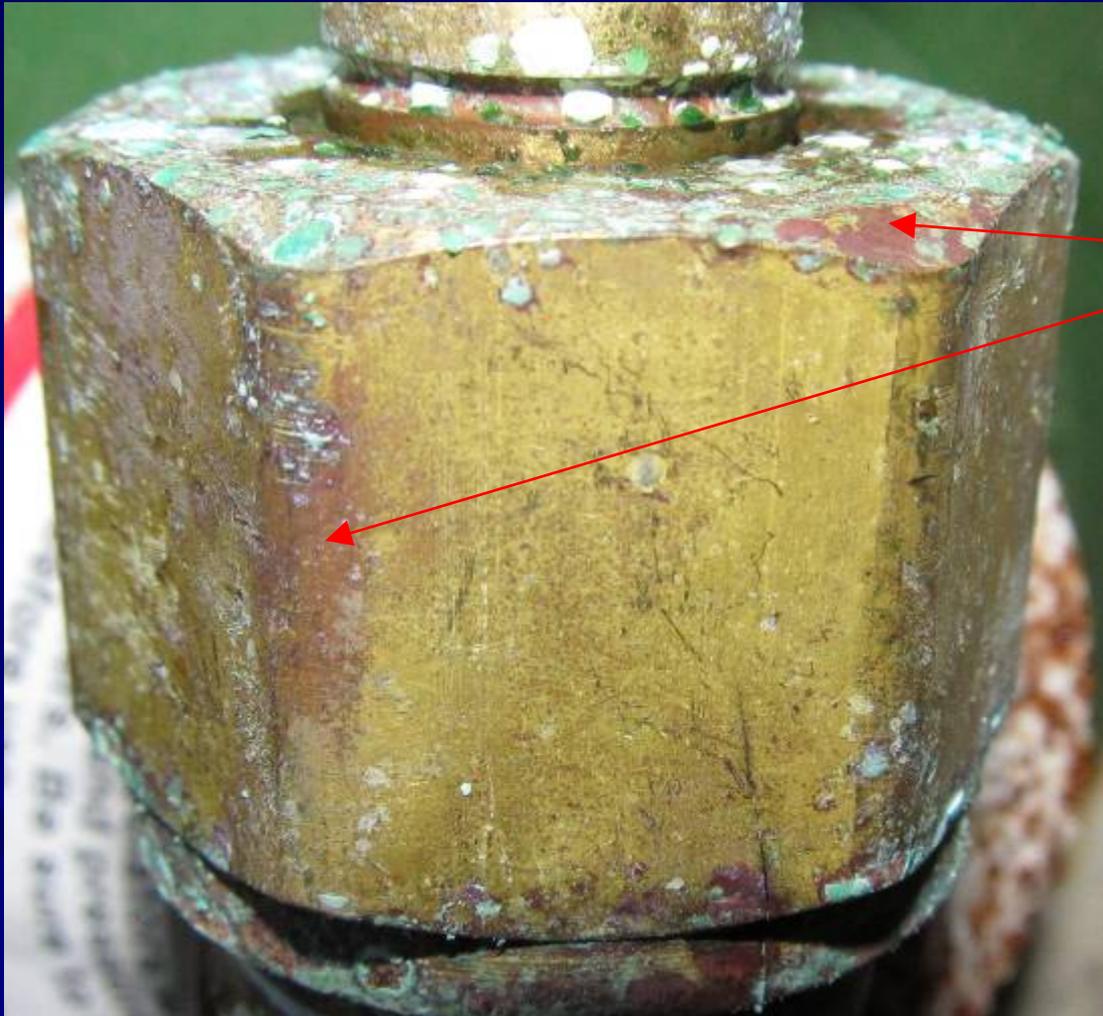
Copper colored and reddish areas indicate dezincification where the zinc has come out of the matrix and only copper is left behind.

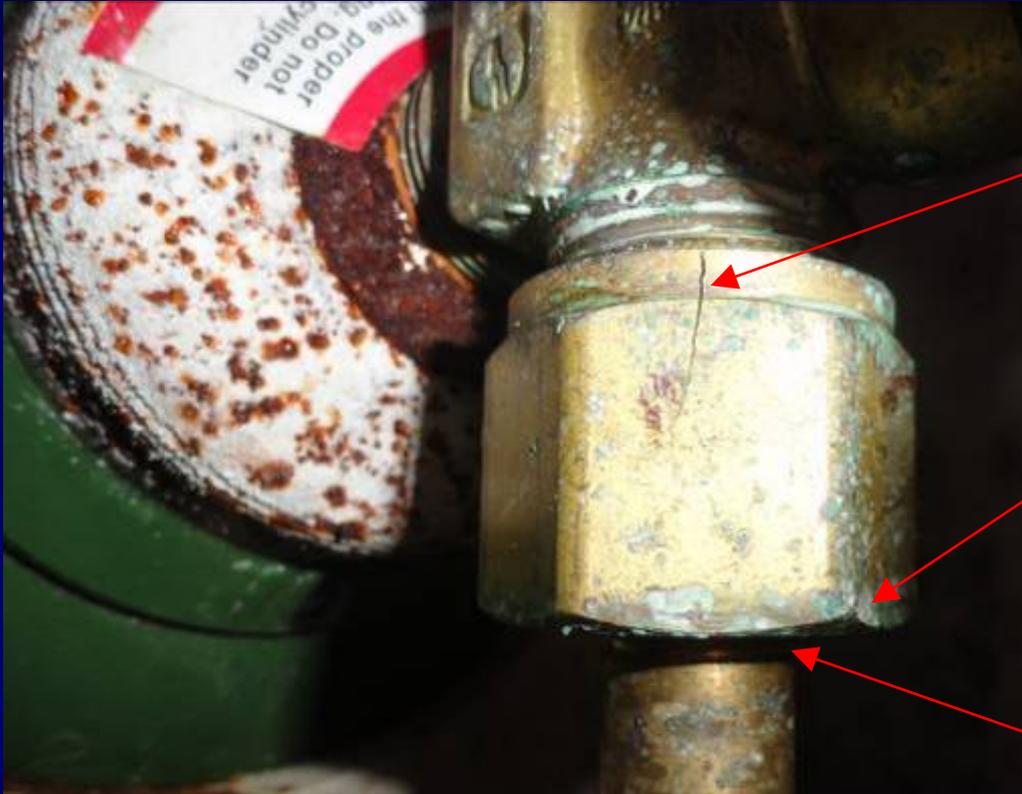
A crack has developed in a high pressure fitting.

Green and white corrosion along with indications of dezincification are also present.

Also check for cracks on the rear face

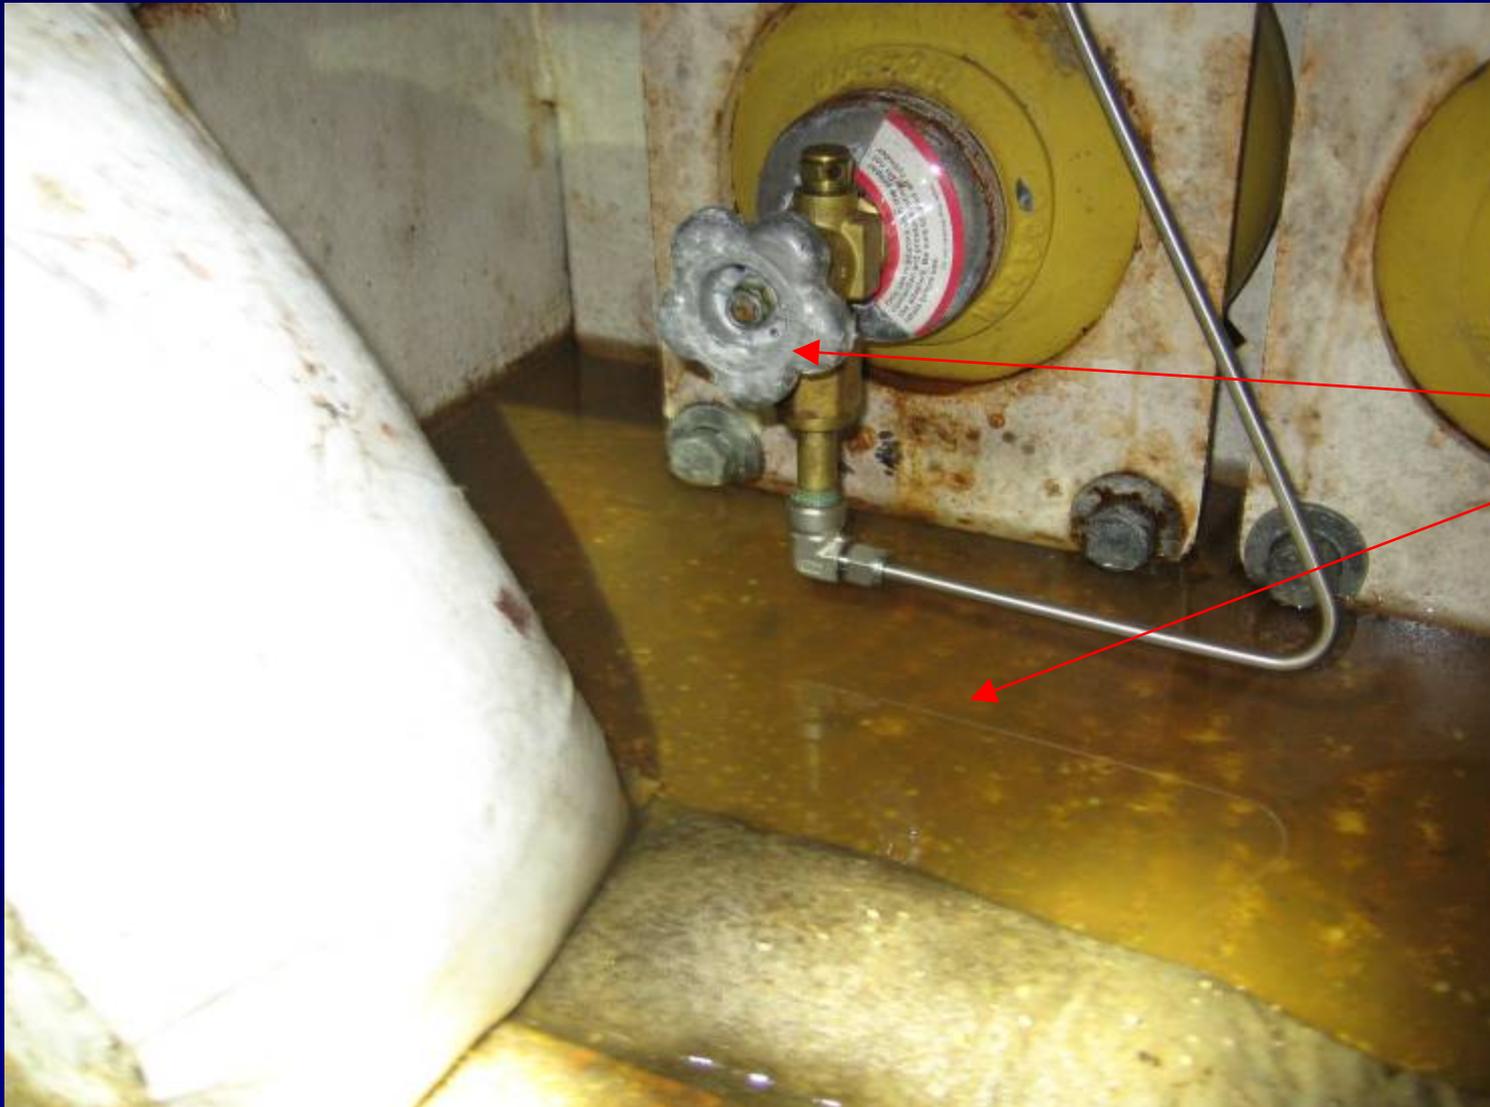
Water accumulation and corrosion are obvious
