District 2 Coal Mine Near Miss

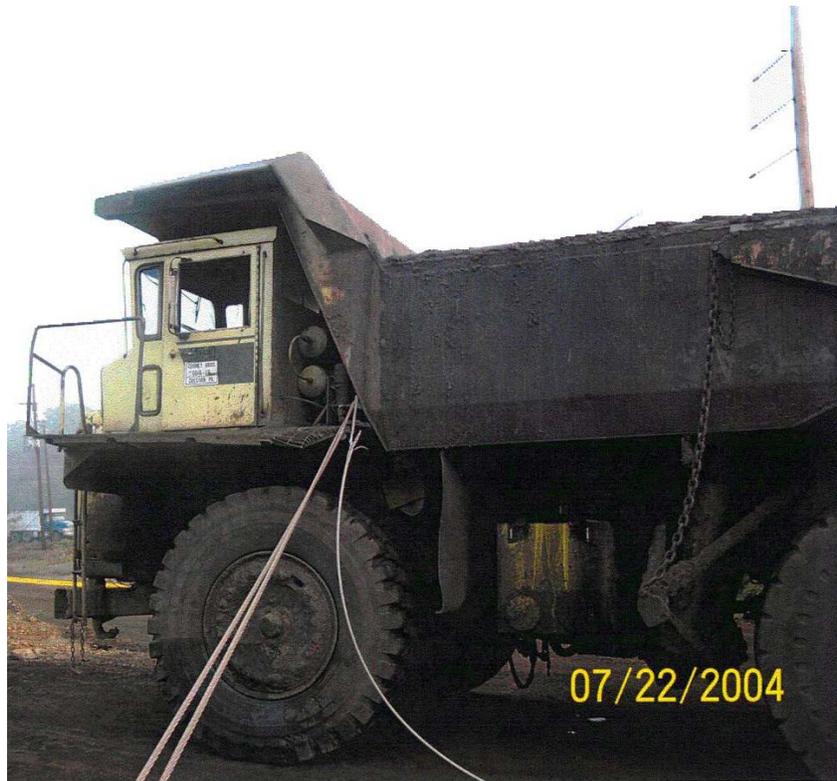
At 6:00 am, on the morning of July 22, 2004 a contract rock truck driver arrived at the truck parking lot. The driver was to operate the Euclid R-50 rock truck which was parked with the bed pinned in the raised position. The driver removed the pin and entered the truck. The driver proceeded to travel 210 feet down the haul road and toward the plant without lowering the truck bed. At this point the raised bed contacted a 23,000, high voltage power line. Realizing he had hit the power line the driver stopped the truck and lowered the bed pinching the power wires between the truck bed and frame. The accident resulted in the contract rock truck driver being entrapped in the cab of the Euclid R-50 rock truck for a period of 1 hour and 45 minutes.

- Erect signs to identify danger zones
- Ensure all overhead power lines are high enough for all equipment to safely travel under
- Install high visibility spheres on energized power lines to help make the line location obvious to all workers.
- Locate parking areas away from power lines.
