## Metal/Nonmetal Northeast District

### Maintenance Accident

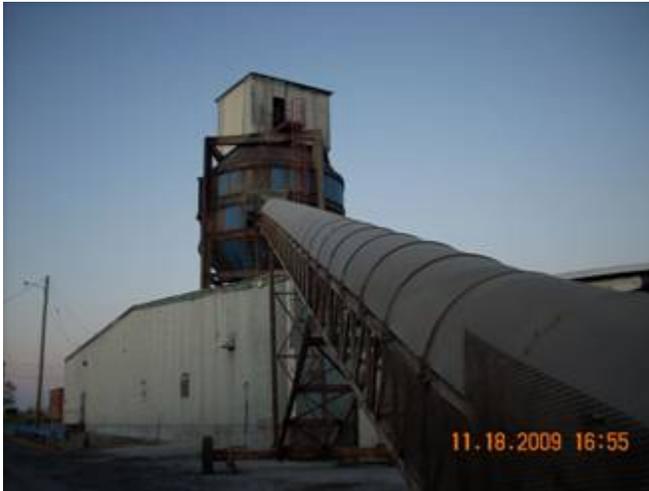
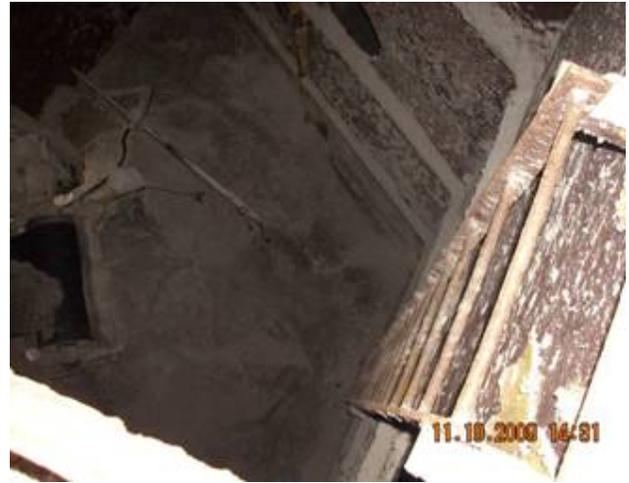
On November 18, 2009 two employees entered a salt bin to dislodge stuck material from the draw hole. Both employees were wearing safety harnesses and upon reaching the bottom of the bin, tied-off their lanyards to the access ladder. The bridged material gave way engulfing the miner up to his shoulders. Power to the bin was not de-energized and locked out. The discharge conveyor was running. There were no injuries.

- Equipment shall always be de-energized, locked out and blocked against motion while conducting maintenance or repair.
- Never walk on lodged material.
- Use the shortest possible lanyard when wearing fall protection.
- Ensure a second person tends a lifeline when entering bins, hoppers, or tanks.
