REPORT NO. MW11-005

STRUCTURAL INVESTIGATION OF SURGE BIN TOWER COLLAPSE
HILLTOP BASIC RESOURCES
BIG BEND QUARRY
MINE I.D. NO. 15-18147
BATTLETOWN, MEADE COUNTY, KENTUCKY

FEBRUARY 15, 2011

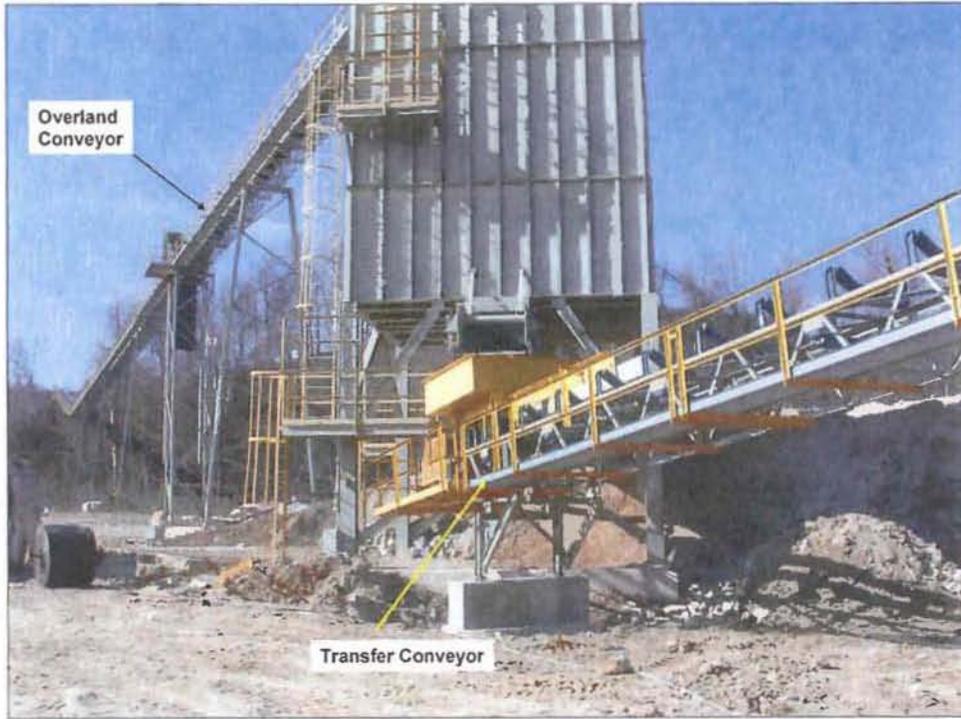
Photo 1 – East side of Surge Bin Tower during the year 2006.

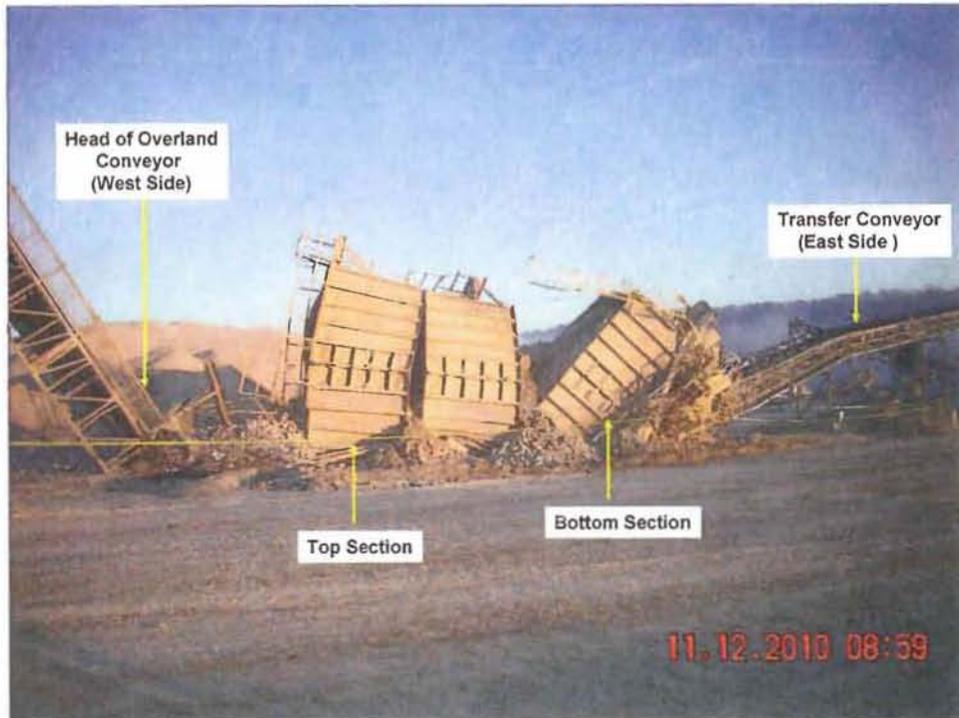
- The two top sections of the bin separated from the bottom section as they toppled (rotated 90 degrees relative to the bottom section) toward the west in the direction of the Overland Conveyor. The movement of the bottom section of the bin was also to the west. The west side of the bottom section of the bin came to rest in a lower position than that of the east side (photo 2). This indicates that the underneath of the west side of the bin “fell out from underneath” or “gave-way” prior to the east side. It is believed that the loss of support on the west side of the bin was caused by the failure of the columns (excessive bending or buckling).

Photo 2 – South side of Surge Bin Tower with respect to looking north.

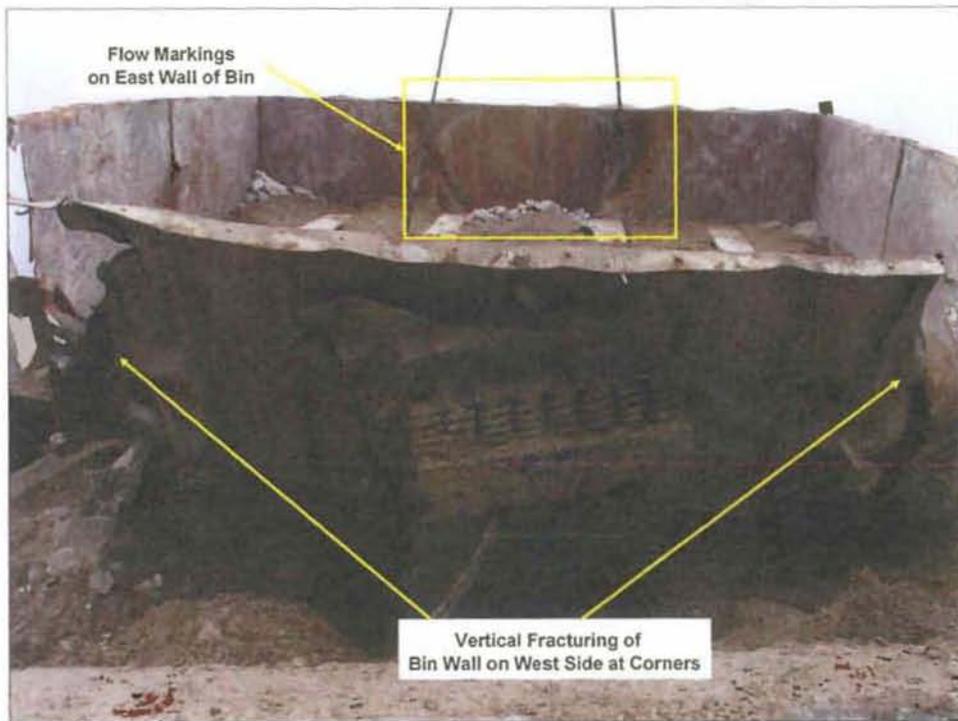
- Photo 3, which is the interior portion of the Transfer Conveyor (east) side of the bin, shows abrasive markings on the wall that the material discharging from the bin would flow against. These markings were only present on the east side of the bin and this indicates that the drawdown cone of the discharge flow was offset from the central interior of the bin (asymmetric flow).

- Vertical fractures along the west side corners of the bottom section of the bin (photo 3) were resulting damage from the collapse. The fracturing occurred through the thickness of the bin walls and not in the vertical welds which fastened the corners of the bin walls. Measurements taken along these vertical tears indicated that the loss of wall thickness from corrosion at these fracture surfaces was less than 5 percent. These fractures are not believed

to be the cause of the failure, but are a secondary effect of the failure. In order for the two top box sections of the bin to topple over, they had to break free from the bottom section, and they did this by tearing the west side corners of the bottom section.

Photo 3 – Bottom section of the bin showing wall markings and fractures.

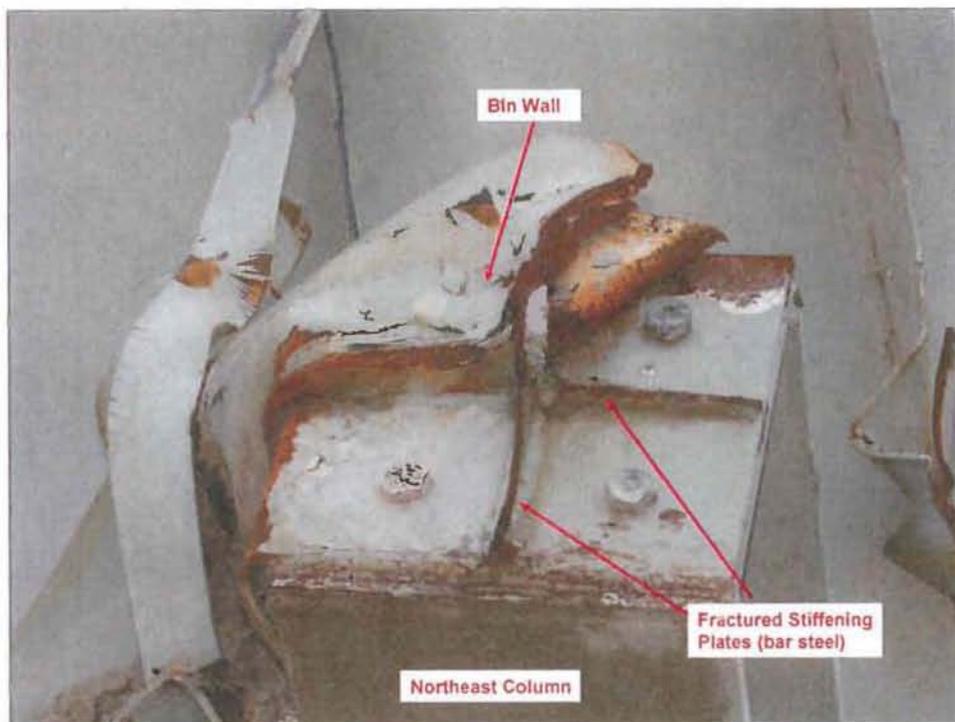
- Fracturing/detachment of the bottom of the bin occurred at the top of all four columns. It appears that most of the fracturing of the bin attachment to the top of the east side columns was caused after the tower became unstable. For example, photos 4 and 5 shows the top of the east side columns where portions of the bin wall and corner stiffening plates/bars fractured. The majority of the deformation and the fracturing observed in photos 4 and 5 are believed to be the result of the pulling away of the bin walls from the columns when the bin shifted and fell to the west. The bin also disconnected from the west side columns. Photo 6 shows the portion of the bin wall remaining on the top of the southwest column and how the portion of the bin wall remaining on the top of the column was bent and pulled down below the top of the column. Photo 7 shows the portion of the bin wall remaining on top of the northwest column and the crimping of the bin wall above the column. The crimping could have occurred because of a compressive failure in the bin wall itself or because of lateral deflection which would have accompanied the buckling of the column. The fracture surfaces of the remnants of the bin wall attached to the top of the columns did not appear depleted or damaged from corrosion. With respect to the columns on the west side, the small amount of bin wall that was remaining attached to the top of the columns shows the load transfer between the columns and bin was occurring over a small area. Smaller areas of load transfer will create greater stresses in that area. Higher stresses led to a greater chance that a fracture will occur.

Photo 4 – Top of northeast column following the collapse.

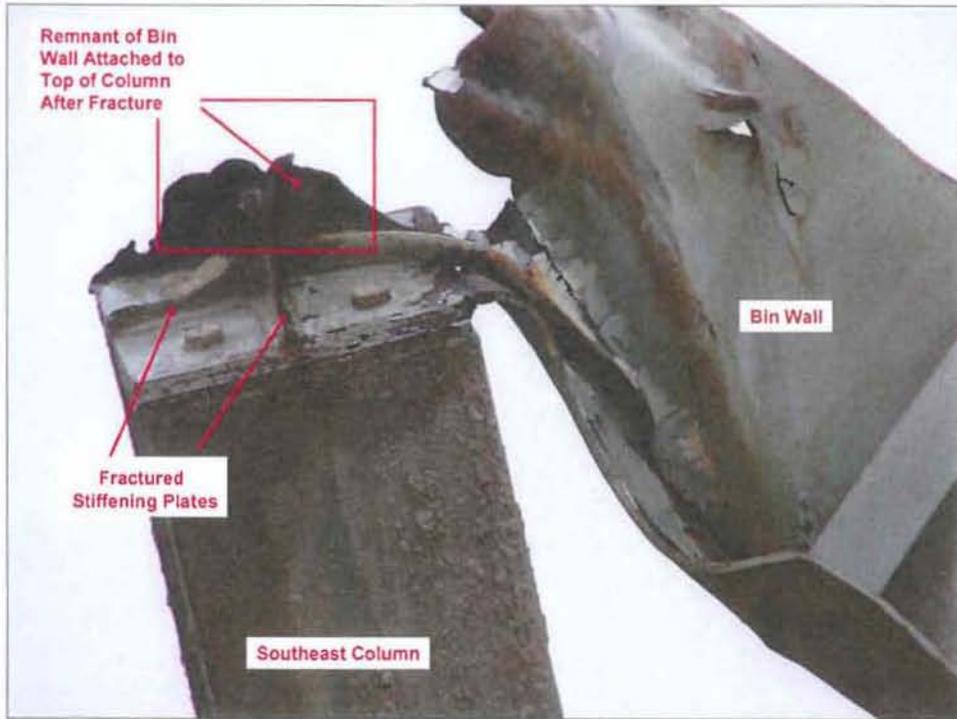
Photo 5 - Top of Southeast column following the collapse.

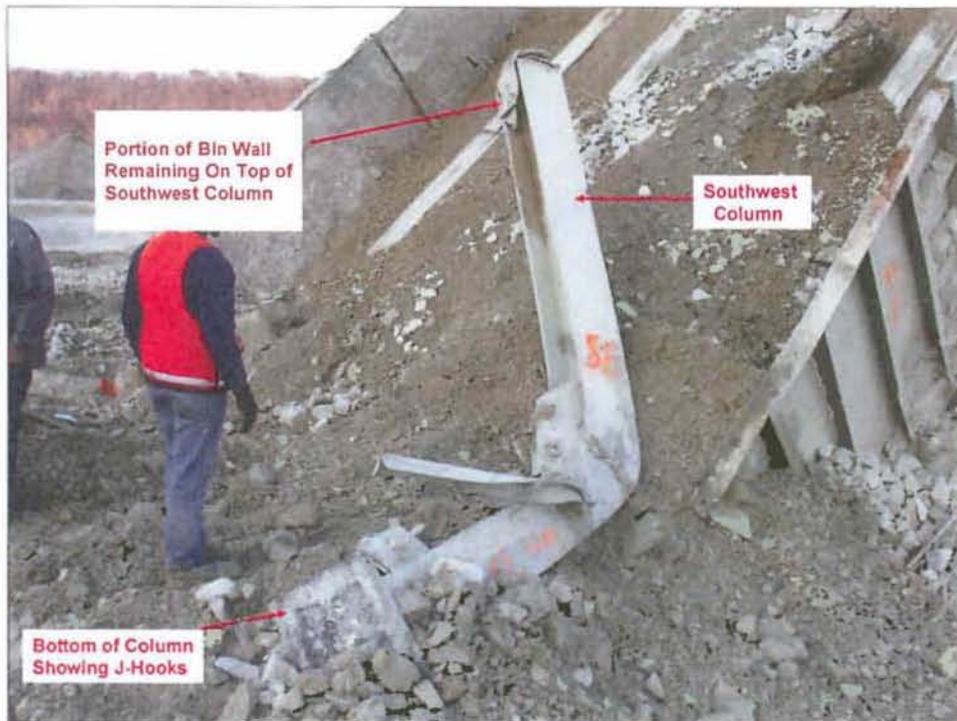
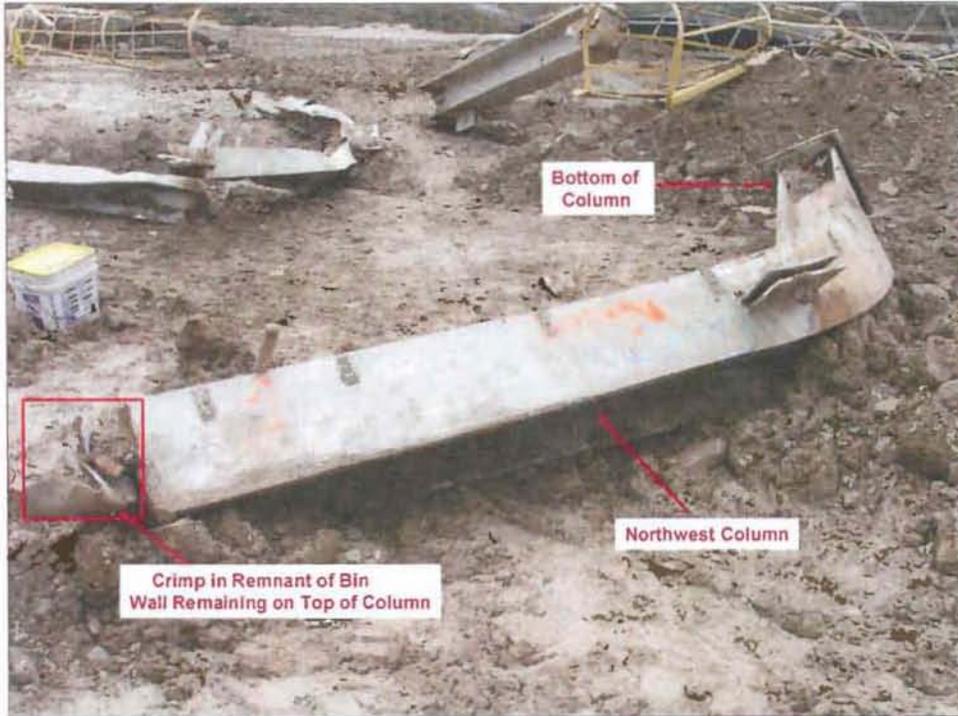
- The columns on the Overland Conveyor side (west side) of the bin were significantly bent or buckled. This is an indication that the load carrying capacities of the columns were exceeded. Since the bin was not overloaded at the time of the collapse, and the columns were not deficient from weathering/corrosion, a shift or a deviation in the manner in which the columns were loaded would have had to occur to cause them to buckle. When the load applied to a column is not concentric to its long axis, the loading becomes eccentric (applied from a distance), and this creates a bending moment (force with a lever arm) on top of the column which makes it easier for the column to buckle. Fatigue cracks or corrosion at the bin corners would have reduced the structural rigidity at the bin corners and caused the load from the bin to be applied at some distance away from the geometric center of the column. Also, it is possible that the bin walls or connections at the corners themselves locally failed (fractured or compressed) causing the bin to detach from the column connection. Once the bin detached from one of the columns at a corner, the bin would have then sat down on that column and loaded it eccentrically causing the column to buckle.

Photo 6 – Buckled shape of southwest column of the bin following collapse.

Photo 7 - Buckled shape of southwest column of the bin following collapse.

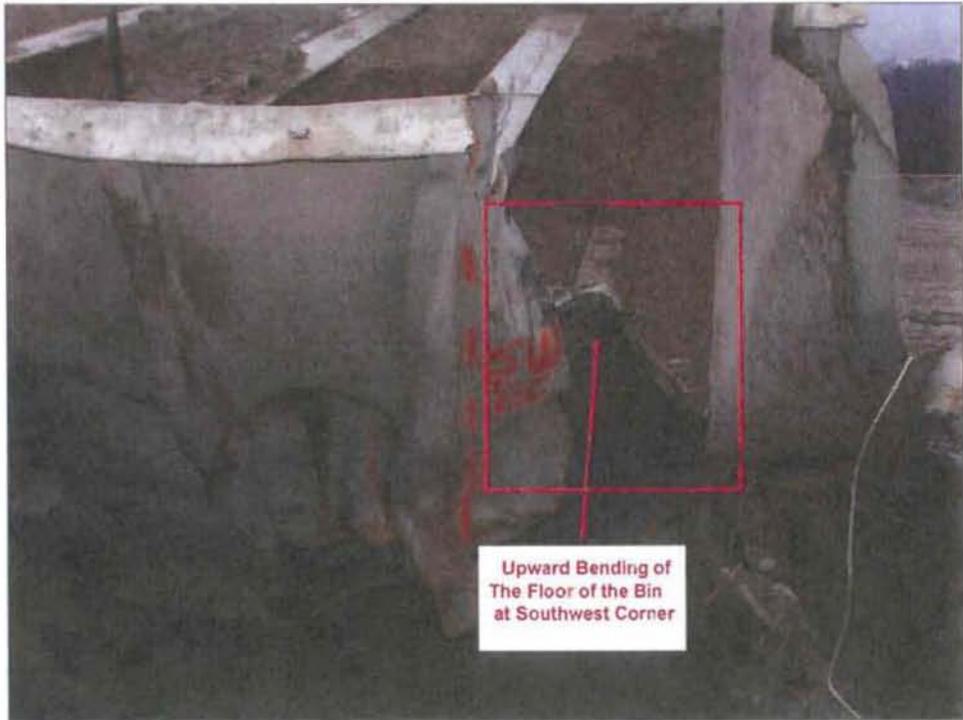
- Upward bending or prying was found at the corners of the bin floor at the west side columns (photo 8). This deformation is indicative of excessive bending or rotational loading being transferred between the west columns and the corner of the flooring. There are two behaviors that may have produced this deformation. The first would result from the bending or buckling of the west side columns themselves. As the columns excessively bent/buckled, the bending load at the top of the column would have increased causing such deformation. The second mode of behavior is that if there was a loss of stiffness or rigidity where the bin attached to the east side columns, the west side columns would be required to carry more of the bin load. This would result in the structure momentarily behaving as a cantilever beam with the east end free or not supported, and all of the load would be forced to go to the west side, producing the deformation observed at the west corners.

Photo 8 - Southwest corner of the bottom of the bin.

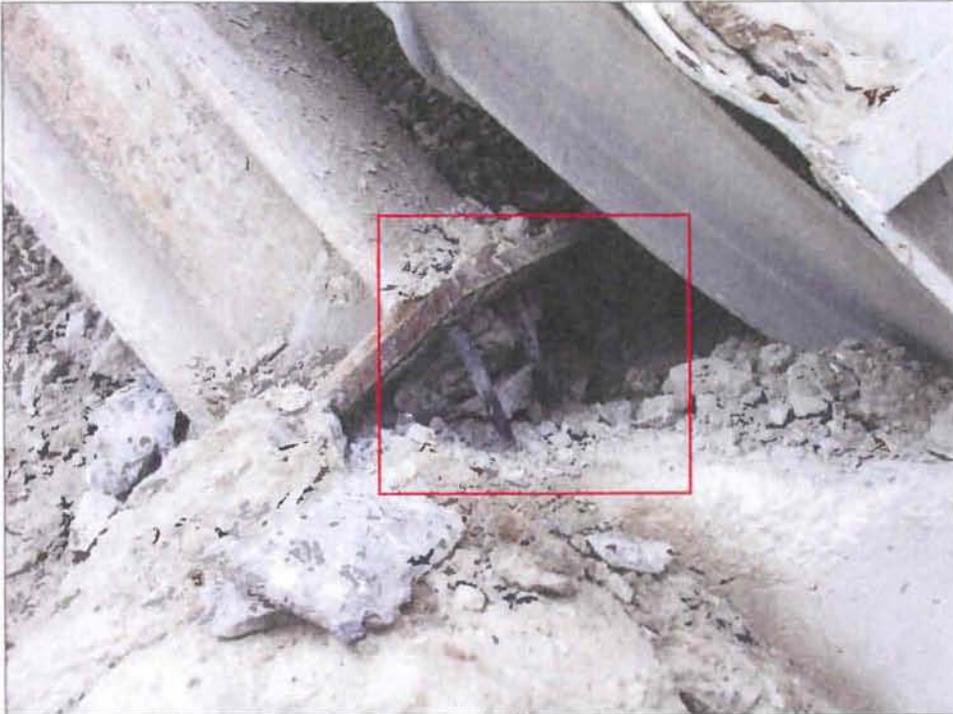
- A final major deformational characteristic, which is not believed to be direct cause of the collapse, was that the base of all four columns had pulled free (uprooted) from the concrete foundation that they were anchored upon (photo 9). It appears that the base of the east side columns pulled free after the initial trigger of the failure. After the bin detached from the top of the east side columns, the bottom section of the bin slid down against the columns, and this applied a lever action to the top of the columns which uprooted the columns. It is believed that both west side columns were pried free from the foundation during the action of the columns buckling. The extreme deformations of a column during buckling are conducive for allowing the column to act like a lever and pry itself free from the foundation.

Photo 9 – Base of northeast column uprooted from the footing.

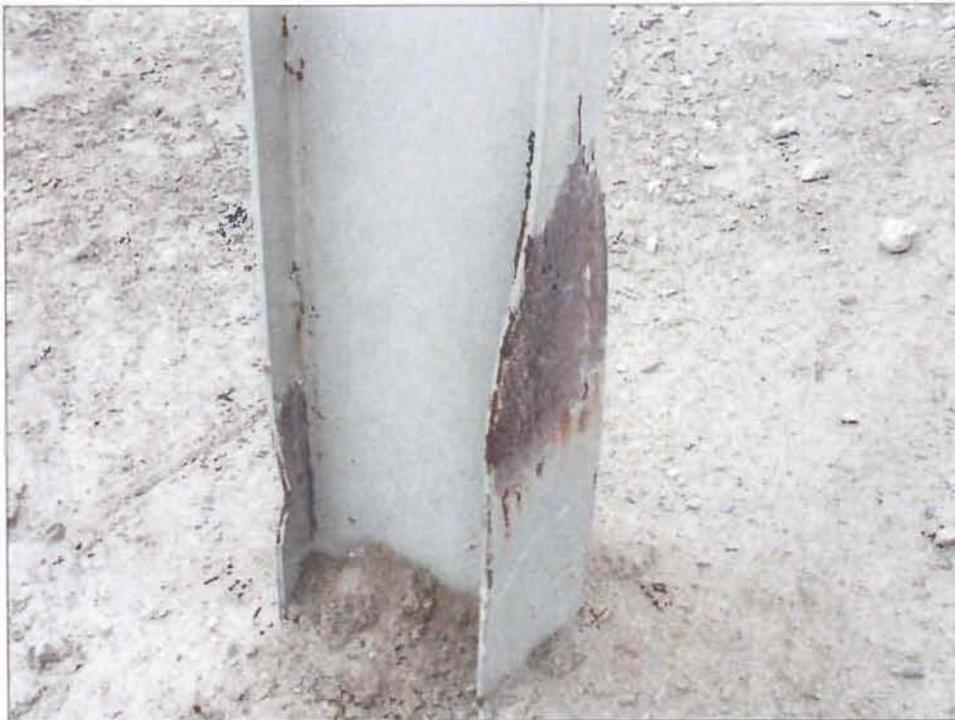
It was observed that the base of the legs of the A-frame bent closest to the Surge Bin Tower of the Overland Conveyor has been impacted by equipment (photo 10). The base of the column should be repaired. The repair can be accomplished by installing/fitting a channel or angle steel sections within the interior of the columns so that they rest against the web and flanges of the existing column sections. This repair should be done for both legs of the bent.

Photo 10 – Base of north leg of A-frame bent closest to Surge Bin Tower.
