**REPORT OF INVESTIGATION  
SURFACE COAL MINE**

**Fatal Powered Haulage Accident  
October 3, 2001**

**Bent Mountain Mine  
Lodestar Energy, Inc.  
ID No. 15-18015  
Meta, Pike County, Kentucky**

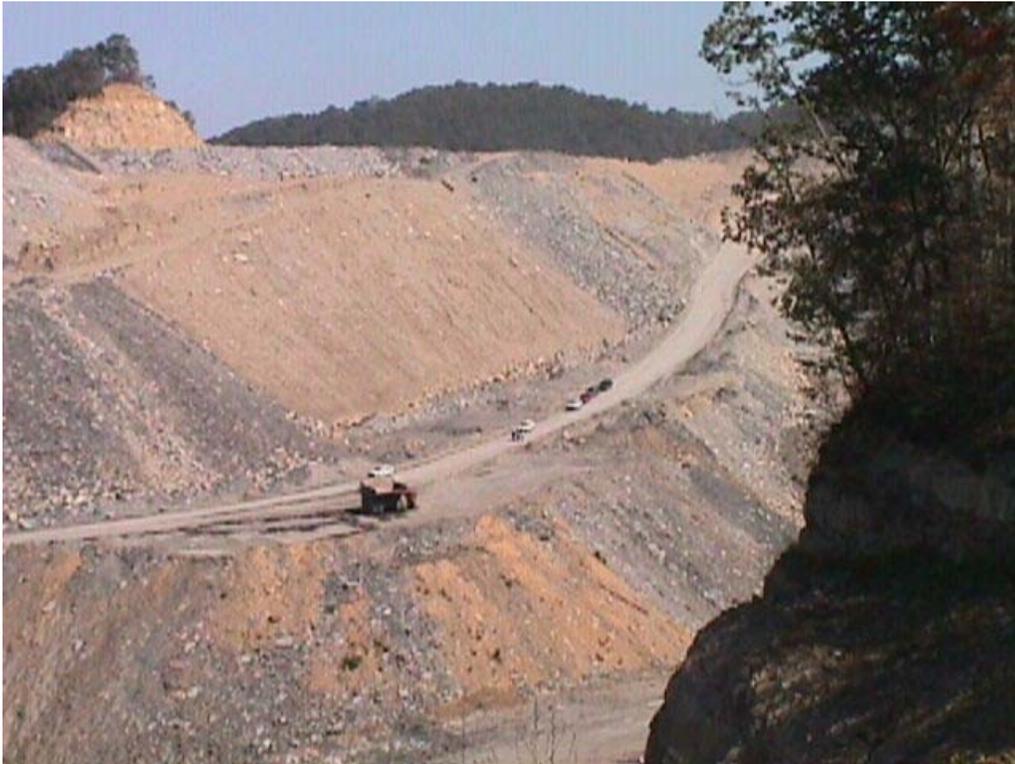
**PHOTOGRAPH 1 - OVERVIEW OF HAULAGE ROAD**

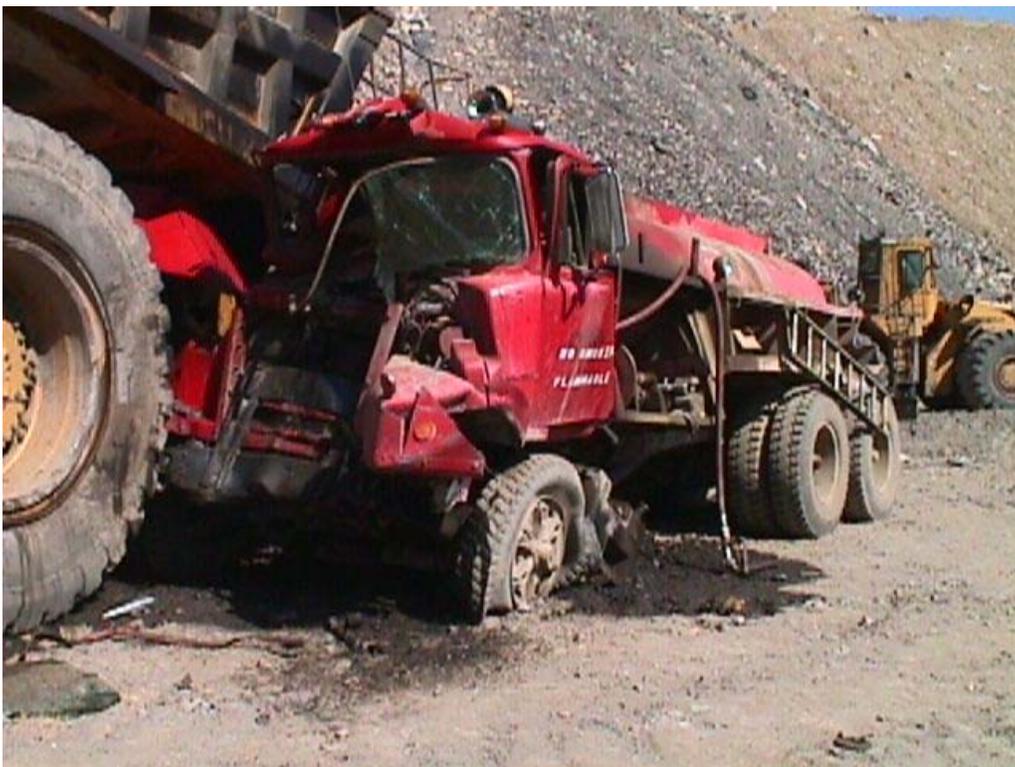
**PHOTOGRAPH 2 - FUEL TRUCK IMPACT SITE**
