## Coal Mine Fatal Accident 2003-05

Operator:	Wabash Mine Holding Company
Mine:	Wabash Mine
Accident Date:	February 15, 2003
Classification:	Fall of Rib
Location:	District 8, Keensburg, IL
Mine Type:	Underground
Employment:	195
Production	1,057 tons/day

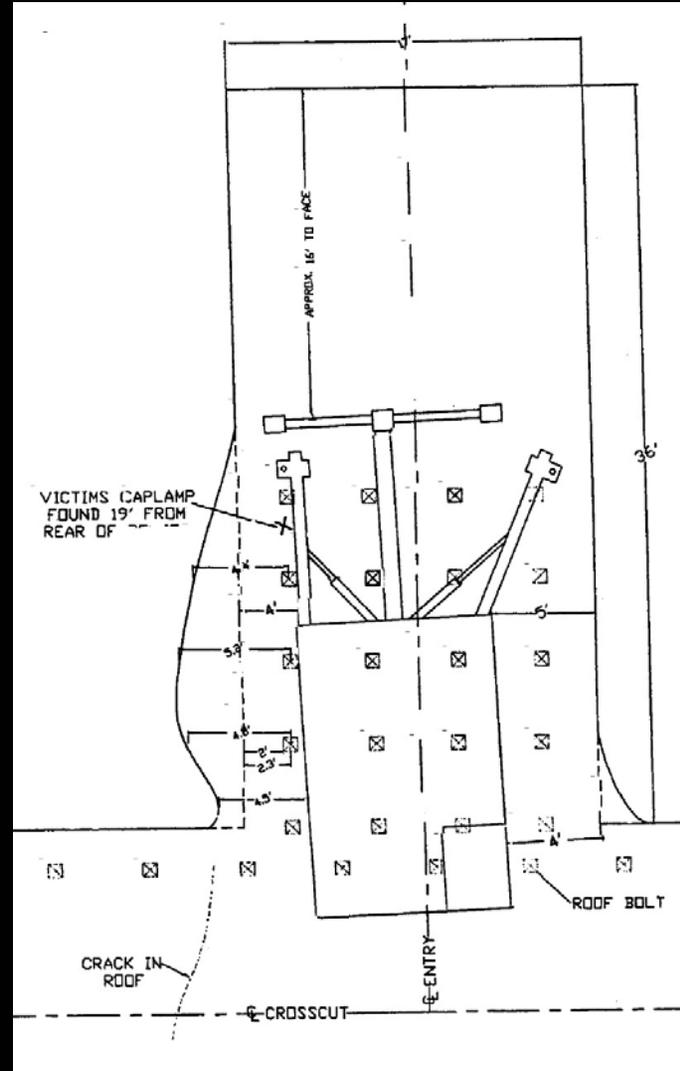
- The roof-bolting machine operators completed installing the 4<sup>th</sup> row of bolts and started moving the machine forward to the next row.
- One of the rib bolters noticed a crack that extended all the way down the rib. He then walked between the left rib and the roof-bolting machine to get a pry bar to pull the rib down.
- As the rib bolter neared the front of the moving machine, the rib fell and covered him with rock and coal, with the exception of his feet and part of his face.
- The other rib bolter started to follow him, but decided to go back when the rib fell, just brushing his legs.

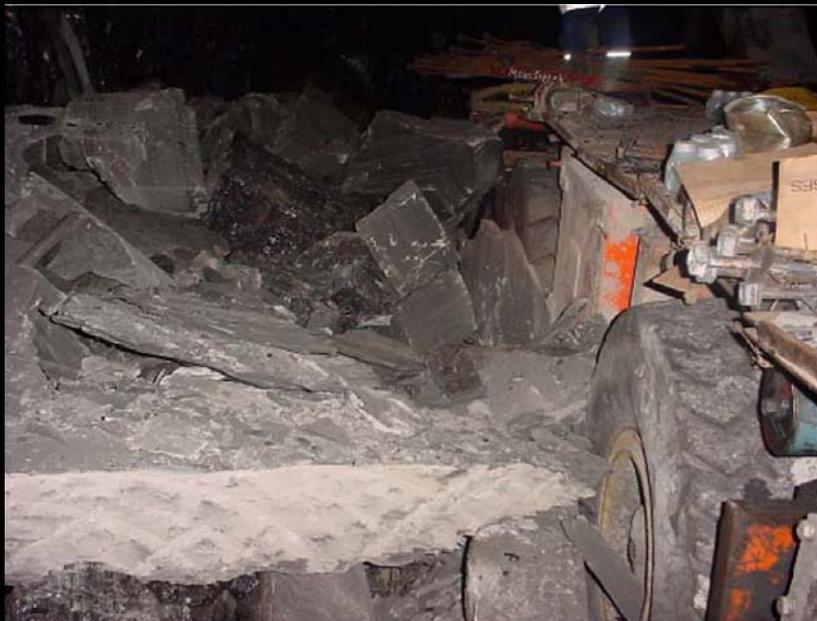
- The roof-bolting machine operator stopped the machine by hitting the panic bar, went around under the ATRS, and saw the amount of rock that was on the victim. The other rib bolter climbed on top of the machine and observed the victim covered up and asked for help.
- Measures to rescue the victim were delayed as coal and rock continued to fall from the rib. When they first reached the victim, the section foreman checked for signs of life, but found none. Once the rib stopped falling, the crew extricated the victim and transported him to the surface.

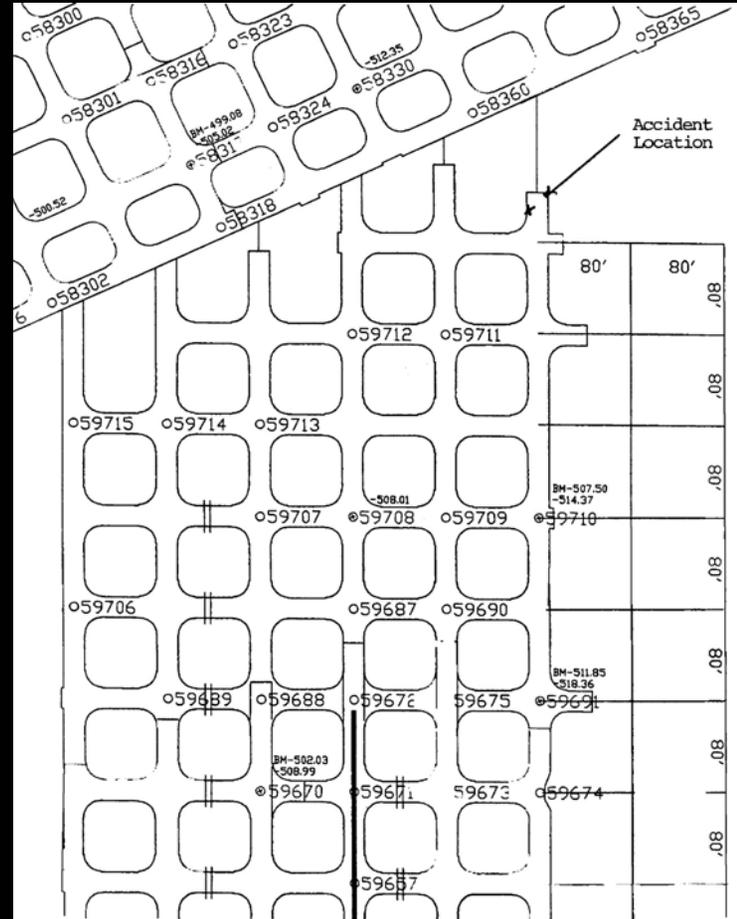
- This area of the mine exhibited rib pressures and stresses due to the overburden pressure. The depth of overburden cover at the accident location was ~900'. The immediate mine roof strata consisted of 60' of gray shale.
- The B-2 Section was originally an 8-entry section, with a crosscut centerline spacing of 80'.
- The Nos. 1 & 8 Entries were dropped during the previous month due to problems with ventilation.
- The B-2 Section had been driven in a southeast direction, but experienced adverse roof conditions and was subsequently turned northeast to help control roof and rib conditions.

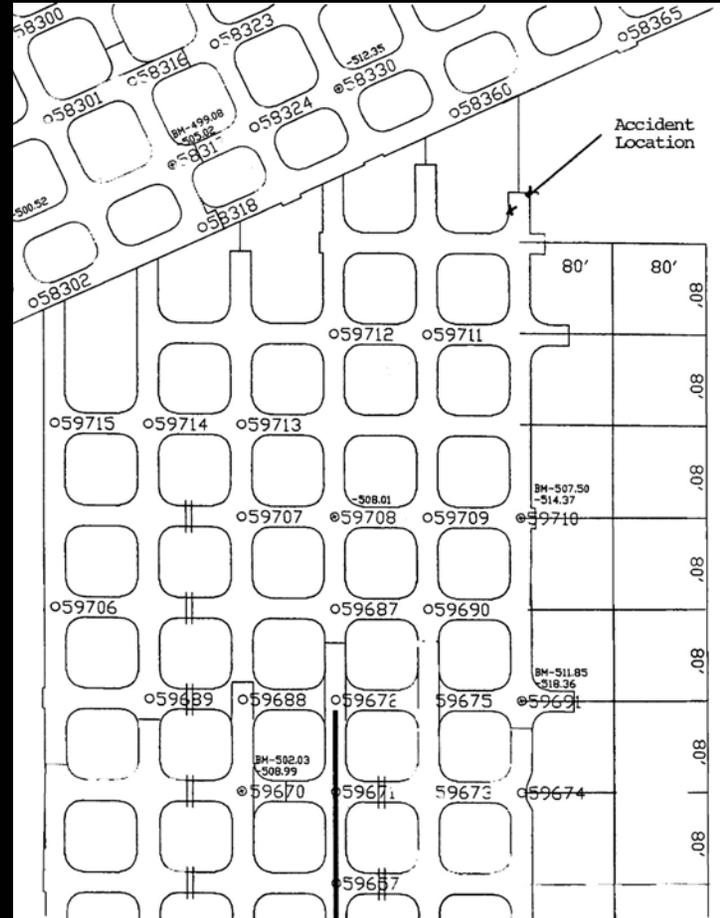
- The B-2 Section was mining toward an old B-2 worked out panel, and had been experiencing severe adverse roof and rib conditions. While working in the old B-2 panel, adverse roof conditions and some squeezing were encountered.
- The roof and rib conditions worsened as the B-2 working section got closer to the old panel.
- The approved roof control plan permits entry and crosscut centers of 60-120' in mains/submains, with 50-120' entry centers in panels.
- The 4-way diagonal intersection measurement cannot be greater than 70'. Roof support is typically provided by 60" fully grouted, Grade 60 rebar bolts on a 5' x 5' centers.
