Coal Mine Fatal Accident 2003-17

Operator:	Bledsoe Coal Corporation
Mine:	Beechfork Mine
Accident Date:	June 20, 2003
Classification:	Powered Haulage
Location:	District 7, Leslie Co., Kentucky
Mine Type:	Underground
Employment:	91
Production	4,000 tons/day

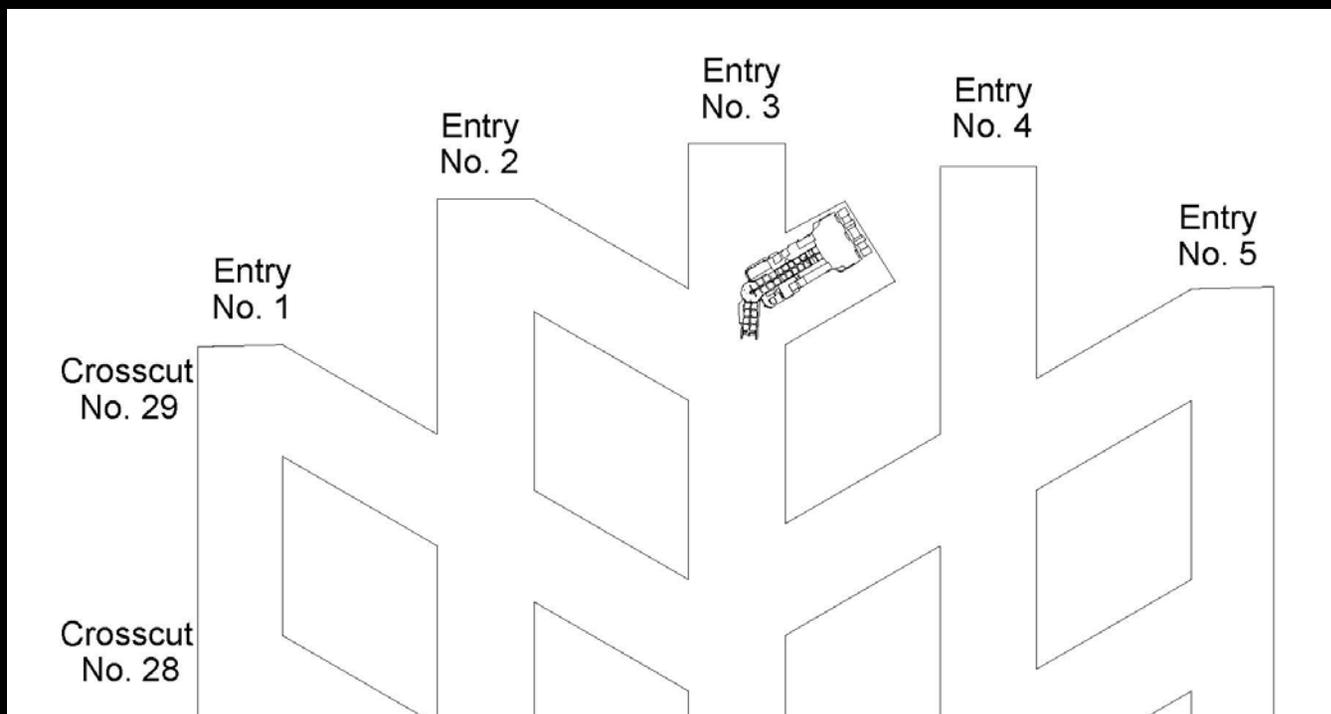
- Coal was being mined using a remote-controlled continuous mining machine with an attached Long-Airdox mobile bridge haulage system.
- During this time, the victim assisted with hanging curtain for the No. 3 Right working place at crosscut No. 30.
- The victim was last seen at approximately 12:45 a.m. walking toward the No. 2 working place, past the front mobile bridge carrier operator.

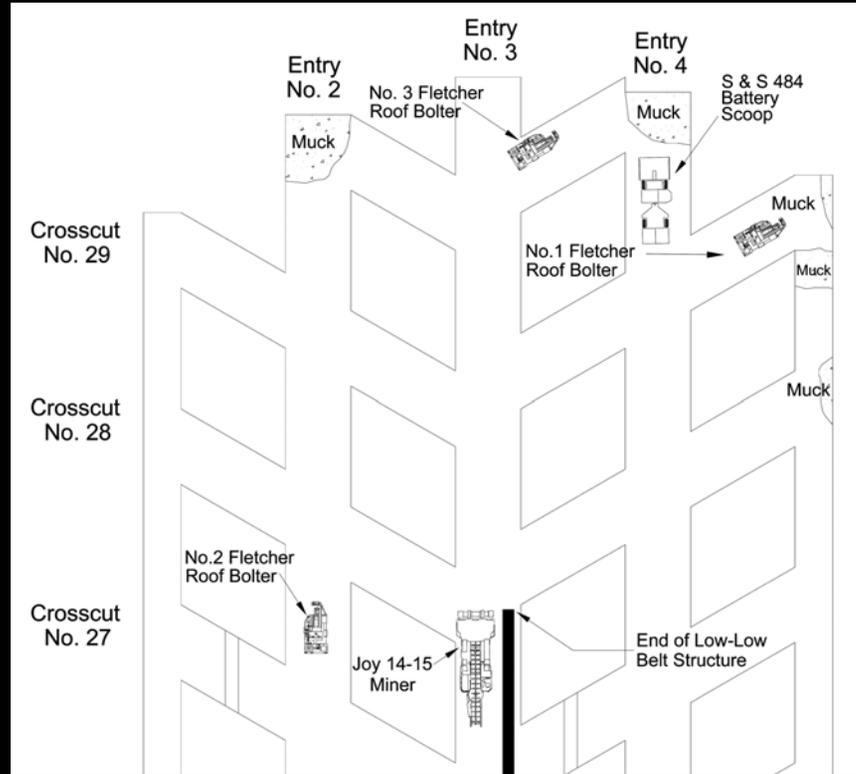
- After the mining cycle was completed, a belt set-up was needed to enable the continuous haulage equipment to reach the working places.

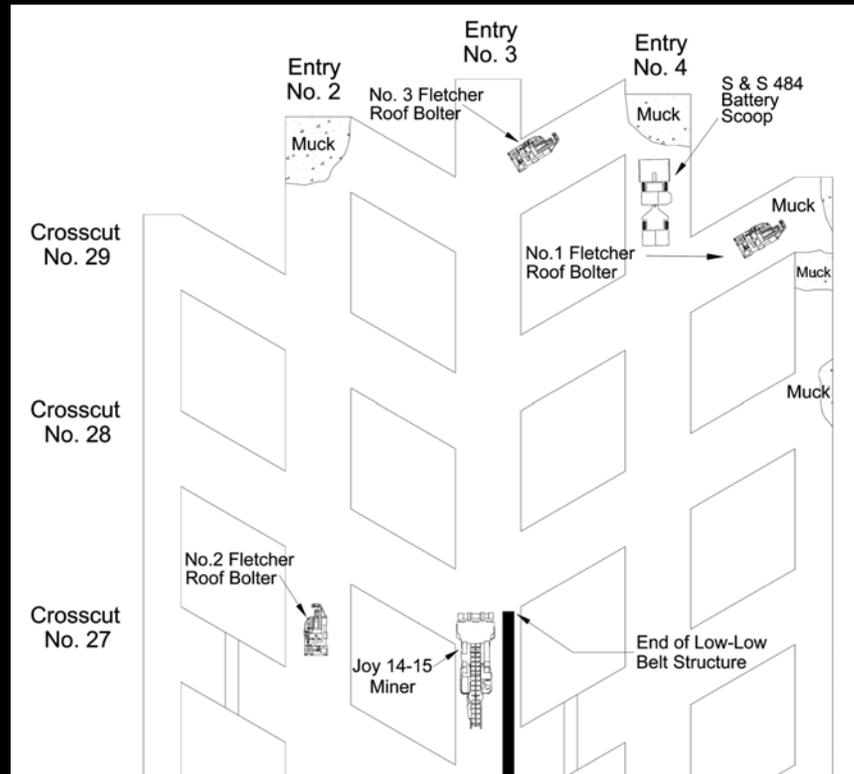
- A battery-powered scoop was then trammed, bucket first, into the No. 4 entry working place with conveyor belt to be used in the belt set-up.
- The continuous mining machine was trammed to just outby the end of the low-low belt conveyor structure.

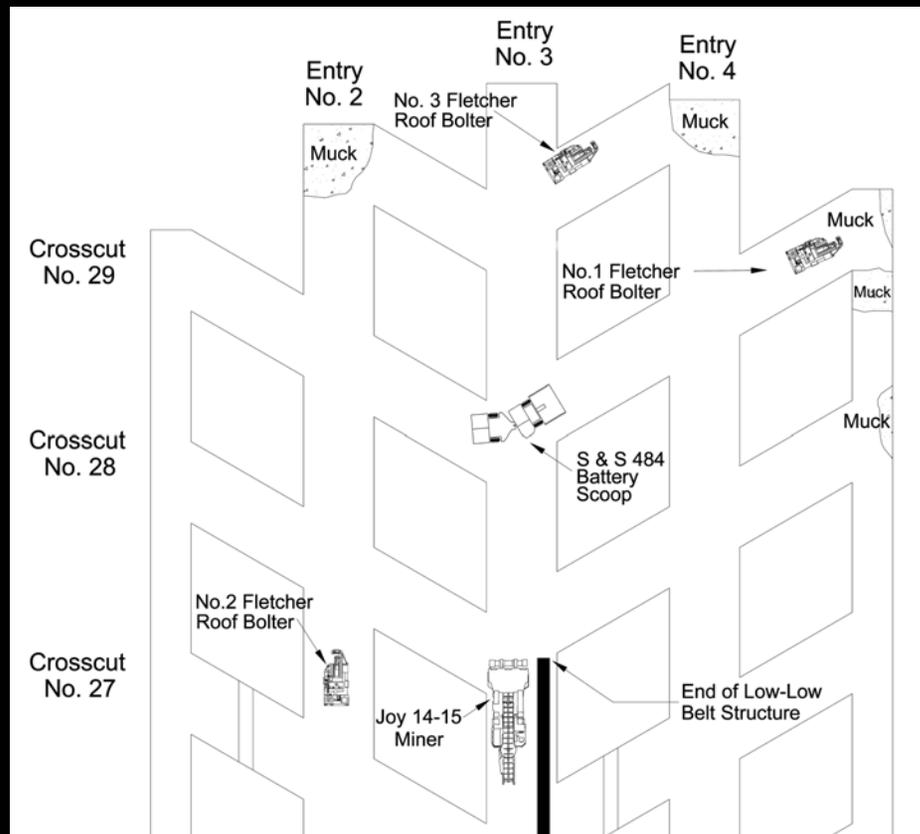
The scoop was then backed, battery-end first, from the No. 4 entry through crosscut No. 29 to a point between the Nos. 2 and 3 entries, where it was turned and trammed outby to the low-low belt tail-roller.

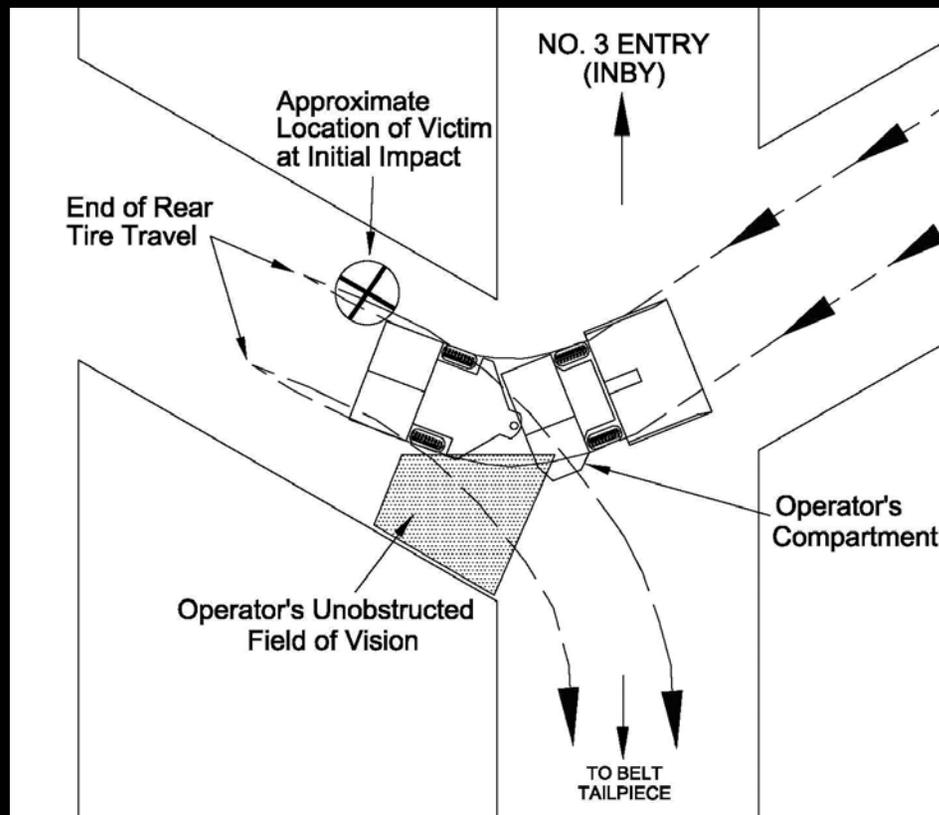
- As the scoop turned into the crosscut, the section foreman was run over by the battery-end of the scoop.
- The scoop operator was not aware of the accident at this time, as the victim was located in a blind spot.

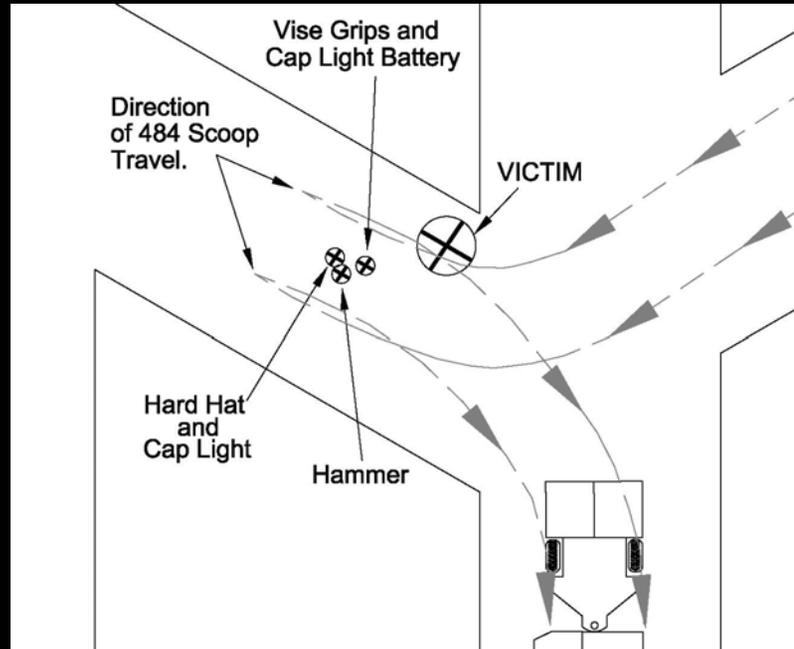
- The mine height ranged from 48-52 inches at the accident site.
- Scoop tire tracks indicated that it traveled battery-end first into the crosscut for a distance of approximately 16 feet.
- The point of the first impact was approximately thirteen feet within the crosscut.
- Interview statements indicated that the scoop entered this area once.

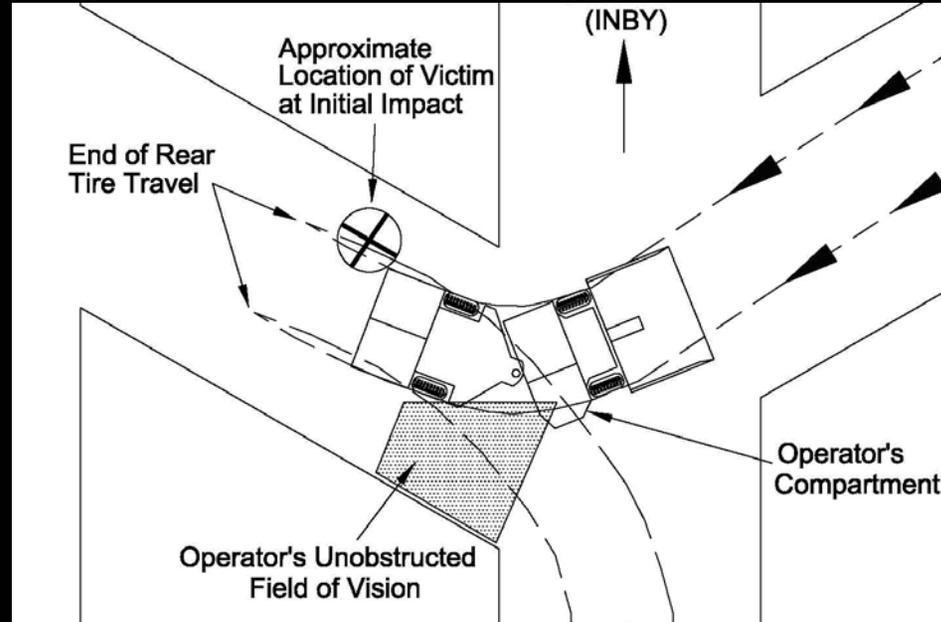
- Crosscuts were turned at 60-degree angles, left and right out of the belt entry. Also, centerlines for crosscuts to the right of the belt were offset ten feet inby those to the left of the belt entry.
- The scoop had to make an acute right turn as it crossed the entry and into the crosscut. This would have obscured the scoop operator's vision along the inby side of the crosscut as the battery-end of the scoop entered the crosscut.

- Causal Factor: Restricted field of vision by the equipment operator and the awareness of the equipment location and route of travel by the victim.
- Corrective Action: The operator shall modify the metal flange present on both sides of the battery tray to allow it to be completely seated down into the frame of the scoop. Safety talks were conducted with all miners at the mine site. Emphasizing the urgency of the awareness of personal interaction with mobile equipment, whether being on foot or being the equipment operator.
