## Coal Mine Fatal Accident 2003-21

Operator:	Performance Coal Company
Mine:	Upper Big Branch Mine-South
Accident Date:	July 19, 2003
Classification:	Electrical
Location:	District 4, Raleigh County, WV
Mine Type:	Underground
Employment:	177
Production	10,000 tons/day

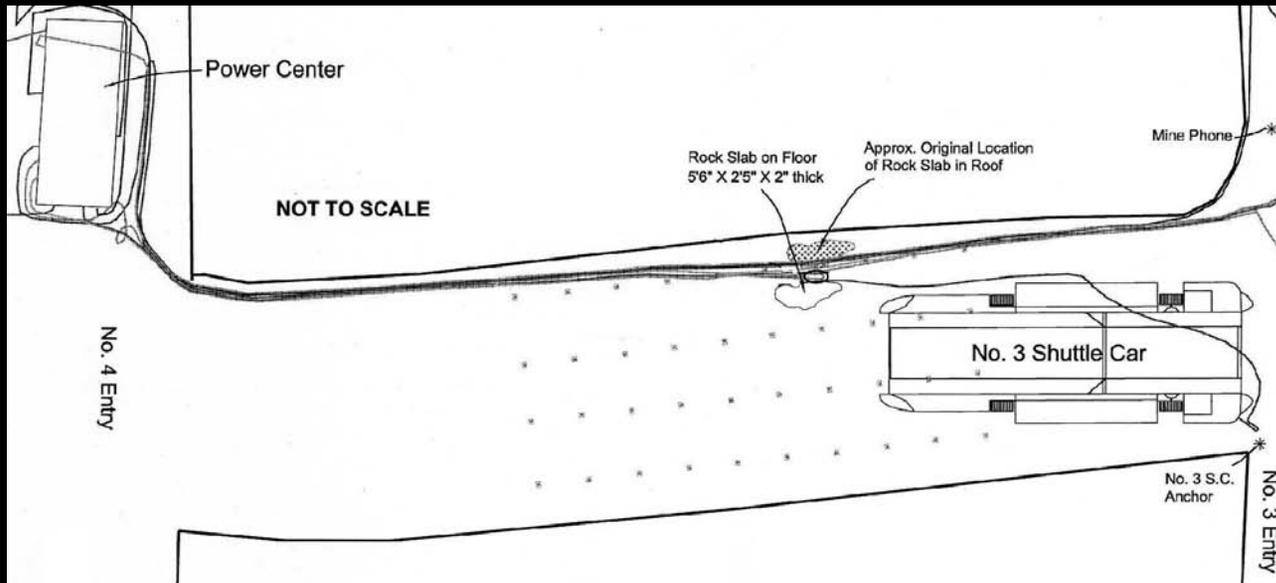
- The continuous mining machine operator and the electrician began looking for damage in the No. 3 shuttle car cable as they walked from the power center along the left rib, where the trailing cables were lying on the mine floor. They found a 2" thick rock, measuring 5-½' x 2-½', lying on both shuttle car trailing cables, approximately 4-½" from the inoperative No. 3 shuttle car.
- The No. 3 shuttle car operator and the electrician flipped the rock off of the cables and observed an area in the No. 3 shuttle car cable, which appeared to be swollen. They did not detect damage to the outer insulation in this portion of the cable.

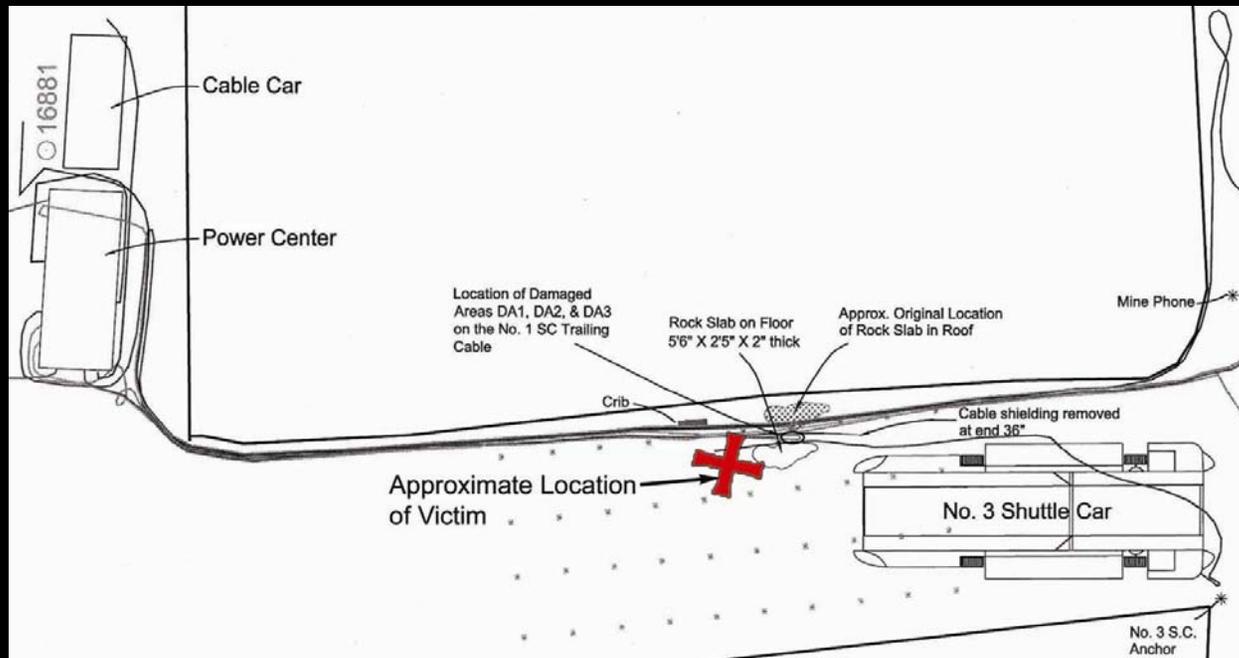
- After finishing the cut, the continuous mining machine operator checked the electrician's progress. He saw the electrician pulling cable off the No. 3 shuttle car reel and throwing it over the discharge end of the shuttle car. The continuous mining machine operator then returned to the face of the No. 2 left crosscut to resume mining.
- Soon after, a roof bolting machine operator noticed a light shining against the mine roof in the crosscut between No. 3 and No. 4 entries. As he walked toward the light, he saw the electrician lying on the mine floor, with the No. 3 shuttle car trailing cable lying across his body.

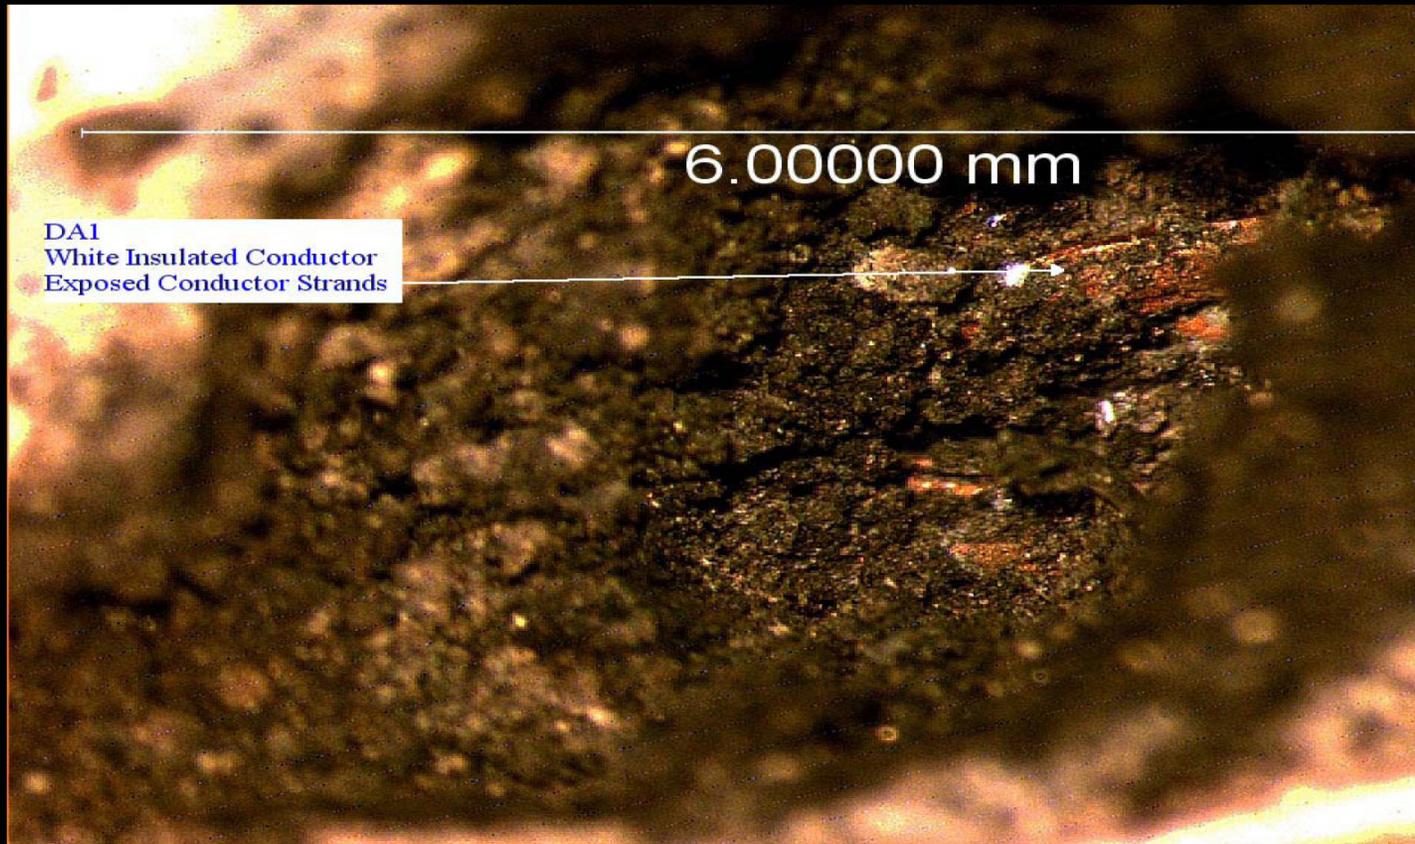
- 3 damaged areas on the No. 1 shuttle car cable were found in No. 4 left crosscut, each exposing an energized 480 VAC conductor.

*Causal Factor:* The No. 1 shuttle car cable was laying in mud and water and contained three undetected damaged areas; exposing two energized 480 VAC phase conductors. Stray electrical energy originated from these damaged areas.

*Corrective Actions:* The examination of trailing cables covered with mud and water makes detection of damaged areas of the cable more difficult. Personnel performing such examinations should take appropriate measures to ensure that a complete and thorough examination is performed.

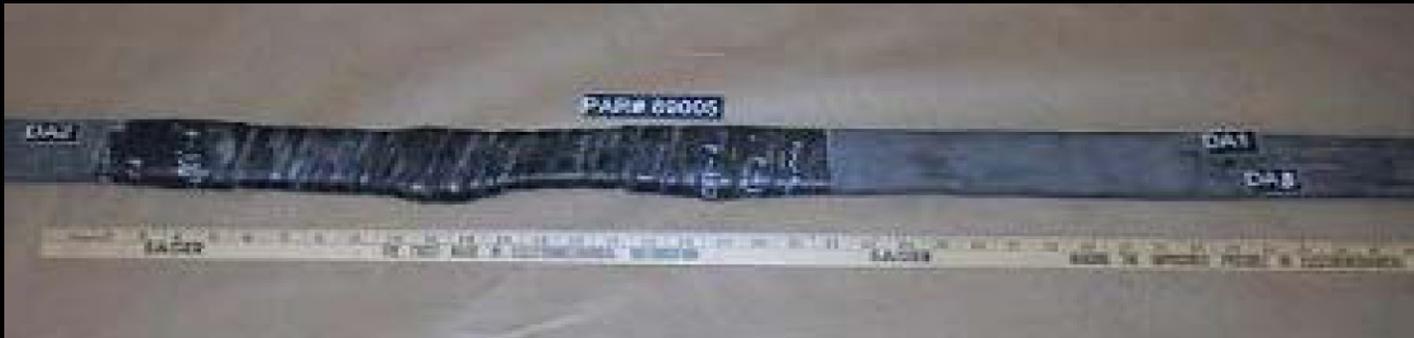
- These damaged areas were discovered in a 32-½" span of the cable located 1-4' from the victim, where he was performing electrical work on the No. 3 shuttle car cable when the accident occurred.

- The electrical work was being performed in an area of wet and muddy conditions. The mine floor was saturated with mud and two to three inches of standing water. The energized, electrical cables, including the damaged No. 1 shuttle car cable, were laying in the mud and water.

*Causal Factor:* Electrical work was being performed in wet and muddy conditions and in close proximity to energized electrical cables.

*Corrective Actions:* When a damaged portion of a cable is lying in the immediate vicinity of other energized cables, certified electricians should de-energize all of the cables or move the damaged portion of the cable a substantial distance from the energized cables, to a dry area if possible, before repairs are made.

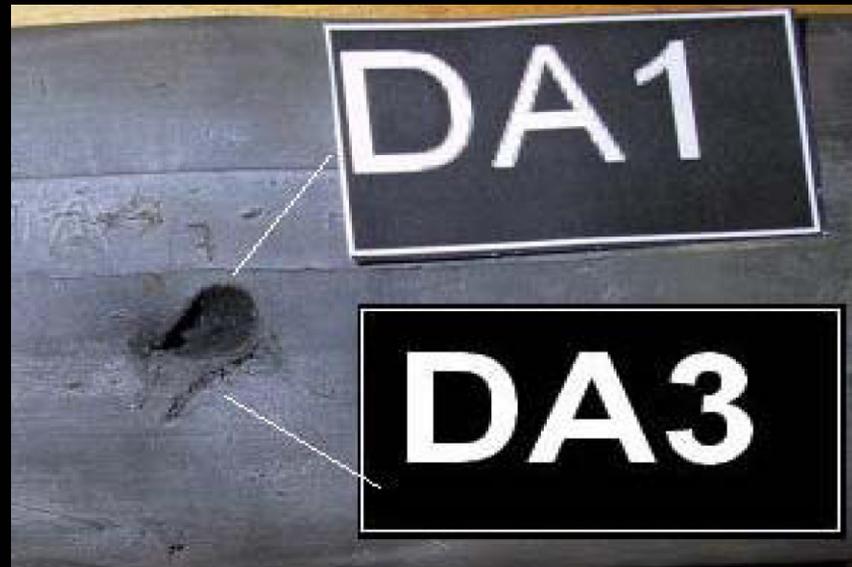
- While examining the No. 3 shuttle car cable for damage, the No. 3 shuttle car operator and the victim found a 2" thick rock, measuring 5-½' x 2-½', lying on several trailing cables ~4-½' from the No. 3 shuttle car.
- They flipped the rock off of the cables and noticed a swollen area on the No. 3 shuttle car cable. However, they did not examine the other cables for possible damaged areas.
- This indicates that the miners did not consider the possible damaging affects of rock falling on cables other than that associated with known operational problems.
- A chip of rigid, non-metallic, granular material was embedded in the white insulation and granular debris was found between the white insulation and the conductor at the damaged area labeled DA3.
