Coal Mine Fatal Accident 2003-22

Operator:	Warrior Coal LLC
Mine:	Cardinal Mine
Accident Date:	August 20, 2003
Classification:	Roof Fall
Location:	District10, Hopkins Co., Kentucky
Mine Type:	Underground
Employment:	220
Production	14,400 tons/day

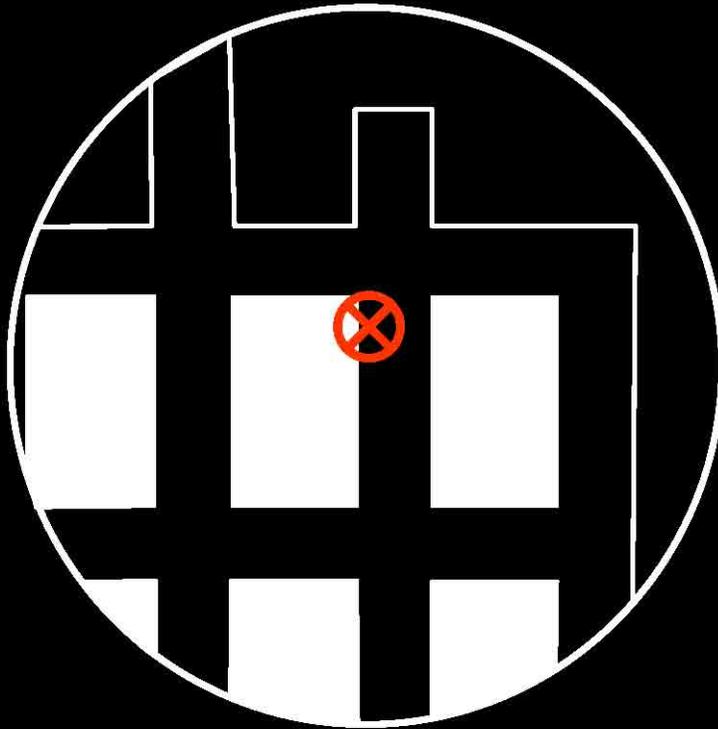
48", 5/8 diameter fully grouted bolts

4' between rows, 5' between bolts w/in a row

6" square, domed plates

8³/₈" x 18¹/₄" x 1³/₄" wood headers

FOSROC B23-4'-H10 resin

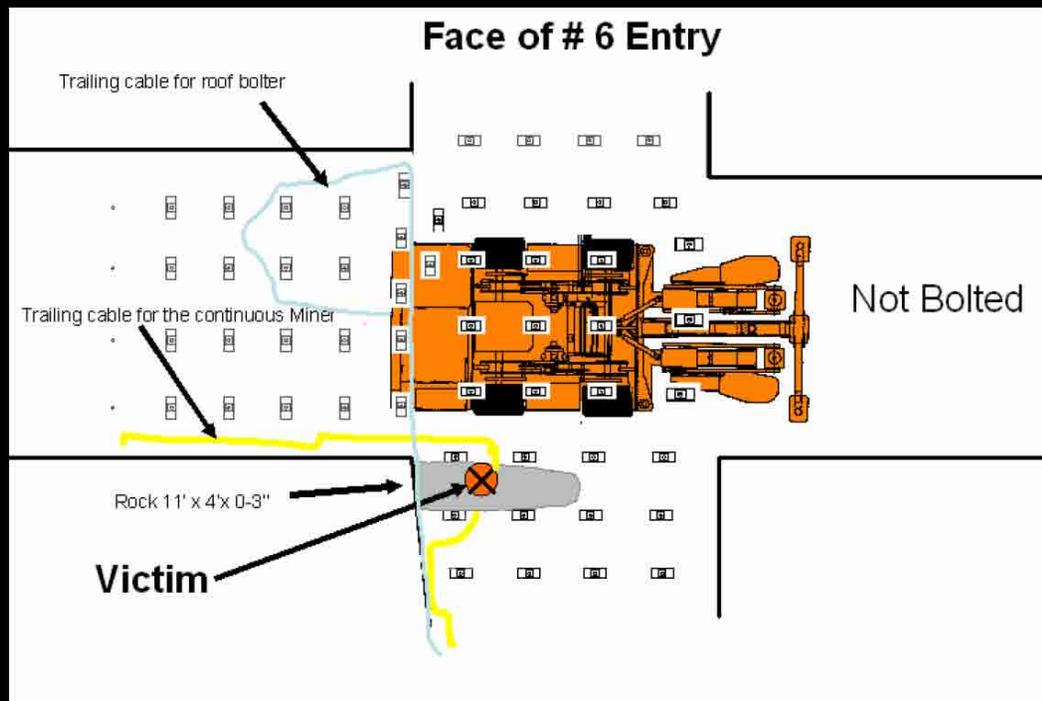
- The unit foreman was helping a co-worker relocate the trailing cable for the continuous miner near the outby edge of the last open crosscut in the No. 6 entry.
- The mining height was 7' and the entry width averaged 19 ½'.

- As the unit foreman bent over to pick up the cable, falling rock struck both the him and his co-worker.
- The co-worker was hit with a glancing blow, knocking him away from the remaining falling material.
- The foreman was forced to the mine floor by the rock and fatally injured.

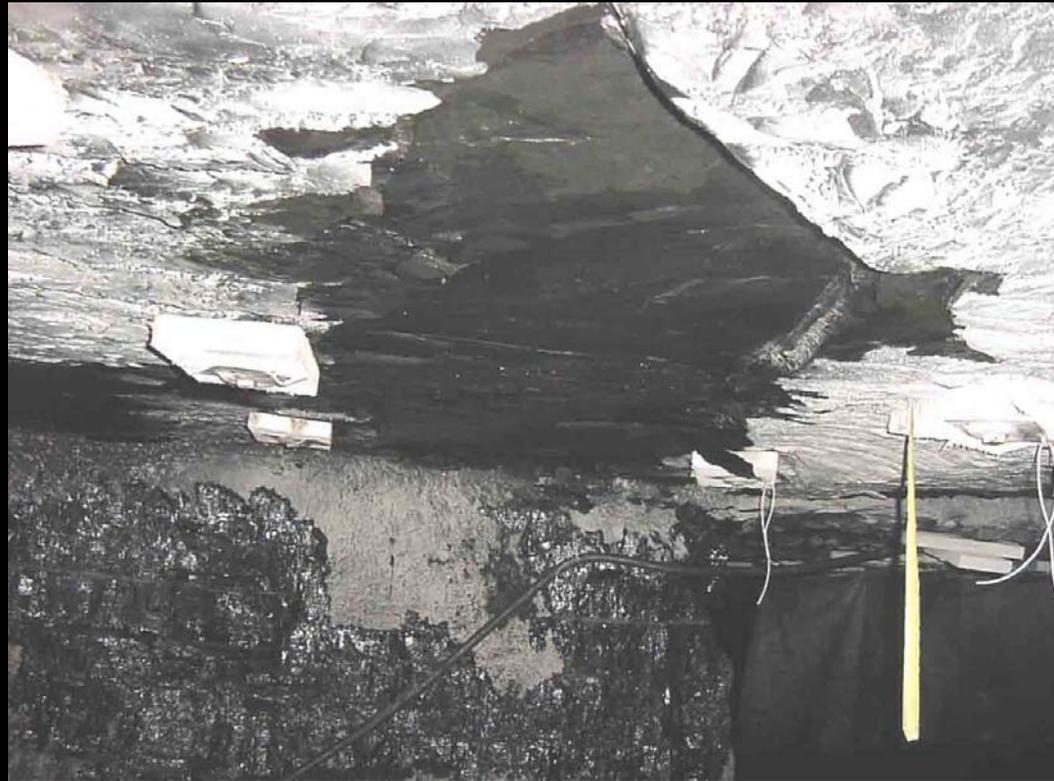
- On August 20, 2003, a 52-year old unit foreman, was fatally injured when he was struck by a section of rock that fell from between two rows of roof bolts.
- The rock measured 11' x 4' x 0-3" thick.
- The falling material comprised of several pieces estimated to weigh a total of 1,600 pounds.
- The fall cavity was bounded by several steeply angled slickensides and intersected on by a tight, vertical joint.
- Bolt spacing adjacent to the fall was within roof control plan specifications.

- The fallen material consisted of several pieces of immediate roof that fell from between permanent supports.

- **Corrective Actions:** Through revisions to the approved roof control plan, the spacing of the permanent roof bolts was changed from 4' wide and 5' on center to 3½' wide and 4½' on center. The size of the wooden headers positioned between the 6" x 6" roof bolt plates and the mine roof was increased from 18" in length to 26". Reducing the area between the roof bolt spacing across the entry and between the advancing rows of roof support reduces the likelihood in addition to the size of gob falling from between the permanent roof support. In addition, all underground employees were retrained to improve their recognition of roof conditions which require further actions.

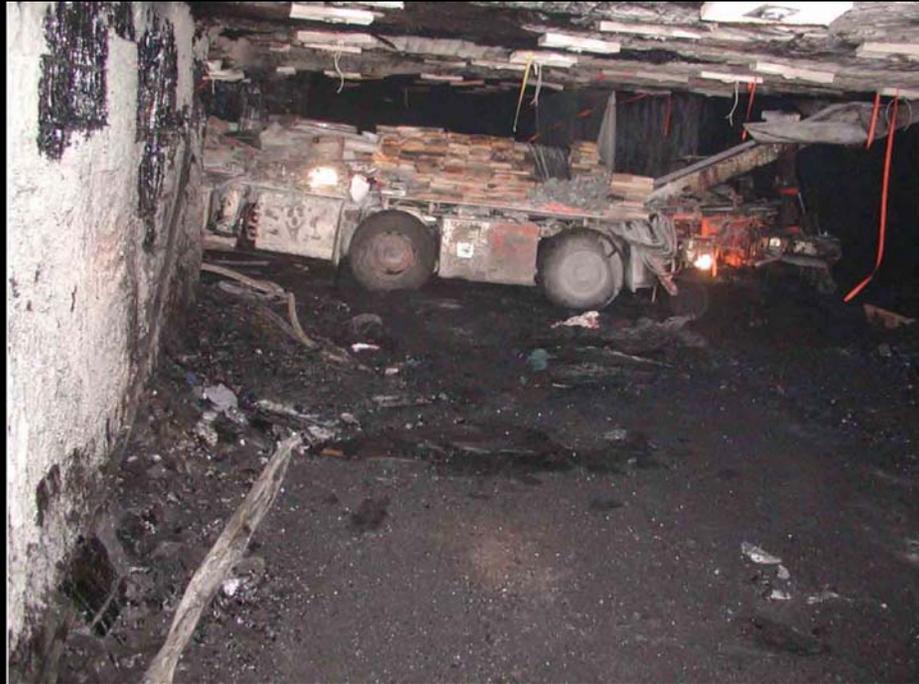
- Pillar spalling was typically limited to pillar corners.
- Roof damage appeared to occur most frequently at the roof/rib interface near the inby pillar corners.
- Roof and rib conditions on the section generally were good.

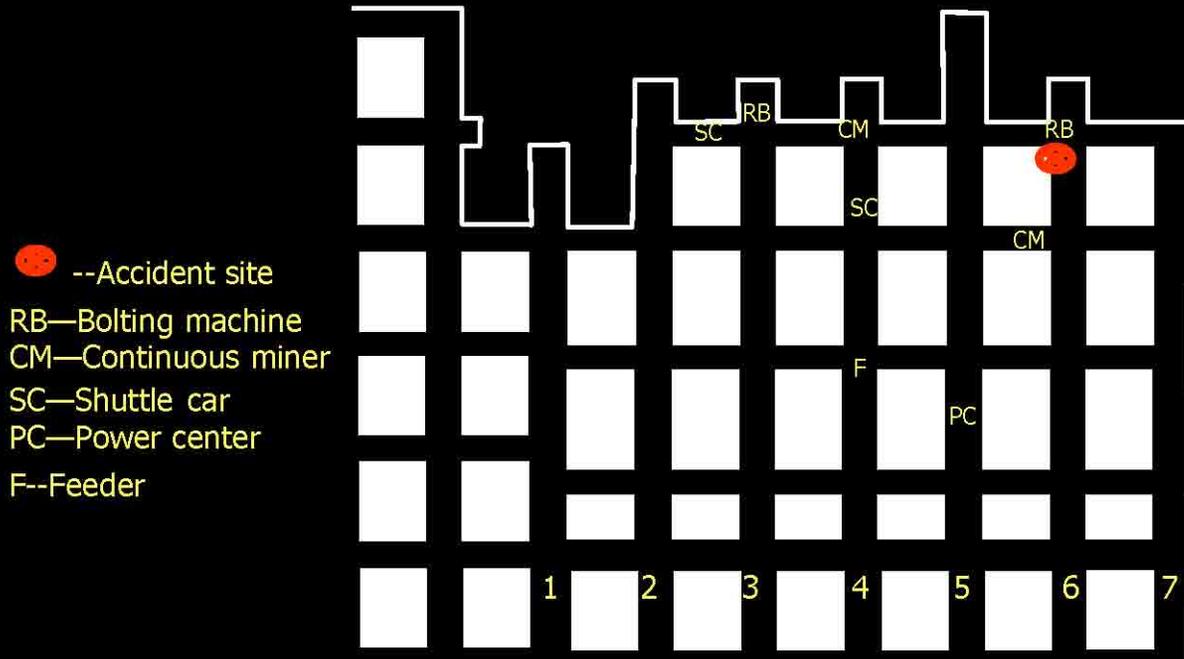
- The roof where the fall occurred had been supported during the second shift on August 19.
- Pre-shift and On-Shift examinations of this area failed to detect visible hazardous conditions of the roof and ribs.
- Slickensides, bedding planes, and localized cutter roof conditions contributed to instability of the slab at the accident site

- **Causal Factor:** The standards, policies, and administrative controls in use at the mine were inadequate to identify the hazardous roof condition and did not ensure that the roof was supported or adequately controlled to protect persons from hazards from falls of roof.
