REPORT OF INVESTIGATION

**Fatal Explosives Accident
June 13, 2003**

**# 1 Mine
Cody Mining Company, Inc.
McDowell, Floyd County, Kentucky
ID No. 15-17373**

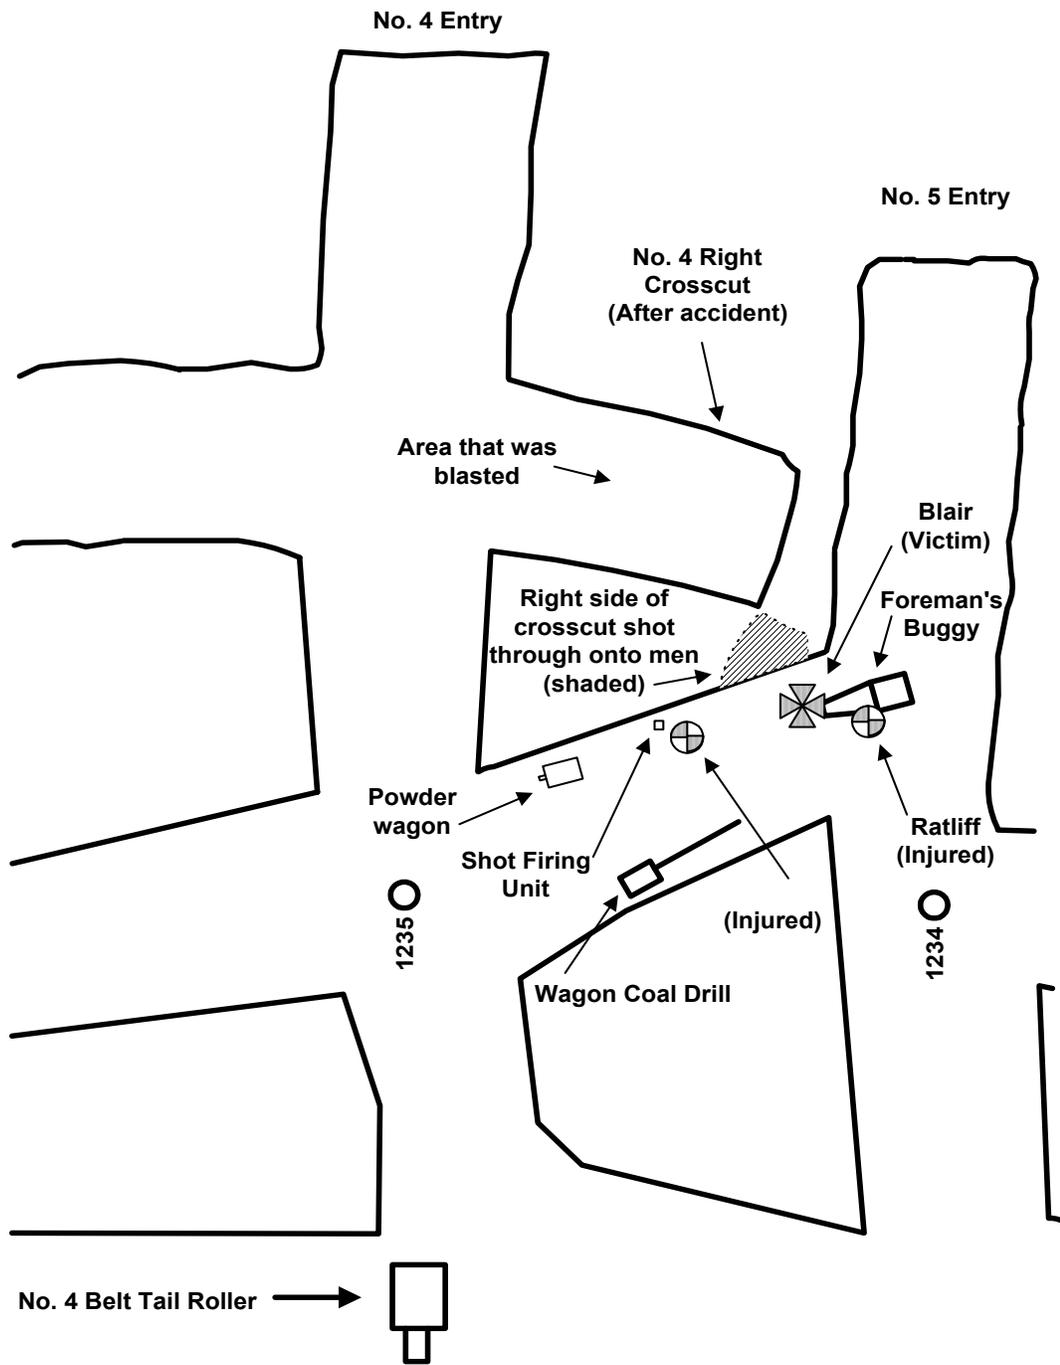
Figure 1 - Detail of Accident Scene

The pre-blasting check, required by 75.1325, was similarly inadequate. Robert Delong, Robert C. Ratliff, Jr., and Paul E. Blair, were located in the last open crosscut between survey stations 1234 and 1235 when the No. 4 Right crosscut was blasted. Interview statements by Delong indicated that, after observing a scoop leaving the section loading point, Robert C. Ratliff, Jr., gave the "all clear" signal to Delong to blast the No. 4 Right Crosscut.

At approximately 12:30 p.m., when the No. 4 Right Crosscut was blasted, the shot broke through into the outby crosscut where Robert Delong, Robert C. Ratliff, Jr., and Paul E. Blair were located. Blair was fatally injured, Robert C. Ratliff, Jr. received serious injuries, and Delong received minor injuries.

1234 and 1235 when the face of the No. 4 Right crosscut was blasted. When the explosives were detonated, the right corner of the No. 4 Right crosscut shot into the last open connecting crosscut where the miners were located.

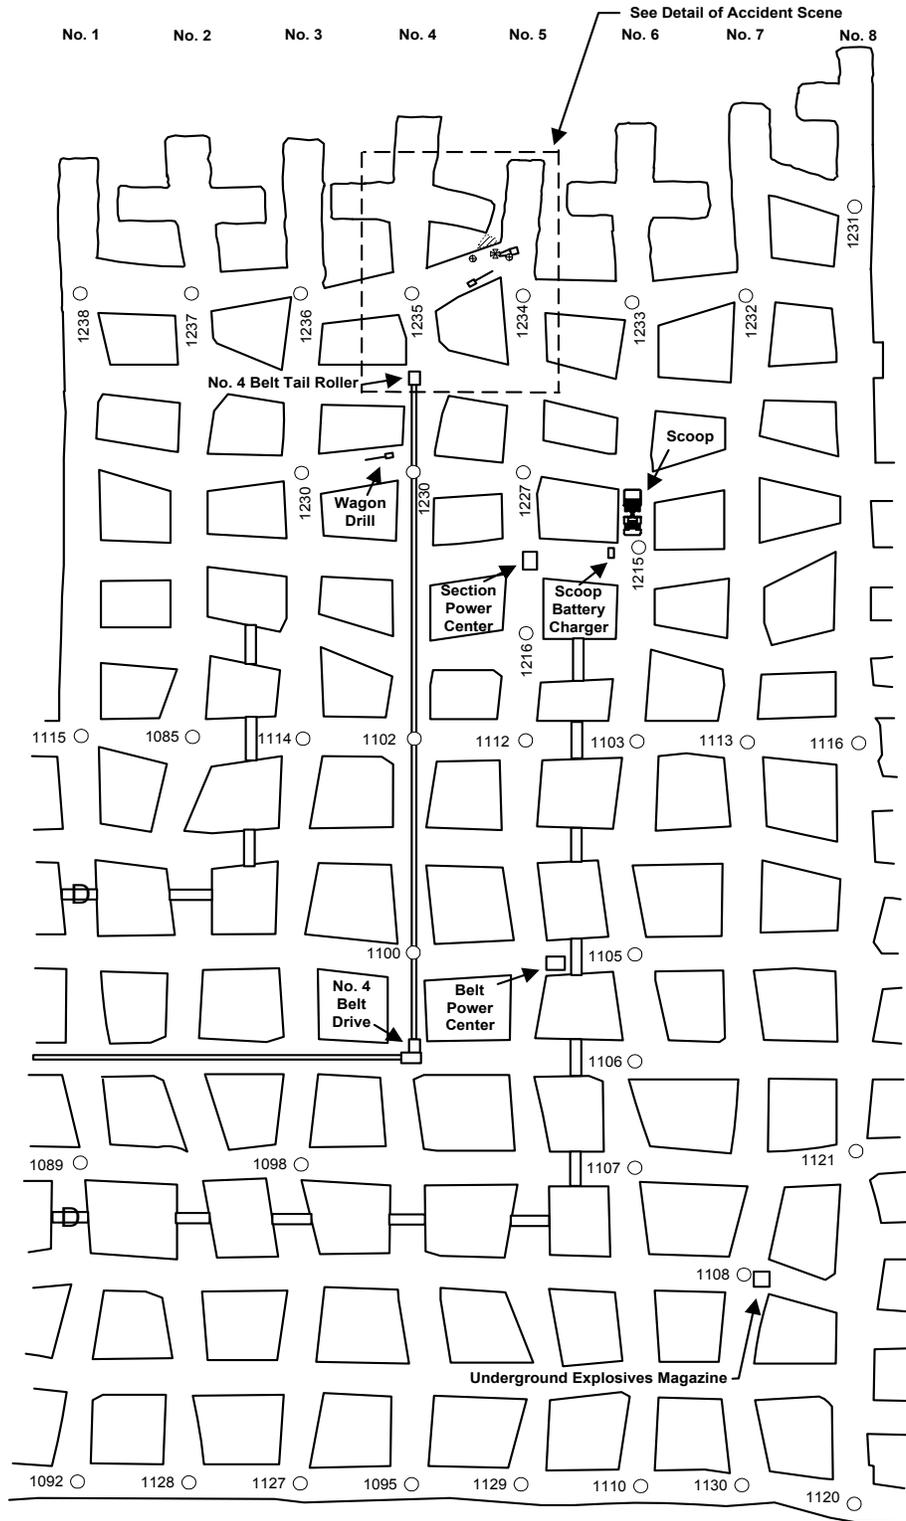
Figure 2 - Sketch of 001-0 Section

Poor mining practices resulted in excessive widths of entries and crosscuts, undersized pillars, misaligned openings, accidental cut-throughs, and other violative conditions. These practices resulted in crosscut centers that were smaller than those specified in the approved roof control plan. Numerous crosscuts and entries had been mined as much as 25 degrees off their projected center lines. Observations on the working section and throughout the mine indicated that sightlines or other effective methods of directional control were not being used to maintain the projected direction of mining. This resulted in the two crosscuts involved in the accident being mined toward one another (refer to Figure 1). The No. 4 Right Crosscut working place was mined from 14 to 16 degrees to the right of its projected center line, while the last open crosscut was mined from 24 to 28 degrees to the left of its projected 90 degree angle off the No. 4 Entry. An additional factor that caused the No. 4 Right Crosscut working place to be mined off center was that it was blasted or "broken" continuously from the right side of the face during the mining cycle. This practice resulted in the crosscut being progressively mined to the right of center (in an outby direction) with each shot.

Wider mine openings also reduce adjacent pillar dimensions. Entry and crosscut widths exceeded the maximum of 20 feet permitted by the approved roof control plan at numerous locations on the working section, where widths of up to 25' were measured. Mining widths at the accident site were 21'6" in the No. 4 Right Crosscut

working place and 20 feet in the last open crosscut where Robert C. Ratliff, Jr., Blair, and Delong were located during the accident.
