REPORT OF INVESTIGATION

Fatal Powered Haulage Accident  
June 26, 2003

Guthrie Creek Mine  
Uptown Motors, Inc.  
Parrish, Walker County, Alabama  
ID No. 01-03162

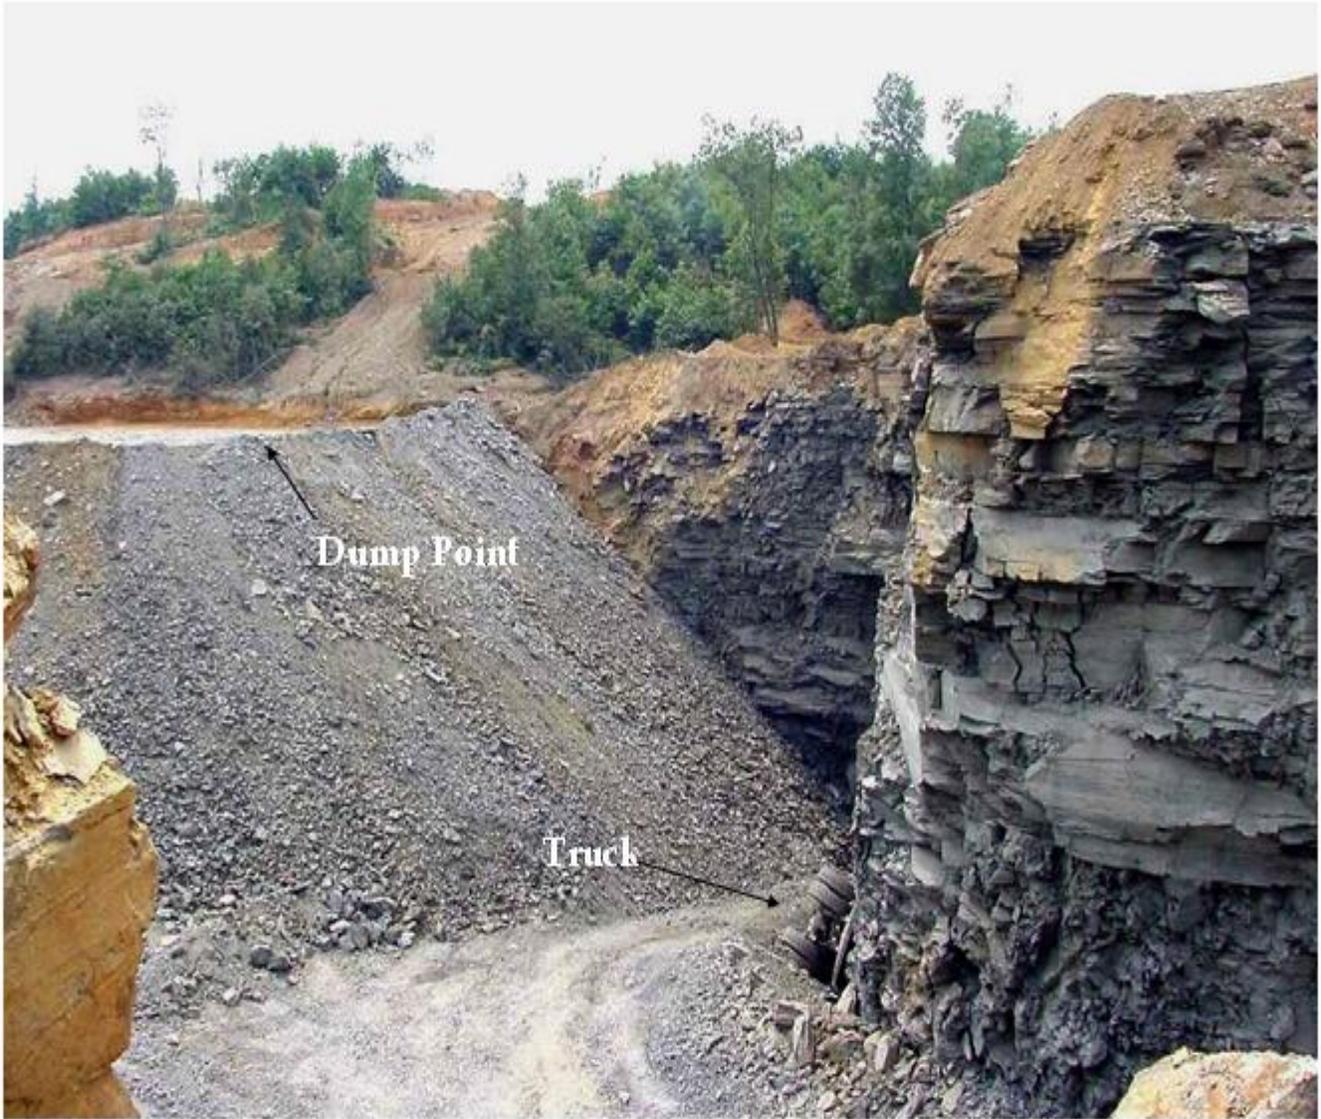
**PHOTOGRAPH OF ACCIDENT SITE**

On Thursday, June 26, 2003, at approximately 7:05 a.m., Bobby R. Rawls, age 59, a rock truck driver at the Guthrie Creek Mine, was fatally injured when the truck he was operating traveled past the edge of the 001 Pit dumping point location and traveled down the spoil embankment. The truck struck the highwall at the bottom of the pile and overturned. There were no eyewitnesses to the accident.

The accident occurred because berms, bumper blocks, safety hooks, or similar means to prevent overtravel and overturning were not provided at the 001 Pit dumping point location. Contributing to the accident was failure to identify and correct this condition during examinations of the work area. No defects that would affect the operation of the truck were found during the investigation.

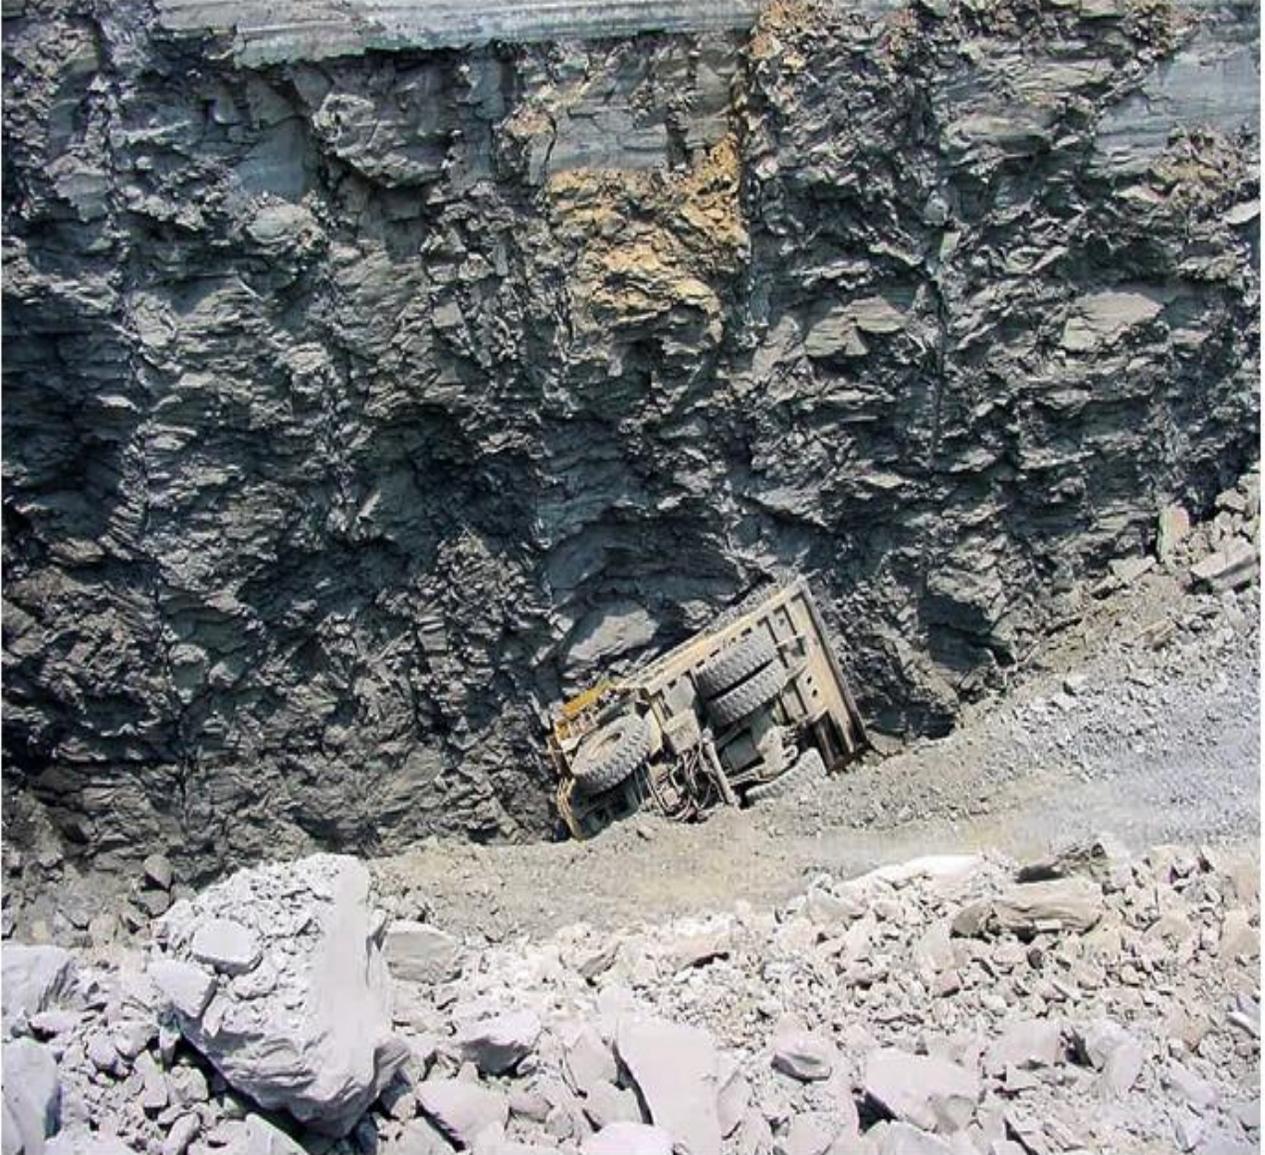
**APPENDIX D- Photograph of Accident Scene**

Investigation of the wrecked truck and the scene revealed that the truck traveled backwards down a 71 percent grade for approximately 119 feet. The truck's parking brake system was not applied and the transmission was in the reverse gear position.

There was no berm provided at the edge of the 001 Pit Dumping point for 82 feet. The daily on-shift examination record showed no hazardous conditions recorded for the 001 Pit Dumping location. Safety Standard 30 CFR 77.1713(a) requires the operator to correct hazardous conditions, such as the lack of berms at active dumping locations, identified during such examinations. There was no indication of ground failure at the edge of the dumping point that would have destroyed evidence of any berm that may have existed prior to the accident.

Corrective Action: Dumping location practices and procedures should be reviewed to ensure that the dumping process does not create hazards to persons that are required to work in those areas.

Corrective Action: Dumping location practices and procedures should be reviewed to ensure that the dumping process does not create hazards to persons that are required to work in those areas. Workplace examinations should be conducted frequently for changes affecting safe operation and prompt correction of hazards when observed. Examiners should be adequately trained to detect hazards.
