**REPORT OF INVESTIGATION**

**Fatal "Other" Accident**

**November 19, 2003**

**Goldstrike Mine  
Barrick Goldstrike Mines Inc  
Carlin, Eureka County, Nevada  
Mine ID No. 26-01089**

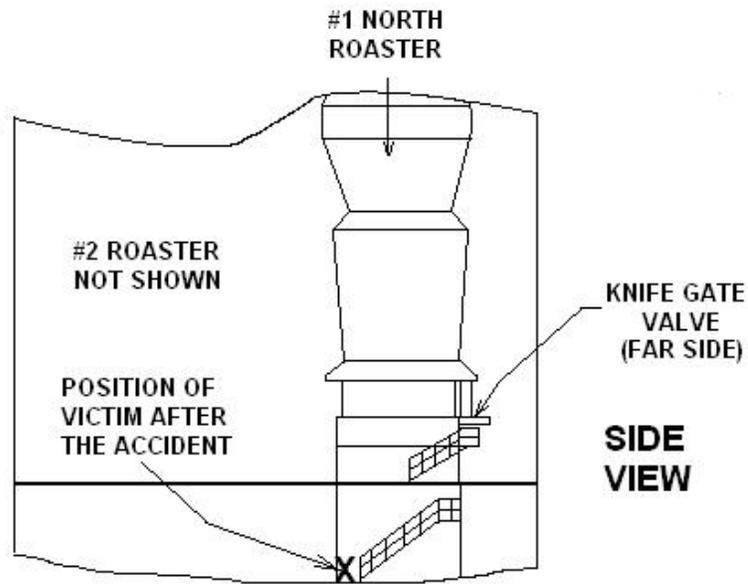
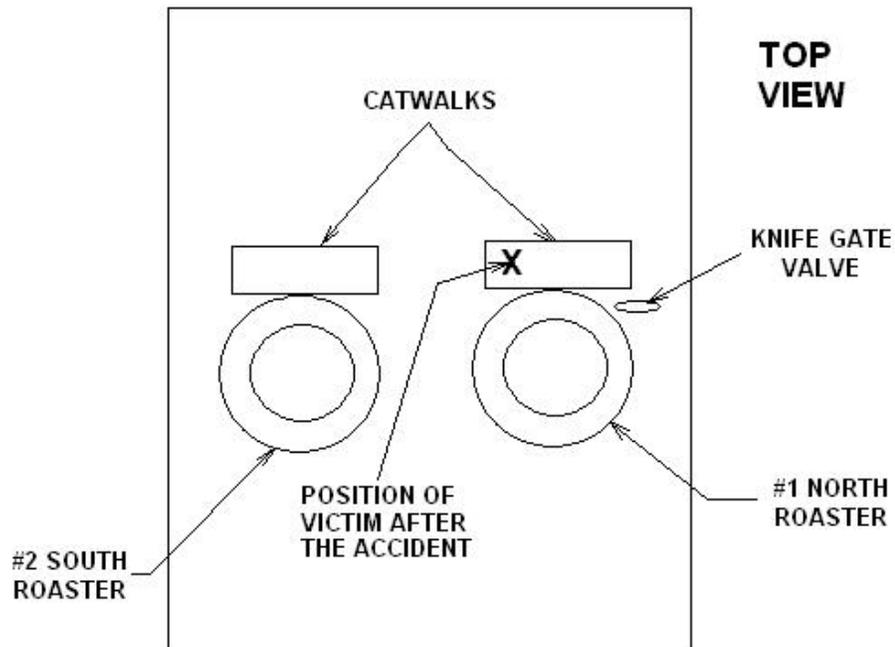
## Sketch of Accident Scene:

The accident occurred in the roaster building on the 5431 level (third floor) about 30 feet above ground. The 200 feet tall, multi-level building contained two roasters and other gold ore processing equipment.

The accident occurred because safe procedures had not been established prior to performing repairs on the B-leg of the #1 Roaster (North) knife gate valve. The roaster was shut down with a large quantity of hot calcine in the upper and lower beds. A gasket in the knife gate valve was removed before the roaster was emptied and the system was allowed to cool.
