MNMM Fatal 2004-18

- Machinery
- September 16, 2004 (North Carolina)
- Sand & Gravel Operation
- Mechanic
- 35 years old
- 12 years experience

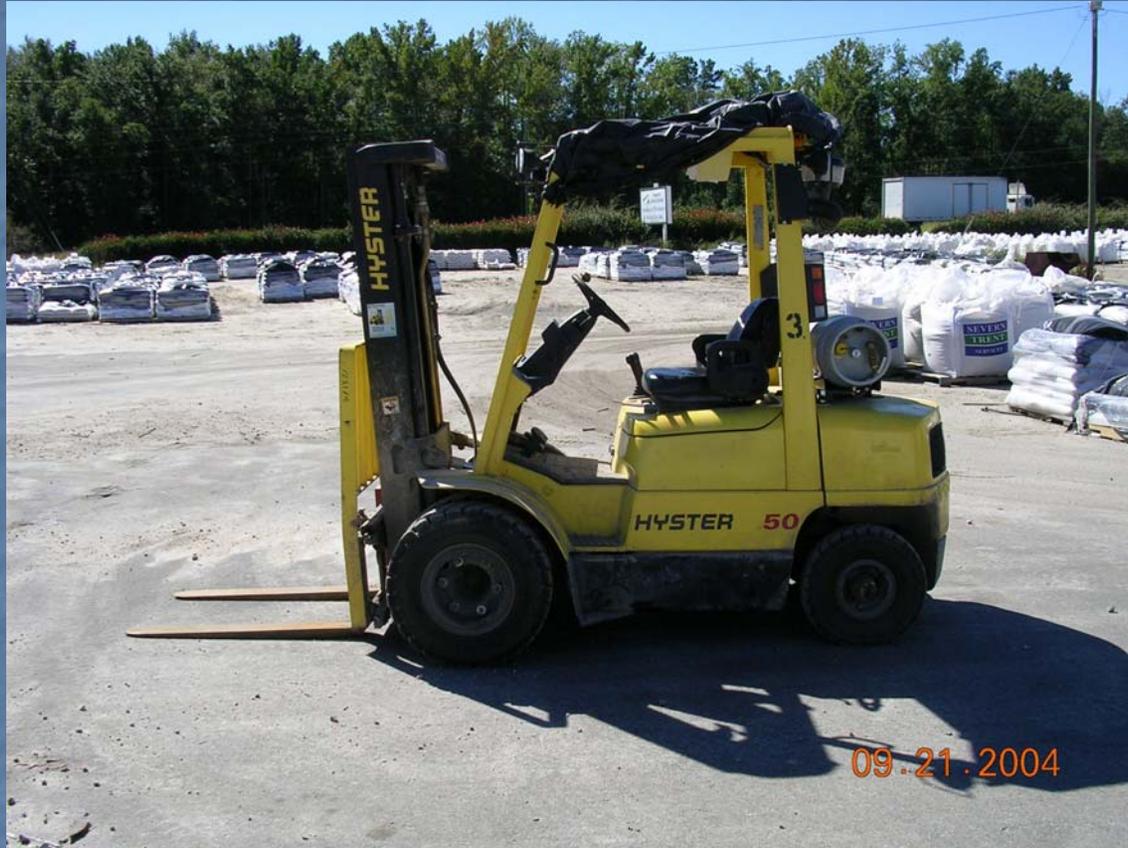
- The victim was fatally injured when the forklift he was repairing fell on him. The jack that was holding up the machine slipped while he was positioned under the forklift to change a starter.

- Conduct a Risk Assessment evaluating all tasks and identifying potential hazards before performing maintenance work.
- Use a lifting device that is compatible with the load being lifted and block equipment against hazardous motion before starting any repairs.
- Take additional care and caution when working underneath equipment. Never work under a load that is only supported with a jack.

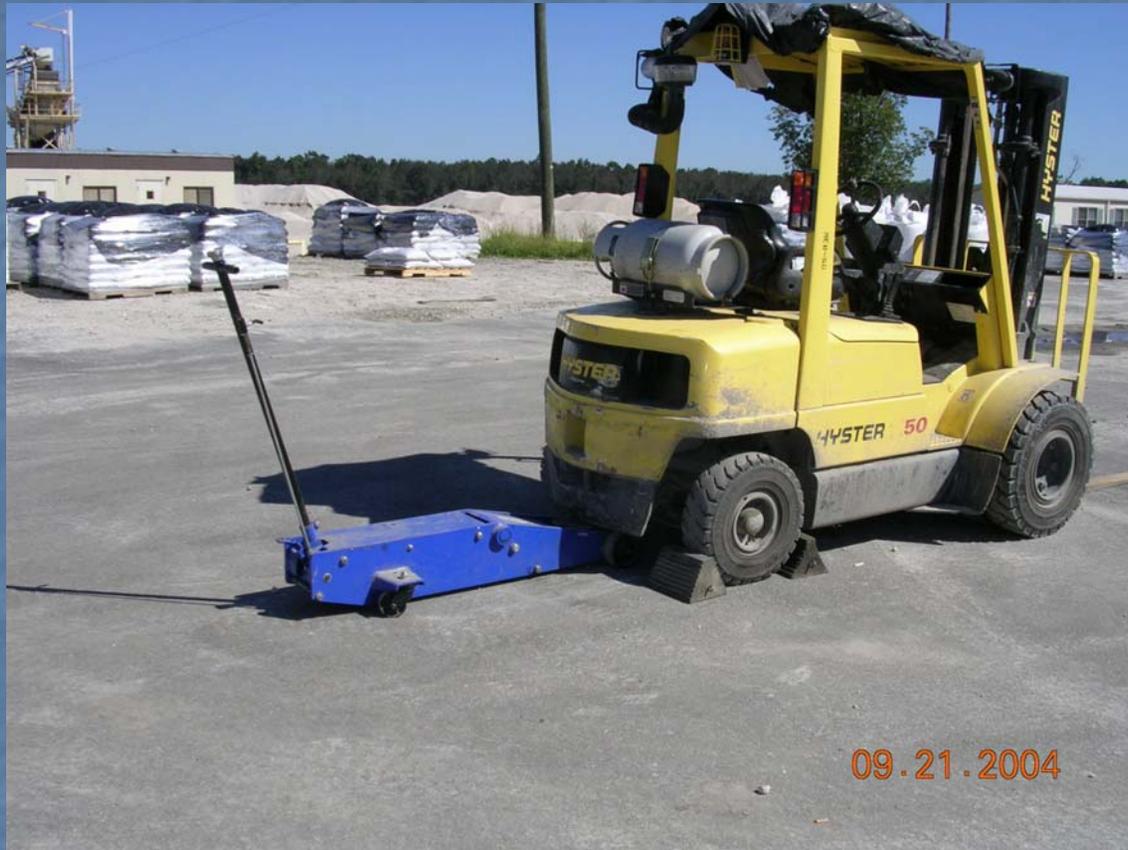
- The accident occurred because the forklift had not been blocked or mechanically secured to prevent it from falling. The hydraulic jack used to raise the forklift shifted, causing the forklift to fall. A risk assessment was not conducted before starting this task. No steps were taken to identify possible hazards. Controls were not implemented to eliminate the risks involved with working underneath the raised forklift.

- Maintenance policies and standards were deficient and failed to ensure the appropriate tools or equipment were provided and used to complete the repair task. The jack available at the mine site was not compatible with the equipment being lifted. Blocking material had not been used to support the raised frame of the forklift.
