## Coal Mine Fatal Accident 2004-21

Operator:	Jeddo Coal Company
Mine:	Jeddo No. 8 Preparation Plant
Accident Date:	October 1, 2004
Classification:	Powered Haulage
Location:	District 1, Luzerne County, PA
Mine Type:	Surface
Employment:	14
Production	1500 Tons/Day

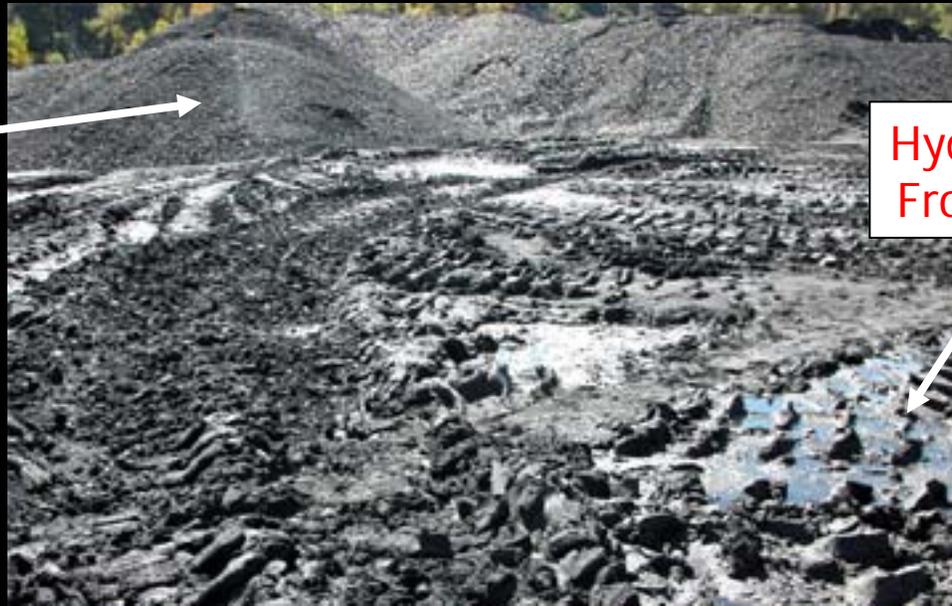
Hydraulic Oil  
From Loader

Causal Factor: Hydraulic oil sprayed onto turbocharger/exhaust manifold and ignited. Grating at the door to the cab did not provide protection to the route of egress.

Corrective Actions: An appropriate fire suppression system should be considered. Such systems have proven to be highly effective. The company has replaced the grating with solid flooring in area behind the operator's cab.

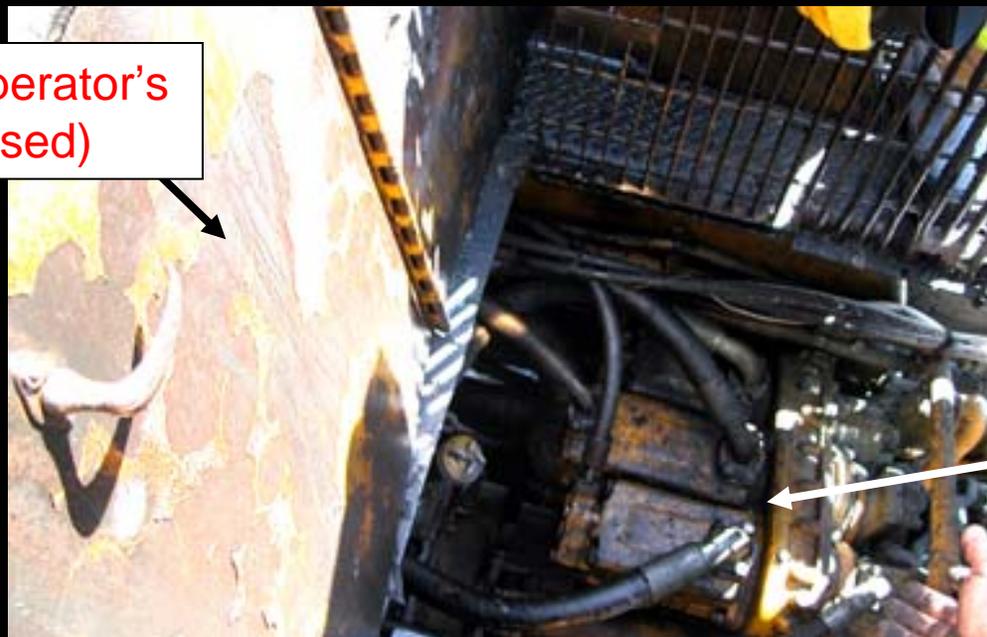
Outside of Operator's  
Door (closed)
