Fatality #22 & 23 - December 05, 2004
Falling Material - NV - Copper
Robinson Nevada Mining Company - Robinson Operation

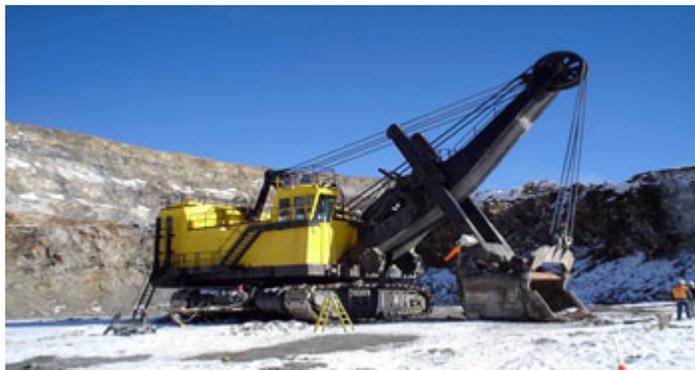
METAL/NONMETAL MINE FATALITY - On December 5, 2004, two mechanics were fatally injured at a surface copper operation. The miners worked for a contractor, retained by the mining company, to mine the reserves. One miner was 31 years old with 11 years experience and the other victim was 23 years old with 3 years experience. The mechanics were repairing the trip latch mechanism on an electric powered shovel bucket. The door was raised and a brace was welded to hold it in place. While they were working in the lower area of the bucket, the welded brace failed and the door released.

- Before any work begins, miners should conduct a Risk Assessment to evaluate all tasks to identify and correct potential hazards, ensuring that the task can be safely performed.
- Before working under a raised bucket door, ensure that the material used for blocking against hazardous motion is adequate and properly installed.
- Examine work areas during the shift for hazards that may be created as a result of the work being performed.
- Consult equipment manufacturers for guidance before repairs begin.
