REPORT OF INVESTIGATION

**Fatal Powered Haulage Accident
October 1, 2004**

**Jeddo Coal Company
Jeddo No. 8 Preparation Plant
Hazle Township, Luzerne County, PA
ID No. 36-08649**

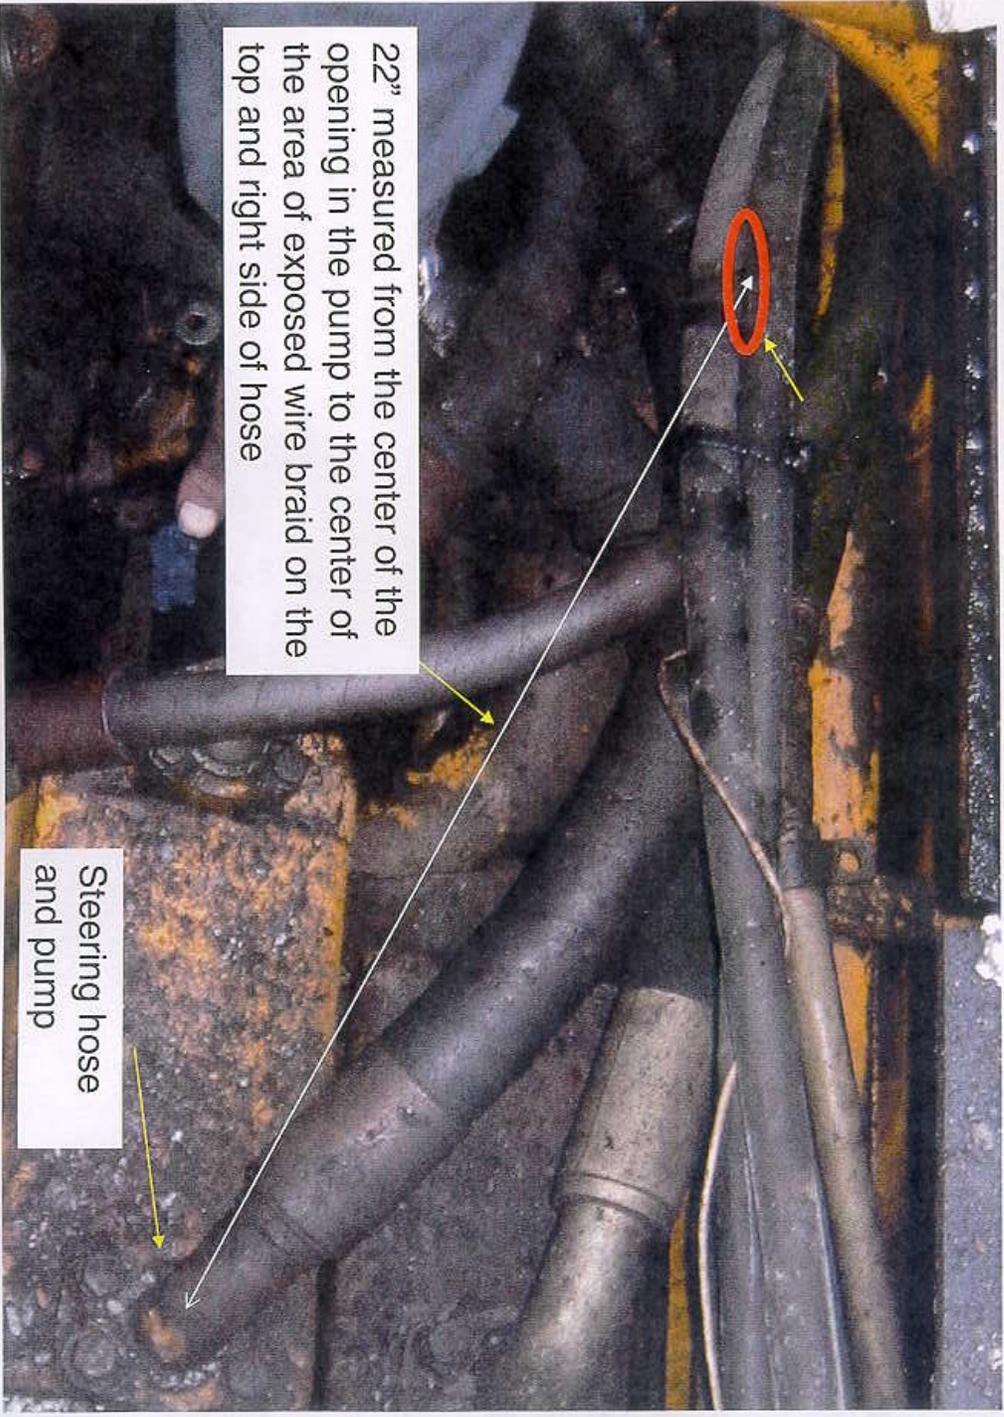
The steering pump hose (large section) was connected to the large section of the steering pump. This was a Gates 24C12 hose with a maximum working pressure of 2500 psi. A Gates date code on the hose indicated it was manufactured on March 4, 2002. Caterpillar specifies a hose 46.8 inches long with a 67.5° fitting on one end and a 90° fitting on the other end. The hose removed from the loader was approximately 50-1/2 inch long and was provided with a one 67.5° fitting on one end and a 90° fitting on the other end. Severe abrasion was found in three areas along the length of this hose. One area of abrasion measuring 1 inch wide x 2 inches long, located approximately 22 inches from the steering pump was found to have all four layers of wire braids broken. The wear

marks on the hose cover and its wire braids indicated that abrasion between the hose and a machine component had occurred.

Red Circle Indicates Area of Abrasion on the Large Steering Hose

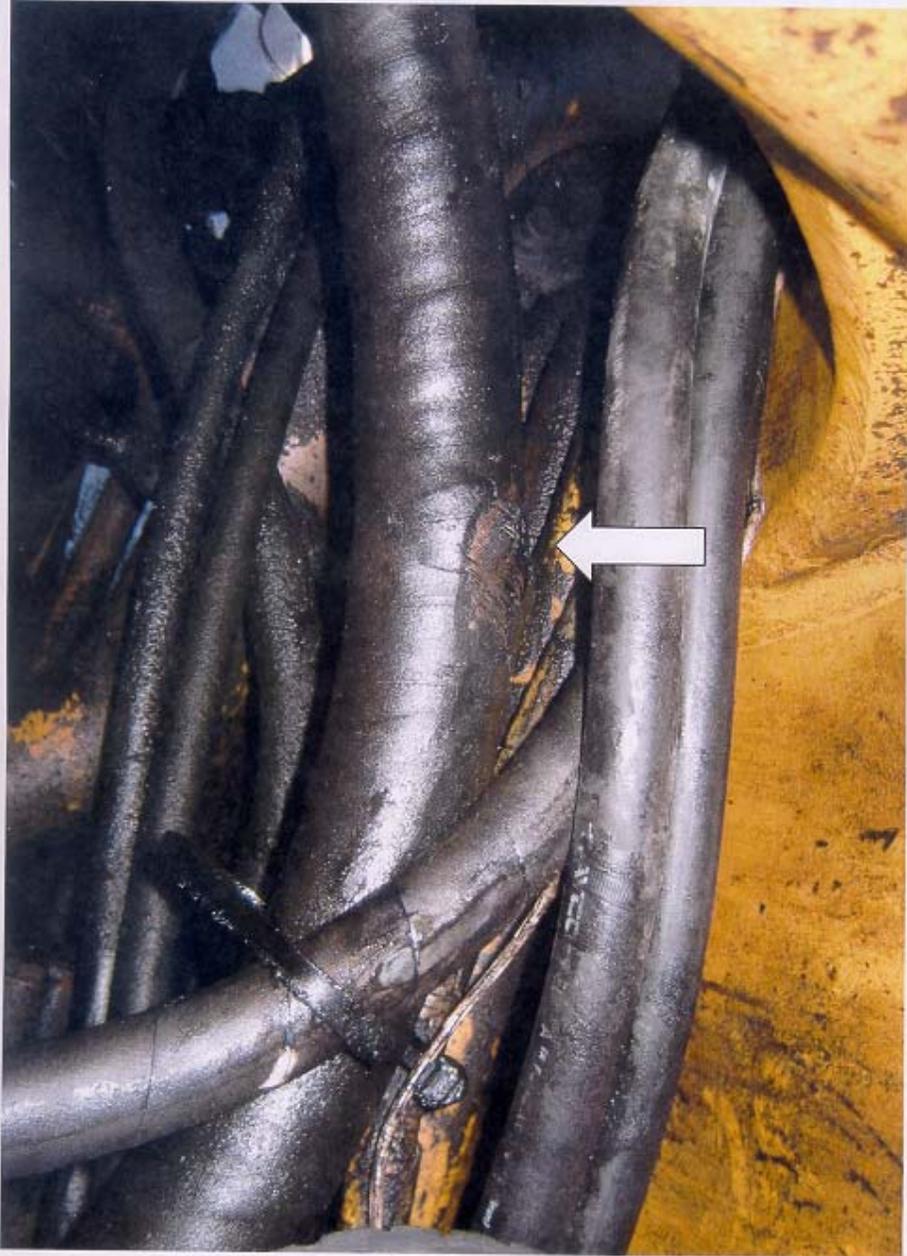
The direct cause of the accident was the failure of the steering hose (large section) which allowed hydraulic oil to contact the turbocharger/exhaust manifold resulting in a fatal fire on the front-end loader. The hose failed due to external abrasion caused by contact with other components of the loader.

Area of Abrasion Where the Steering Hose Failed

Corrective Action: A procedure has been established to assure that when machinery is purchased, a competent person thoroughly inspects, examines and tests the machine to assure that its components and systems conform with the manufacturer's specifications. Any deficiencies will be corrected before the machine is put into operation. The company has incorporated this policy into their safety program and the same policy will be reviewed annually during refresher training.
