REPORT OF INVESTIGATION

Fatal Machinery Accident  
December 21, 2004

Valley Creek Mine No. 2  
Tennco Incorporated  
Clairfield, Claiborne County, Tennessee  
ID No. 40-03231

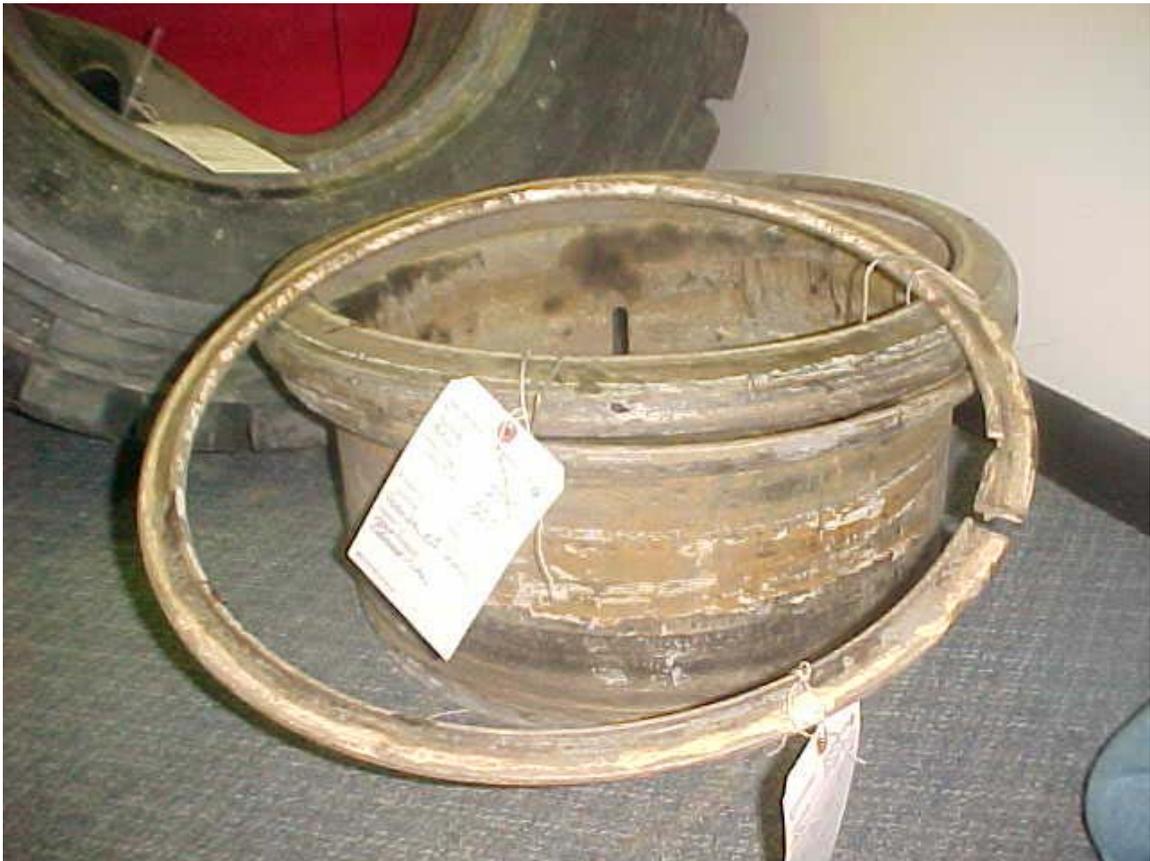
**Picture of Rim Assembly**

The rim assembly consisted of a Hayes Lemmerz 20 X 8.0 LW-20 X 7.5 M rim base. The rim base had a 5/8-inch thick ring welded to it for mounting on the shuttle car wheel unit. The ring had 20 holes on a 17 3/8-inch bolt circle. One of these holes was slotted and extended completely to the inside diameter of the ring to be used for the valve stem, leaving 19 holes for the lug bolts. A F 20 X 10.0 M flange and LR 20 X 7.5-8.5-10.0 M lock ring completed the three-piece components. Referencing the “Multipiece Rim Matching Chart”, 1992 Edition, published by the Occupational Safety and Health Administration, (OSHA), the rim assembly components were not properly matched. Representatives from Haynes Lemmerz confirmed that the F20 X 10.0 M flange was the incorrect flange for the 20 X 8.0 LW-20 X 7.5 M rim base.

A visual inspection of the rim base gutter, which is designed to hold the lock ring, revealed some critical seating areas that contained corrosion and dirt build-up. The inspection also revealed the rim had dirt built up on the flange which is permanently attached to the rim base. The rim had to be cleaned with a wire brush to locate the identification stamping. The inspection did not reveal any noticeable structural failure or excessive wear in the rim base that would have initiated the rim separation.

An inspection of the lock ring revealed that it was distorted. A gap in the split in the lock ring was approximately  $\frac{3}{4}$  of an inch. There is no gap in a new lock ring of the same type. According to information on page H-6 of the National Wheel and Rim Association's 2000 edition of the Wheel and Rim Safety Manual, use of distorted rim components can create a hazard because of improper fit of the components. The manual recommends that any distorted components be replaced. A determination could not be made whether the lock ring was distorted during assembly or if the lock ring was bent during the accident.

The front (weather side) of the removable flange has an indentation used to hold the lock ring in place when the rim is properly assembled. The diameter of this indentation is equal to the outside diameter of the lock ring. When the three piece rim is assembled properly, the lock ring fits inside this indentation. When the tire is inflated the removable flange is pushed against the lock ring. When the flange is pushed against the lock ring the indentation in the flange traps the lock ring in position. The tire assembly blew apart when the lock ring and flange separated from the rim assembly with a violent force. One possible cause of the accident was the lock ring being installed backward. Similar accidents have occurred as a result of this condition. Due to the lack of information concerning physical factors such as the actual tire pressure at the time of the accident and the actual torque on the impact wrench, it is not possible to exclude these other causes. (1) The rim assembly components were not properly matched. (2) The rim base gutter and the rim flange contained corrosion and dirt build-up. (3) The lock ring being deformed or sprung open prior to use. One or all of the aforementioned observations may have been contributing factors in this accident.

The accident occurred when the lock ring and flange separated from the rim assembly violently during the mounting of the 1200-20 air filled tire. The exact mechanism of the lock ring and flange separation could not be determined. The accident resulted from the cumulative effect of deficiencies that occurred during the assembly, handling, and mounting of the wheel and tire unit.

When using split rim air filled tires the size and type of both the tire and the rim wheel components should be checked for compatibility prior to assembly. Multi-piece wheel components should not be interchanged except as provided in the charts or in the applicable rim manual. Rim parts should be inspected for any damage and deformity, wear, free of any dirt, surface rust, corrosion and pitting prior to mounting and inflation. The tire side of the lock ring should be a distinctive identifying color, or some other distinctive means, so as to afford immediate identification of proper placement of the lock ring. OSHA Regulations covering the Servicing Multi-Piece and Single-Piece Rim Wheels, 29 CFR 1910.177 should be followed by Blair Tire Company Inc.

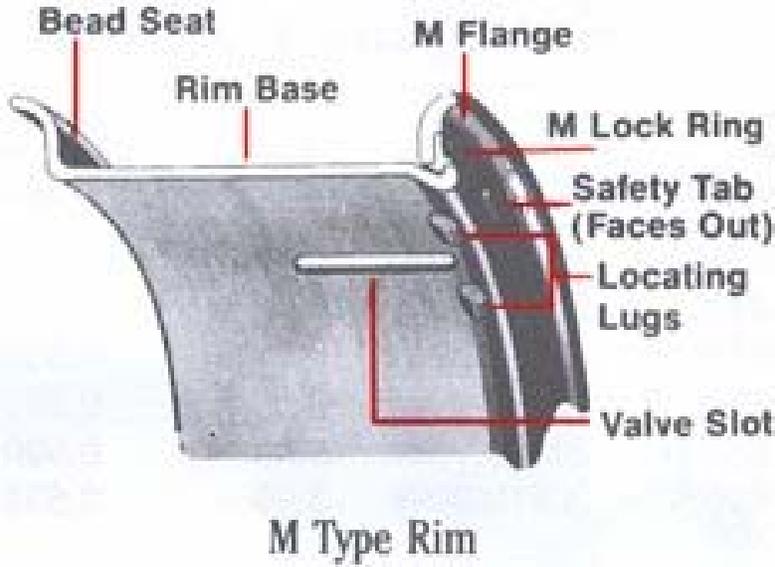
**Appendix B**  
**Three Piece M Style Rims Components**

The components of the rim assembly consisted of a rim base, a split locking ring and a continuous side ring or flange. These parts are designed to allow the locking ring to fit into a gutter on the base rim, “locking” the flange in place on the rim when the tire is inflated. See Appendix B.

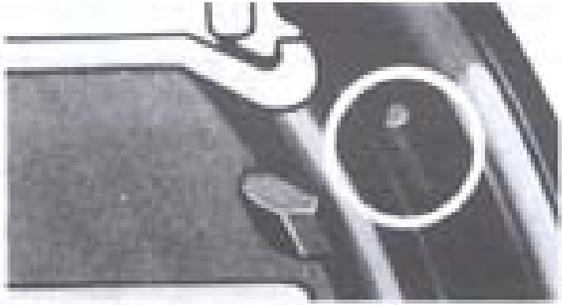
**Safety Tab Assembly**

The lock ring has several features which can be used as a check to be sure that the lock ring is properly installed. 1. A safety tab which rises (faces out) approximately  $\frac{1}{4}$  of an inch above the weather side of the lock ring will be on the left side of the gap in the lock ring when the rim is assembled properly. 2. The gap in the lock ring would be opened to about  $\frac{1}{2}$  inch. 3. The cutout on the lock ring to accommodate a pry bar during disassembly will be on the right side of the gap in the lock ring when the rim is assembled properly. 4. The non-weather side (faces in) of the lock ring was stamped with the warning, "Danger Wrong Side Out – Do Not Inflate". On a clean lock ring, this warning would be visible, to alert for backward installation of the lock ring.
