Coal Mine Fatal Accident 2005-06

Operator:	The Pittsburg & Midway Coal Mining Co.
Mine:	North River #1 Underground Mine
Accident Date:	June 1, 2005
Classification:	Powered Haulage
Location:	Dist. 11, Tuscaloosa County, AL
Mine Type:	Underground
Employment:	360
Production:	3.5 million tons/year

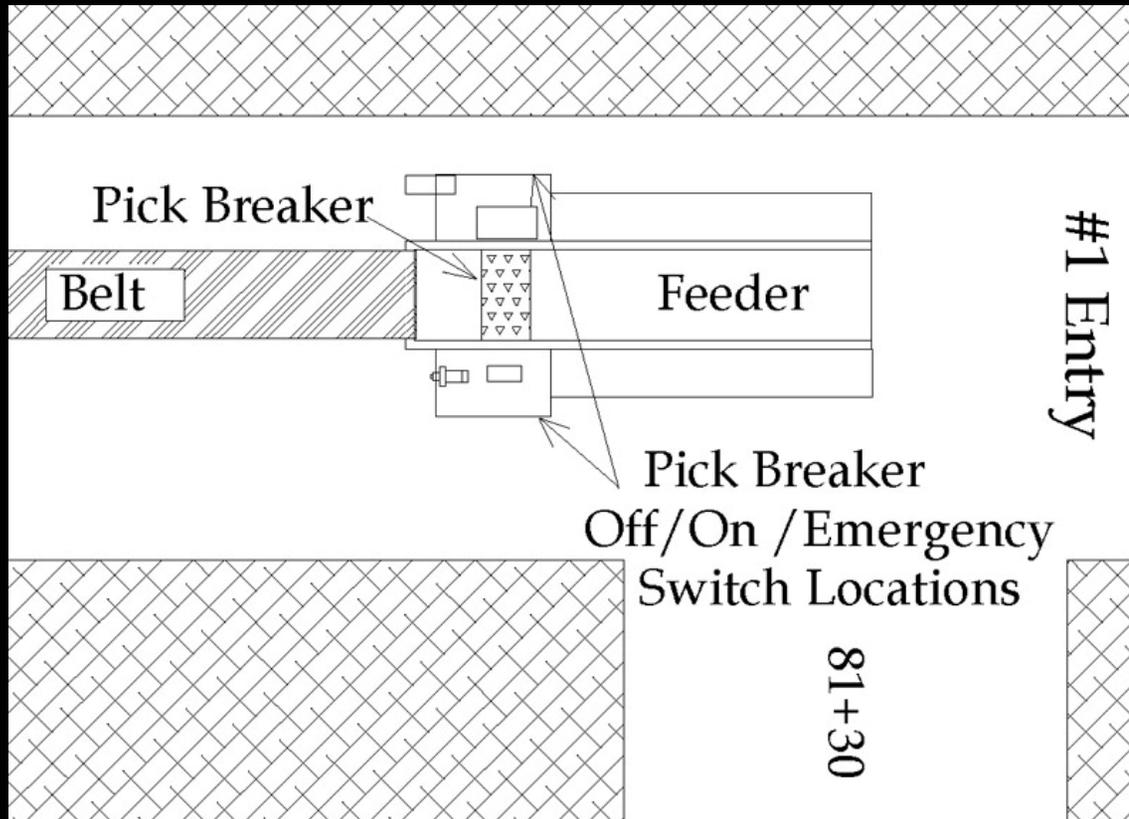
The electrician then went to start the feeder. However, brattice cloth was wrapped around the pick breaker, which he attempted to remove. As he did so, the pick breaker was energized, pulling him into it. The section foreman found him in the feeder shortly after 11:10 p.m. and shut the pick breaker off using the emergency stop button.

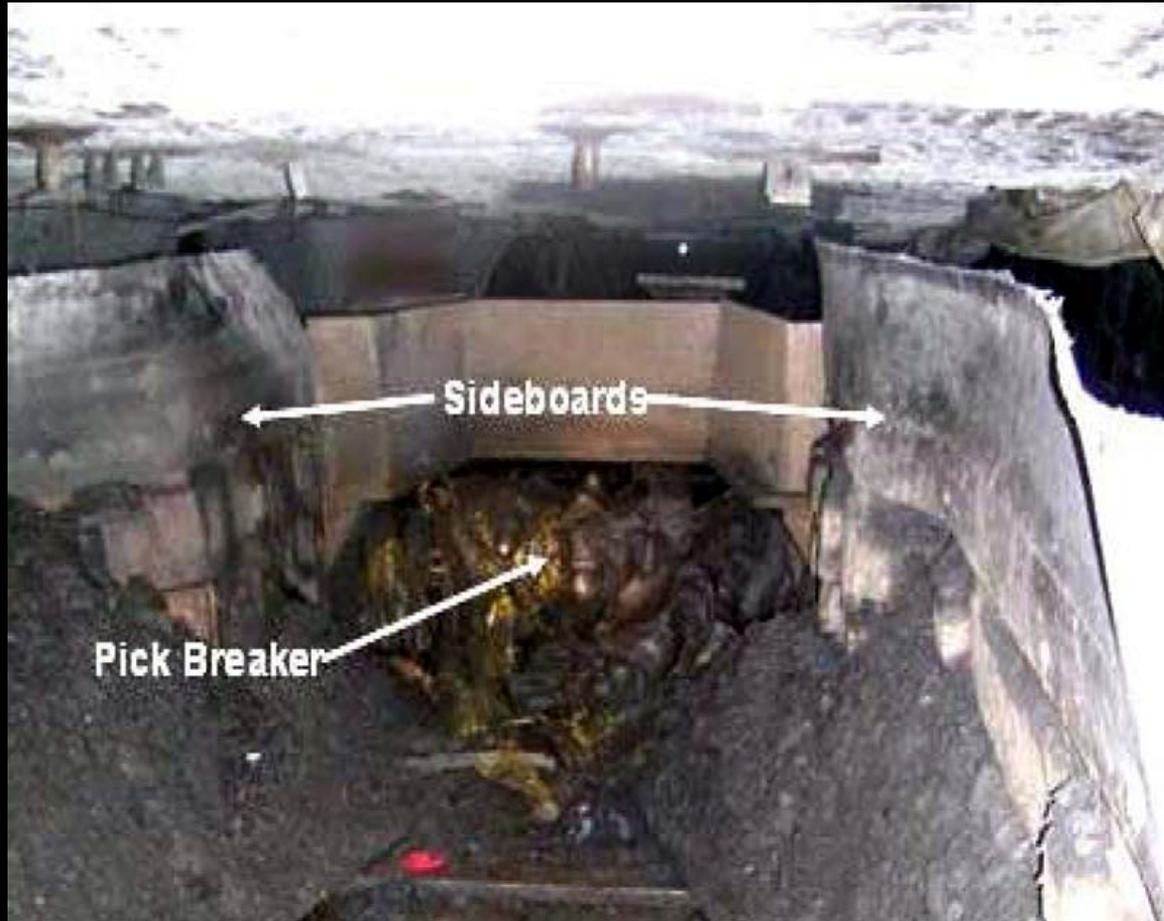
The victim was fatally injured as he was removing brattice cloth from the feeder pick breaker. The pick breaker, which was not blocked against motion, was started, pulling him into the rotating drum. Management's written procedure, which prohibits work on machinery unless power is removed and the machinery is blocked against motion, was not followed.

Causal Factor: Maintenance work was conducted on a piece of machinery that was not blocked against motion and while the power was not off. While management had written procedures that required power to be removed and machinery blocked against motion, these procedures were not followed.

Corrective Action: The entire workforce has been retrained in the procedures for removing the power and blocking the machine against motion prior to maintenance or work being performed on the machinery. Management should periodically confirm that the procedures are being followed. Additionally, delayed startup and alarms have been installed on the section feeders.
