Coal Mine Fatal Accident 2005-08

Operator:	Tusky Coal, LLC
Mine:	Tusky # 1
Accident Date:	June 10, 2005
Classification:	Powered Haulage
Location:	Dist. 3, Tuscarawas County, Ohio
Mine Type:	Underground
Employment:	45
Production:	1,450 tons/day

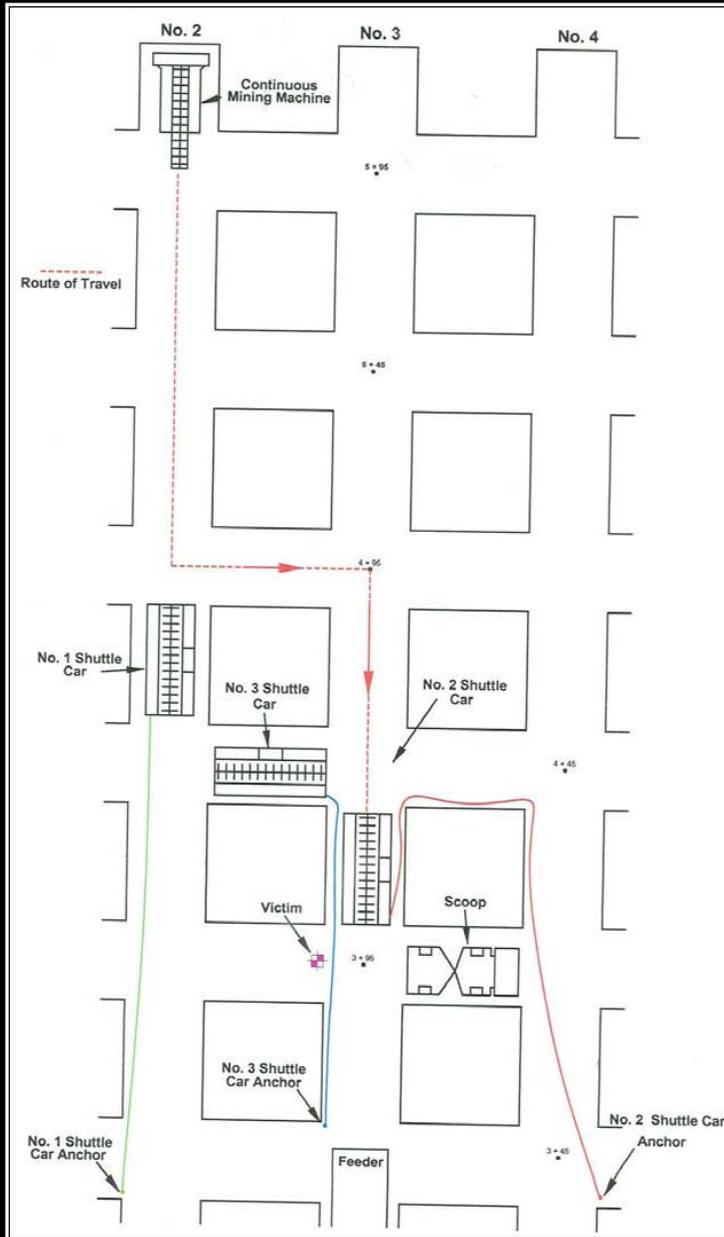
The afternoon shift crew went underground arriving on the working section at 3:30 p.m. After finishing the No. 3 room, the continuous mining machine was moved into the face of the No. 2 entry and mining continued. The No.2 Shuttle Car arrived behind the continuous mining machine. The shuttle car operator informed the victim that he needed to scoop the No. 4 entry. As the shuttle car was being loaded, the victim crawled outby toward the section battery scoop which was located in the first crosscut inby the feeder. The operator drove the loaded No. 2 shuttle car toward the feeder.

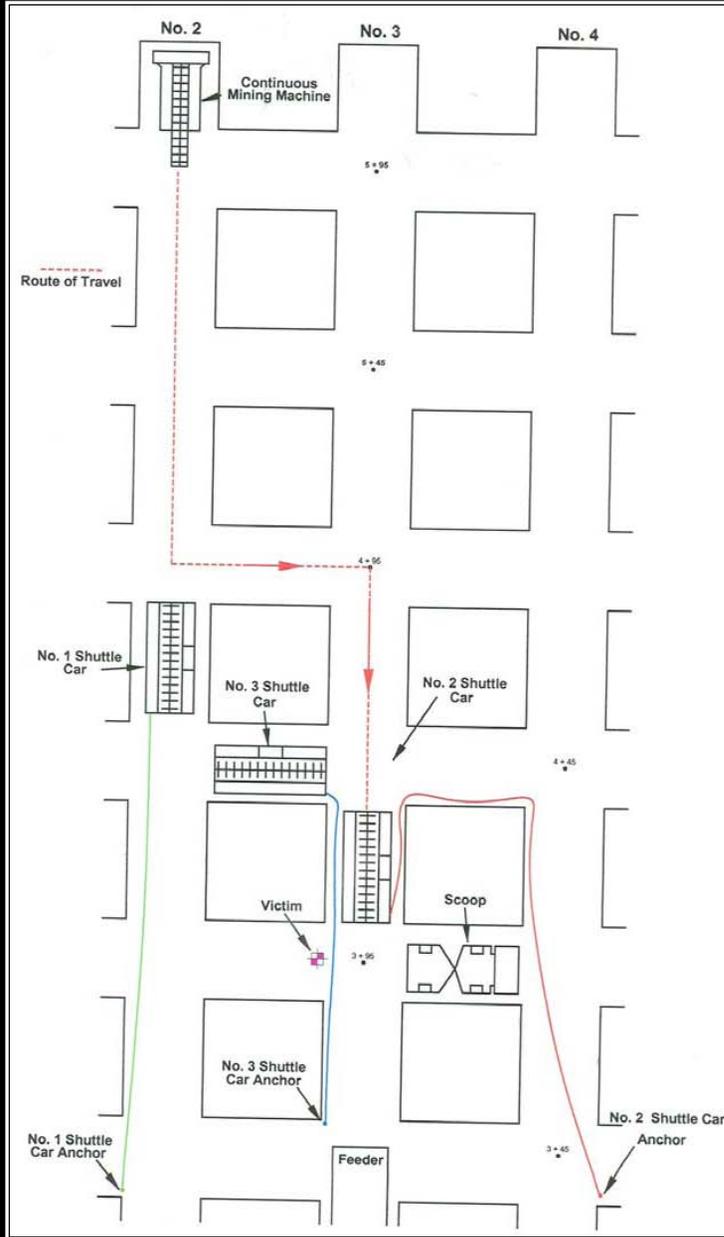
He turned the shuttle car into the third crosscut in by the feeder from the Nos. 2 to 3 entries. As he attempted to turn into the crosscut, he had to stop and back up to realign the shuttle car in order to make the turn. The operator then trammed through the crosscut and entered the No. 3 entry. Visibility was limited due to the mining height and the coal load in the shuttle car. Daniels could see a light to his right in the first crosscut in by the feeder and assumed it was the victim. He was also aware that the trailing cable for the No. 3 Shuttle Car was lying along the right rib line (facing outby) and that this shuttle car was parked in the second crosscut in by the feeder between Nos. 2 and 3 entries.

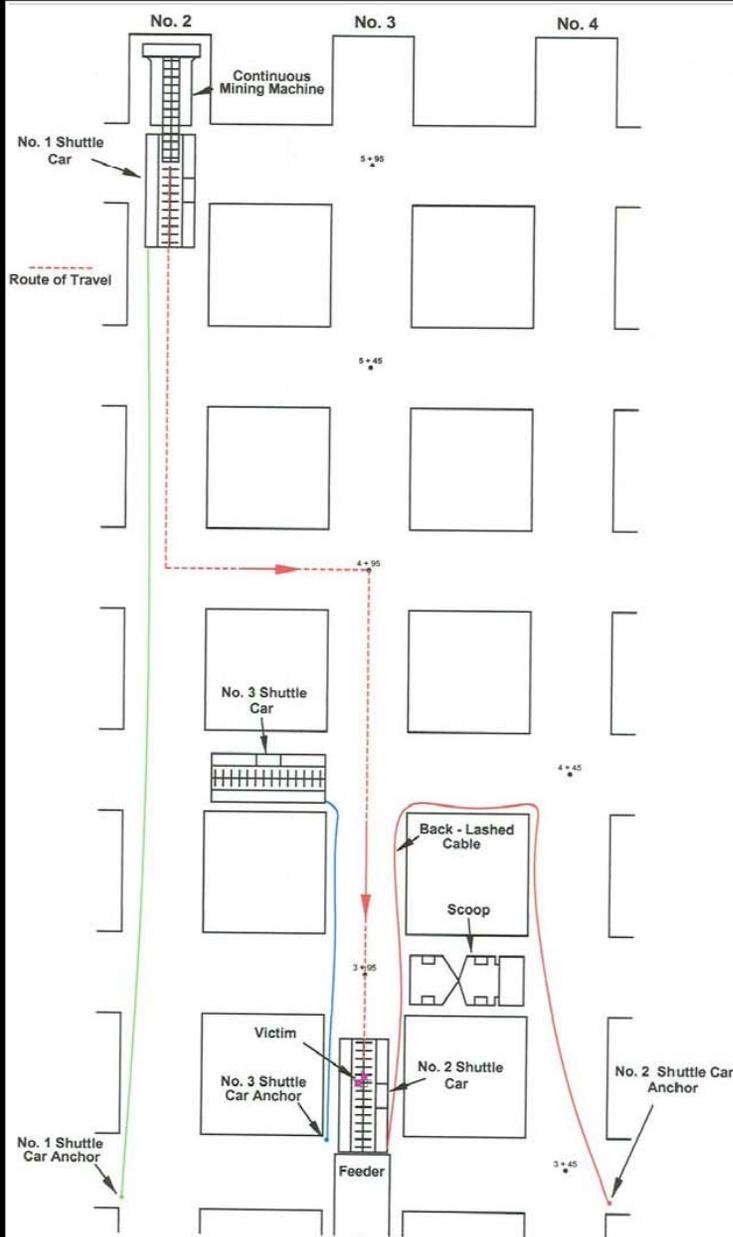
As he began tramming in the No. 3 entry toward the feeder, he abruptly stopped between the first and second crosscuts inby the feeder in order to avoid this cable which was lying along the right side rib line. When he stopped, the front bumper of his shuttle car was in close proximity to the intersection of the first crosscut inby the feeder. The No. 2 shuttle car operator then directed his attention to the left rib line because he was back lashing his trailing cable. He continued to the feeder, stopped and began unloading his shuttle car. During the unloading process, the conveyor chain stalled. He raised the shuttle car boom and restarted the conveyor which ran sluggishly. He finished unloading, dismounted the shuttle car and crawled to the front to check the chain. He saw the victim under the front of the shuttle car. The victim received fatal crushing injuries as a result of being caught under the front end of the shuttle car.

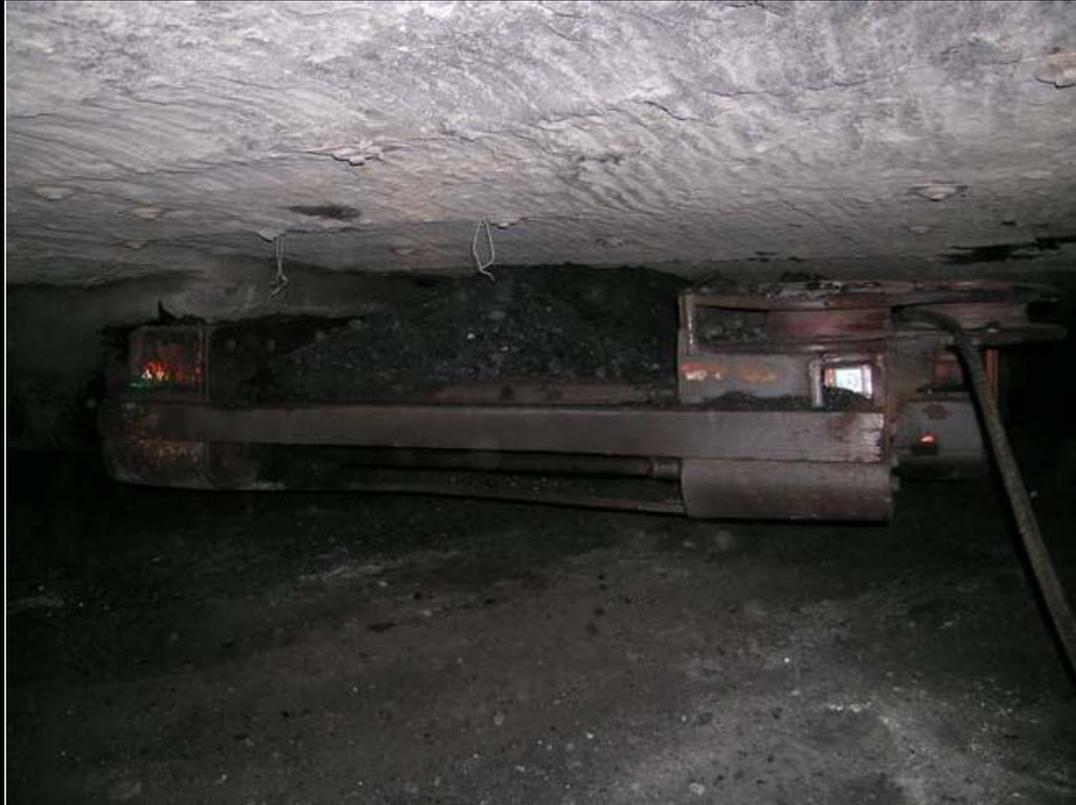
Mining Equipment - The machine involved in the accident was a rubber tired, 480 VAC Joy Shuttle Car, Model 21SC, which was rebuilt by Auxier Welding. The shuttle car measured 27 feet, six inches in length and nine feet, four inches in width. The operator's compartment was located mid-machine, standard side. The operator sits in the compartment with his body facing in the direction of travel. The distance from the mine floor to the bottom of the shuttle car was eight inches. The distance from the top of the machine to the mine roof (in the entry where the accident occurred) averaged five inches.

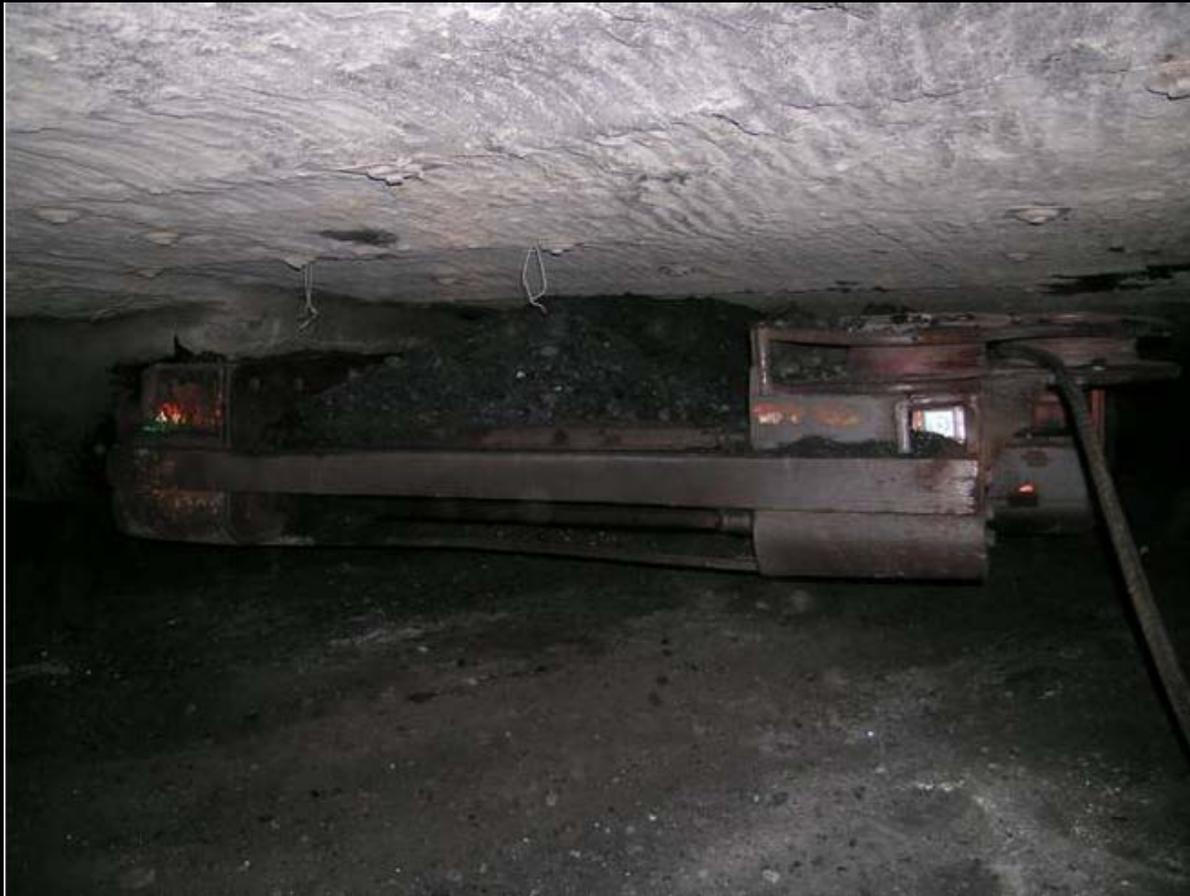
Mining Equipment Continued - A record of the weekly electrical and permissibility examinations did not indicate any defects or deficiencies. A visual examination and a permissibility examination were conducted during the investigation and revealed no defects or deficiencies. Operational tests were also conducted. No defects or deficiencies pertaining to tramming, brakes, steering, hydraulic system, de-energization device, or lights were revealed.

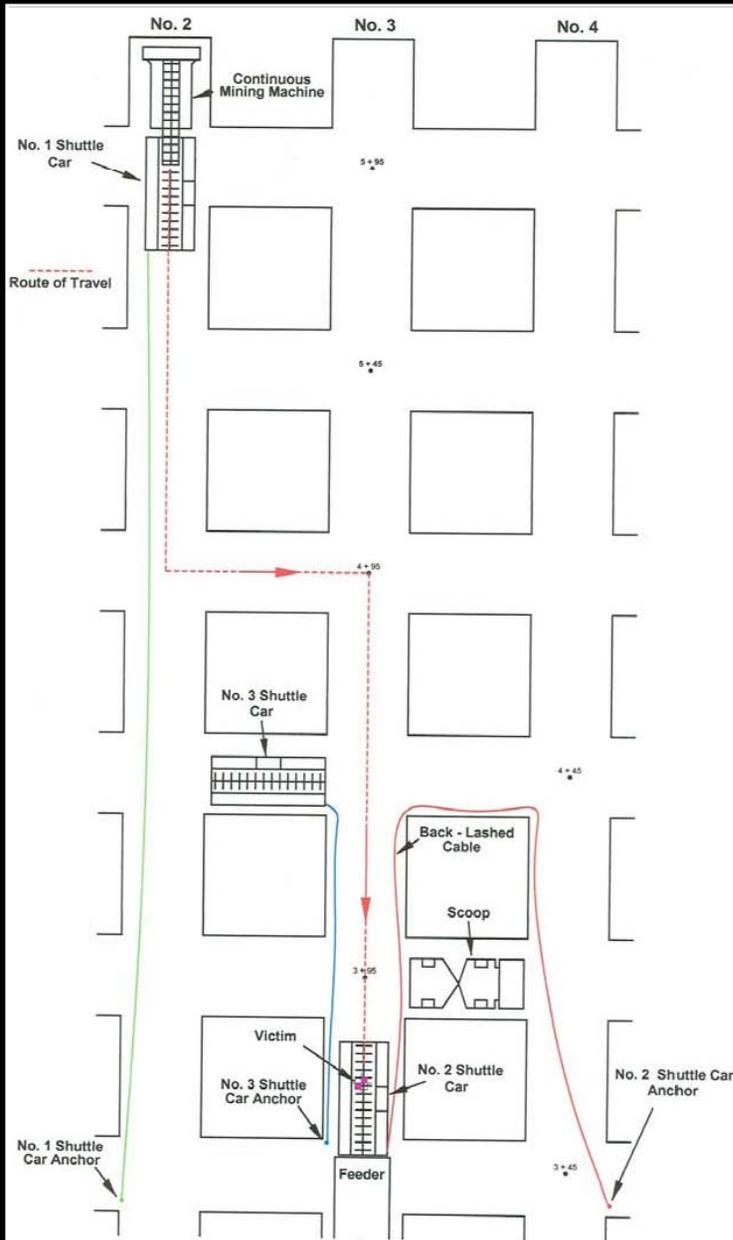
The mine floor in the immediate area was slightly damp, even, and free of extraneous materials. The average mining height in the entire section was 42 inches and the average width was 16 feet.

The No. 3 shuttle car operator, who was parked in a crosscut adjacent to Daniel's stopped position, indicated that he did not hear Daniels give an audible warning before starting up again. It is uncertain whether Wright attempted to communicate his intentions to the shuttle car operator.

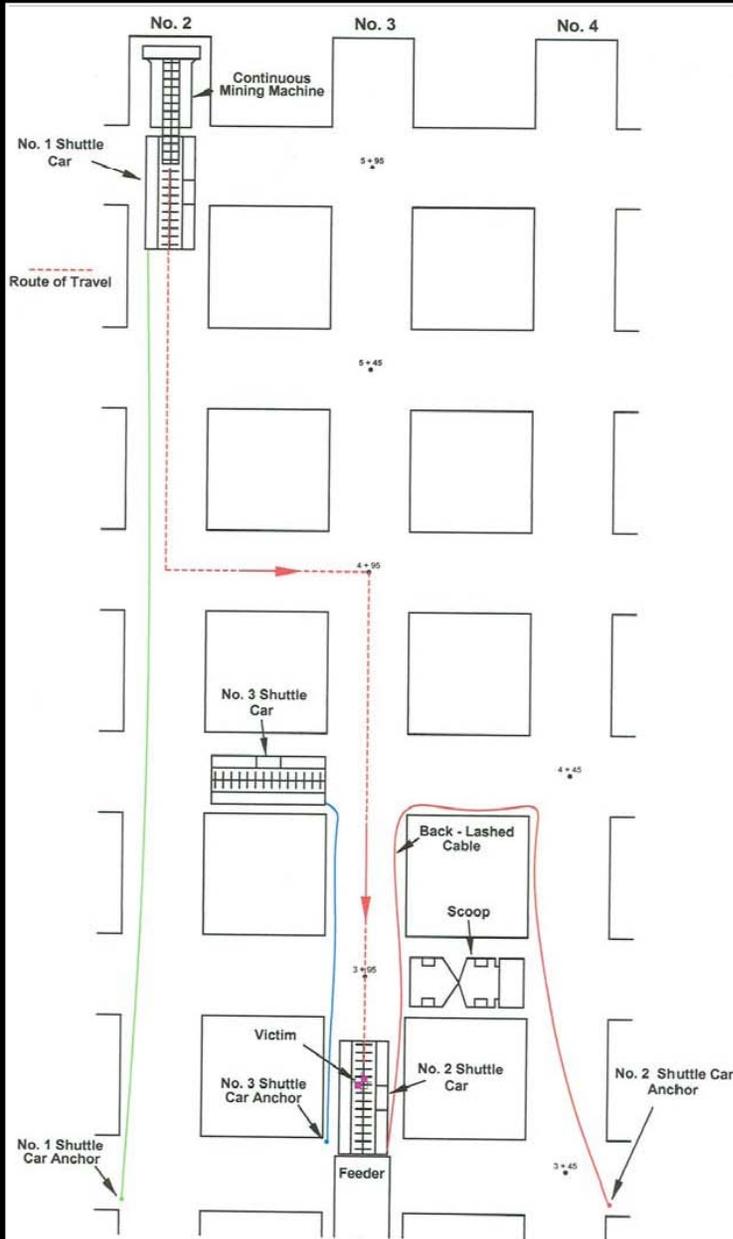
During a re-creation of the conditions and events, it was discovered that the light from a miner's cap lamp could be seen by the operator, but only if the light was focused on the mine roof. The shuttle car operator could see light from a miner's cap lamp to the right and across the front of the shuttle car in the first crosscut in by the feeder, but only if the light was shining on the mine roof. Also, it was necessary for the operator to remain focused on the location of that light to keep it under constant surveillance, and it was also necessary for that light to be constantly focused, on the mine roof for it to be seen. When the shuttle car was trammed to the feeder, the operator's visibility of the right side of the entry and any crosscuts to the right were severely limited by the mining height.
