REPORT OF INVESTIGATION

Surface Coal Preparation Facility Construction

Fatal Slip or Fall of Person Accident  
February 16, 2005

Kellerman Preparation Plant  
Greenfuels Processing I, LLC  
Tuscaloosa County, Alabama  
I.D. No. 01-00563

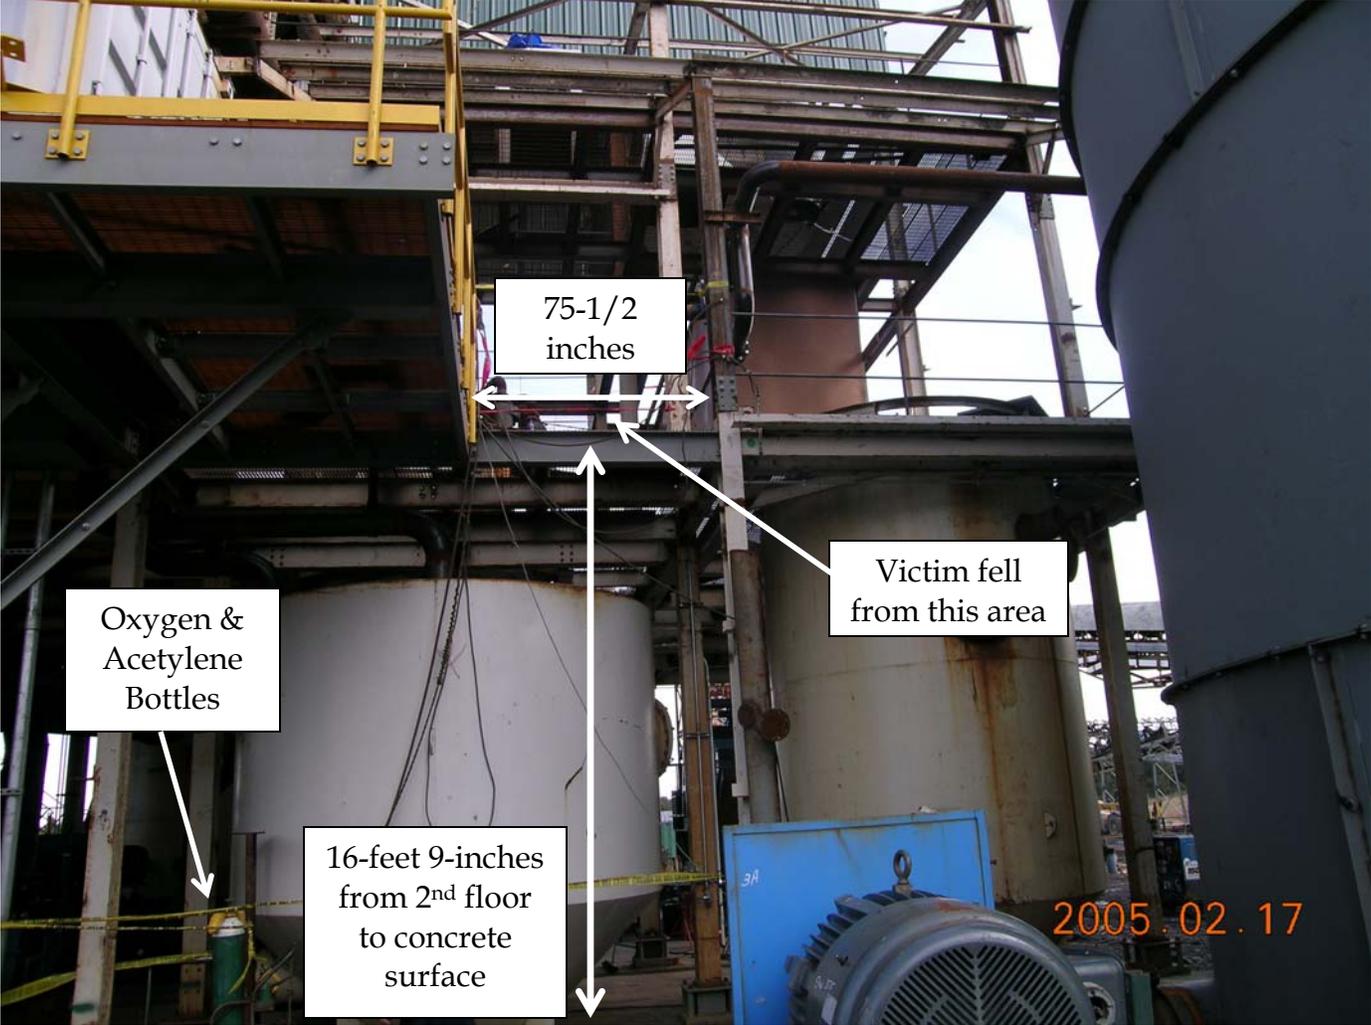
APPENDIX B  
Photograph of Accident Scene

Spivey and Peterson started welding hand-rails and toe-boards in place around the second floor perimeter. They completed installation of the hand-rails except for one location at the back of the plant referred to as the fresh water pumping station installation area. The wire rope barrier had been removed and no other protective device had been used to protect against the fall of men or materials at this location, leaving an opening measuring 75-1/2 inches across at a height of 16-feet 9-inches above a concrete surface.

During the latter half of the shift, materials were hoisted to the second floor at the opening at the fresh water pumping station installation area. These materials consisted of toe-board plating material, a pump and motor assembly, a sheet of 1/4-inch steel plating, and a 6-foot long section of 6-inch diameter steel pipe. These extraneous materials were not removed from the travelway and were still present during the initial accident investigation. The materials were located approximately 30 inches from the edge of the second floor at the opening. Visual evidence indicated that the wire rope barrier was not in place at the time of the accident. The wire ropes were slack and lying on the floor grating with steel toe-board plating material lying across them. It could not be determined that the extraneous materials contributed to the accident since there were no eye-witnesses. It is likely that the opening was left unprotected to facilitate the hoisting of materials to the second floor.

1. *Causal Factor:* Management failed to ensure that openings, through which men or material could fall, were protected by railings, barriers, covers or other protective devices.

*Corrective Action:* Initially, hand-rails were installed at the unprotected area after the site investigation was completed. Additionally, BOSS Industrial Construction, Inc., has developed and implemented an administrative policy requiring wire rope barriers to be installed around all open areas and the perimeter of each floor, above ground level, during the installation of hand-rails and toe-boards. These wire ropes are to remain in place during the installation process. These wire ropes cannot be removed until the field superintendent examines the area and approves of their removal.
