REPORT OF INVESTIGATION

UNDERGROUND COAL MINE

Powered Haulage Accident  
June 1, 2005

North River #1 Underground Mine  
The Pittsburg & Midway Coal Mining Co.  
Tuscaloosa County, Alabama  
I.D. No. 01-00759

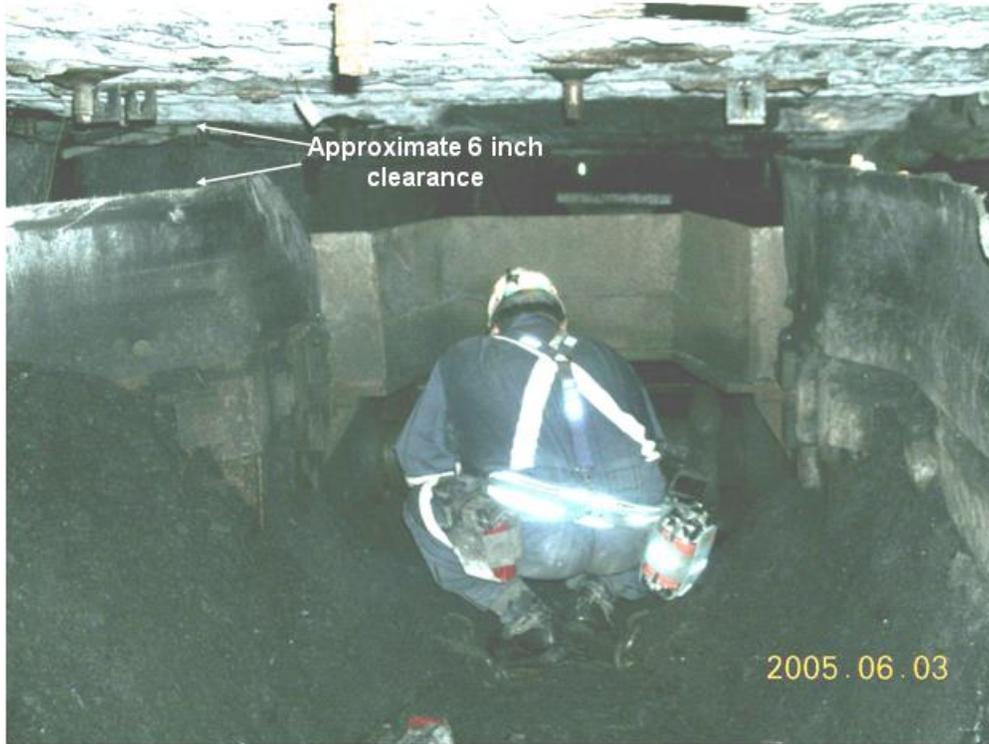
**APPENDIX B**  
**Photograph of feeder with person inside**

On Wednesday, June 1, 2005, at approximately 11:10 p.m., Robert Patilla was fatally injured as he was removing brattice cloth from the feeder pick breaker. The pick breaker, which was not blocked against motion, was started, pulling Patilla into the rotating drum. Management's written procedure, which prohibits work on machinery unless power is removed and the machinery is blocked against motion, was not followed.

Corrective Action: The entire workforce has been retrained in the procedures for removing the power and blocking the machine against motion prior to maintenance or work being performed on the machinery. Management should periodically confirm that the procedures are being followed. Additionally, delayed startup and alarms have been installed on the section feeders.

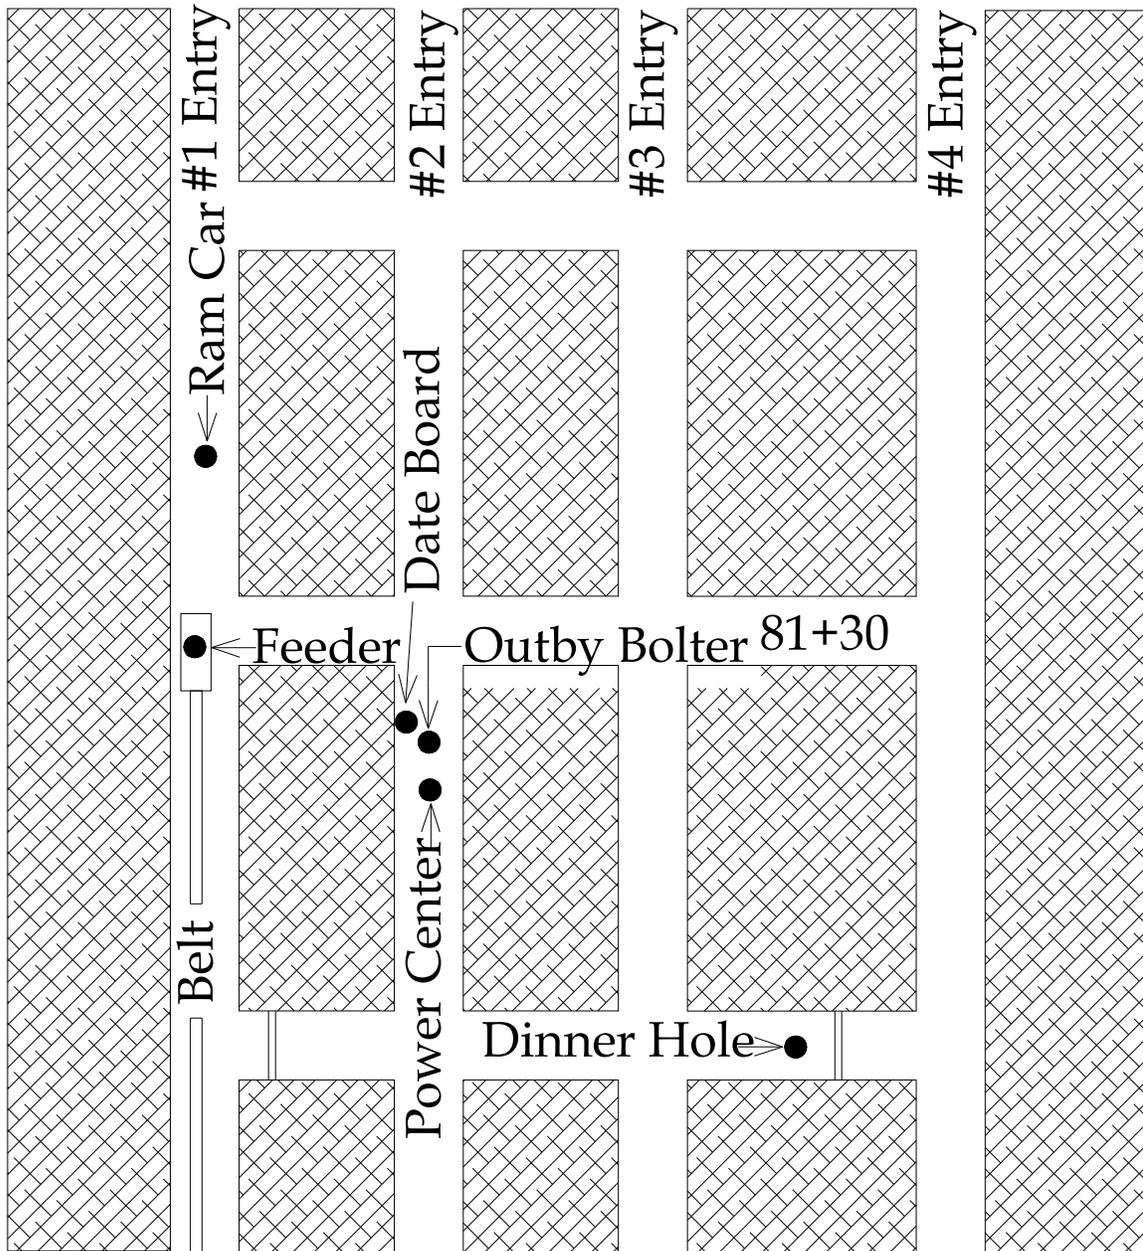
APPENDIX C  
Section Layout

While beginning work at the start of the shift, Patilla closed the circuit breakers to energize all of the section equipment. He then traveled to the feeder to check the feeder and start the pick breaker. Seeing the brattice cloth wrapped around the pick breaker, Patilla apparently decided to cut the cloth off prior to starting the pick breaker. Being positioned in the location of the pick breaker, Patilla could not be seen by anyone approaching the feeder unless they were coming directly from the #1 face area. Unaware that Patilla was in the feeder, someone started the pick breaker from one of the two switches located at the sides of the feeder, which pulled the victim under the breaker. See Appendices C and D.
