REPORT OF INVESTIGATION

Fatal Fall of Roof Accident
July 12, 2005

NEWCO #1 Mine
Sunrise Coal Company, LLC
Jefferson County, Alabama
I.D. No. 01-03102

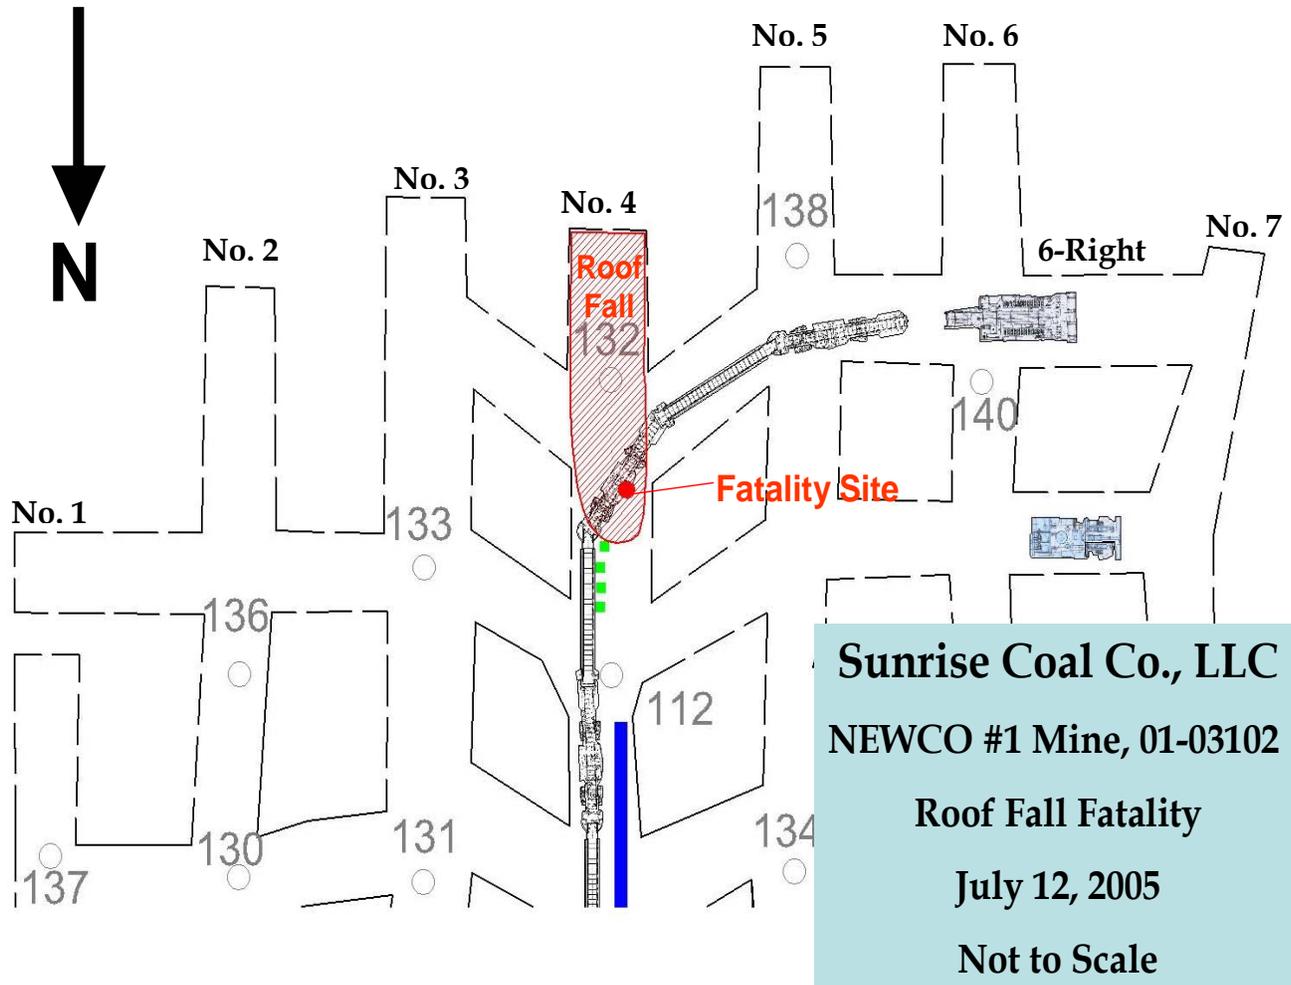
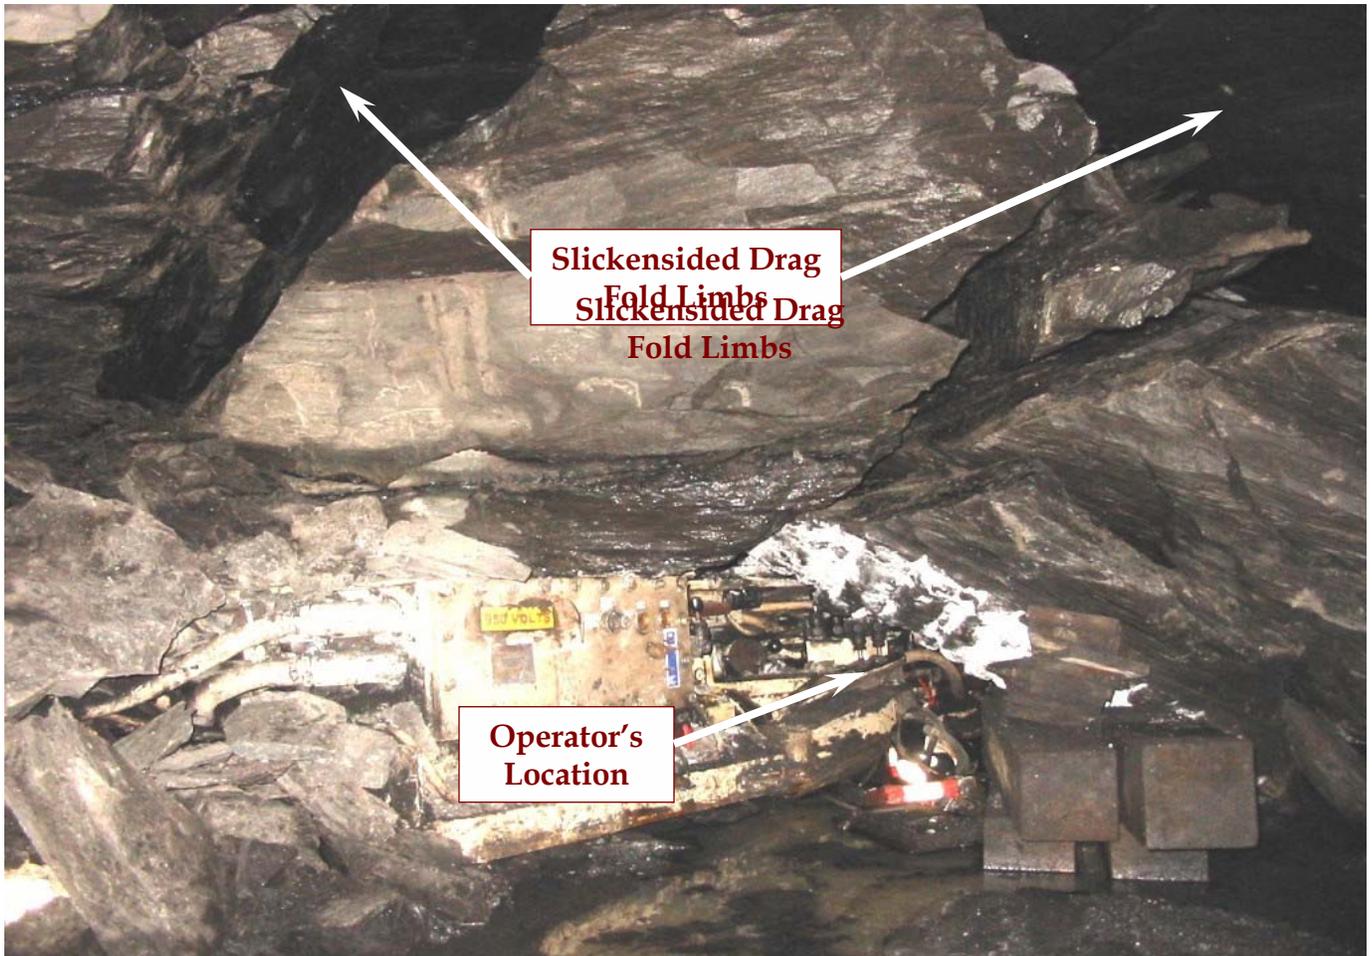
SECTION SKETCH
Location of Accident and Equipment Position at Time of Accident

Mining resumed in 6-Right at approximately 10:30 a.m. and the 6-Right crosscut was holed into No. 7. At approximately 10:45 a.m., while the bridges were backed up and the continuous mining machine was being re-positioned, a roof fall occurred in the first intersection outby the No. 4 face (see SECTION SKETCH on page 1) where Estrada was operating the No. 3 bridge.

The total length of the roof fall was estimated to be 75 to 80 feet. It extended from approximately 34 feet in by survey spad 112 to the No. 4 face. The roof fall spanned the survey spad 132 intersection to within a few feet of the rib lines and was bounded by steeply dipping slickensided limbs of a drag fold (horseback) that closely paralleled the entry. In by the intersection, the fall appeared to span the entry from rib to rib. The height of the fall was estimated to be six to eight feet above the mine roof. Visible fall material consisted of slickensided wedge blocks up to two feet thick and seven feet wide. Additional roof material fell during the investigation on July 13, 2005.

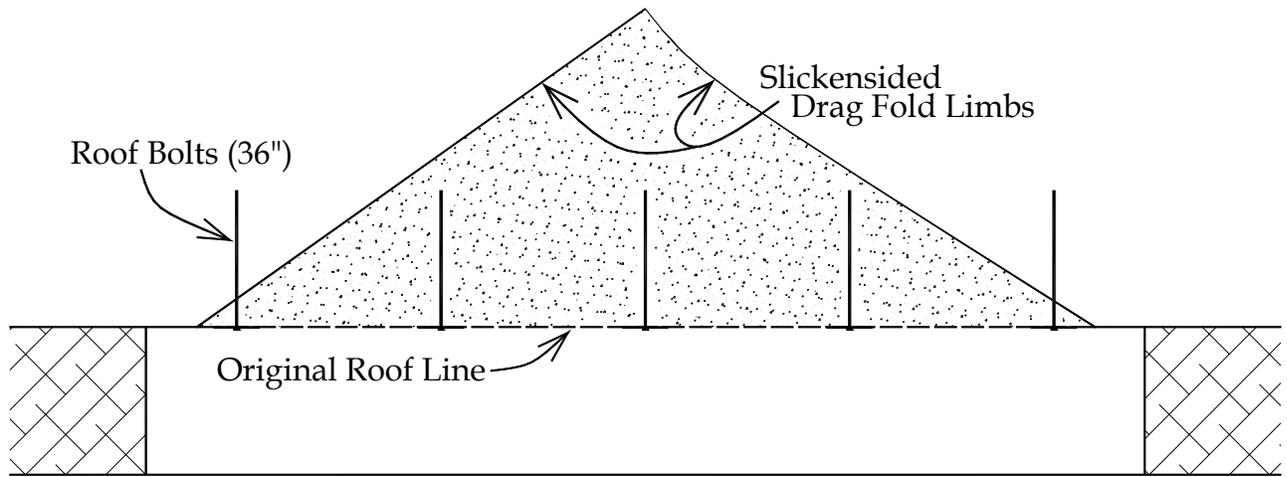
APPENDIX B
Drag Fold Sketch

The roof failed above the anchorage horizon of the 3-foot resin grouted roof bolts. The interior roof bolts were contained in the fallen rock material. The roof bolts closest to the ribs and along the rib-lines were pulled out of the roof as it fell.

Causal Factor: The operator failed to recognize adverse roof conditions that would have prompted installation of longer roof bolts on reduced centers and reduction in entry width in compliance with the approved roof control plan. The presence of a slickensided drag fold (horseback) running nearly parallel to the No. 4 entry was not identified by mine personnel. The maximum thickness of the wedge block beneath the drag fold exceeded roof bolt anchorage by three to

five feet. Roof competency was further degraded by localized areas of water inflow. The primary roof support system was not adequate to prevent the roof fall.

Corrective Action: The operator is in the process of abandoning the NEWCO #1 Mine. However, the operator has acquired another mine and has requested that Technical Support conduct hazard mapping to identify potential roof problems. This will assist the operator by providing knowledge and awareness of potential hazards that can be expected at the mine. Hazard mapping will also provide miners and management with the knowledge needed to identify potential roof problems on working sections and in outby areas so that suitable support can be used to prevent roof failures. Hazard mapping will be recommended and should be conducted if the mine associated with I.D. No. 01-03102 is re-opened for operations in the future.
