REPORT OF INVESTIGATION

Surface Coal Mine

Fatal Machinery Accident
August 18, 2005

Smith No. 1 Mine
Thomas J. Smith Inc.
Shelocta, Armstrong County, Pennsylvania
ID No. 3608065

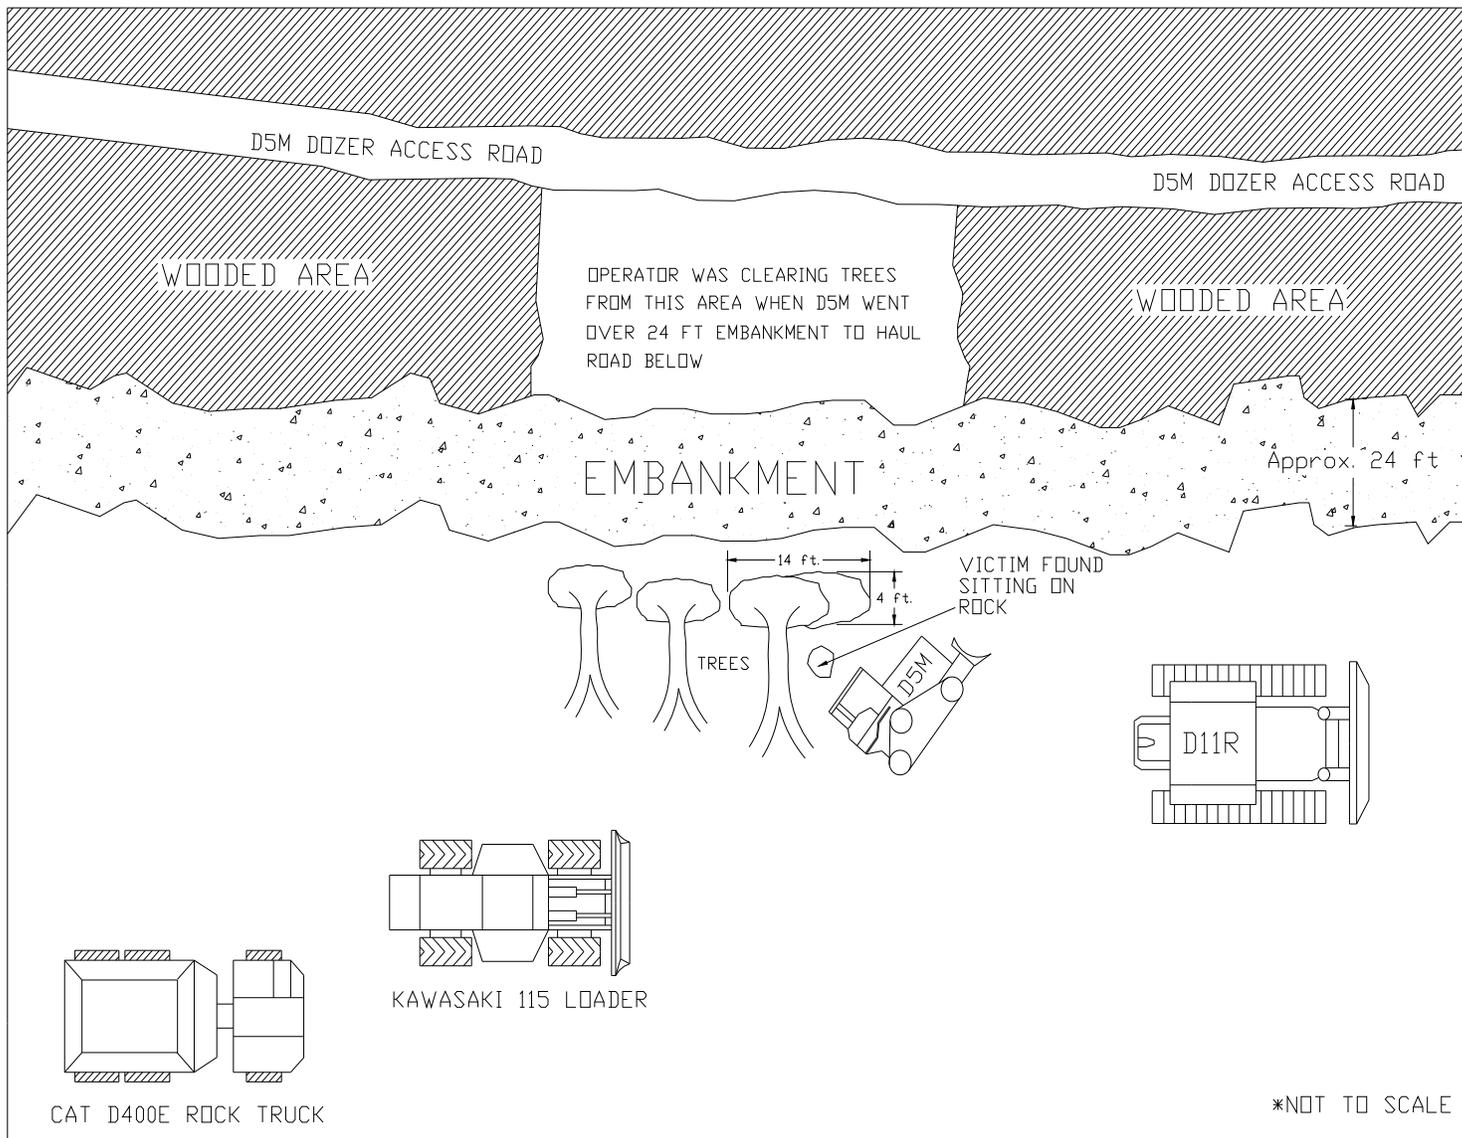
ACCIDENT SITE

The embankment, originally created by the previous land owner, ran parallel with the new haul road being constructed in a north west to south east direction. It was 24 feet high and consisted of shale with a top layer of sandy soil. A row of trees with overhanging root systems existed along its top edge with another tree line 21 feet further back and parallel with the embankment. The work area, in between the two tree lines on top of the embankment, was reasonably level, 35 feet long and 21 feet wide. The edge of the embankment appeared stable. Imprints of the dozer's tracks on top of the embankment indicated the dozer was pushing when it went over. There was no evidence to indicate the dozer was skidding.

The root system was approximately 14 feet long, 4 feet thick and 4 feet high. The dozer blade impact marks on the ground were 4 feet behind the tree's root system indicating the dozer was pushing when it went over the embankment. An impression on top of the root system indicated that the dozer rolled over the root system after impact. The location where the victim was found, along with a work glove and lunch bag indicate that the when the victim was thrown from the dozer he landed in front of the root system.
