REPORT OF INVESTIGATION

Fatal Fall of Roof Accident  
August 10, 2005

Shoal Creek Mine  
Drummond Company, Inc.  
Jefferson County, Alabama  
I.D. No. 01-02901

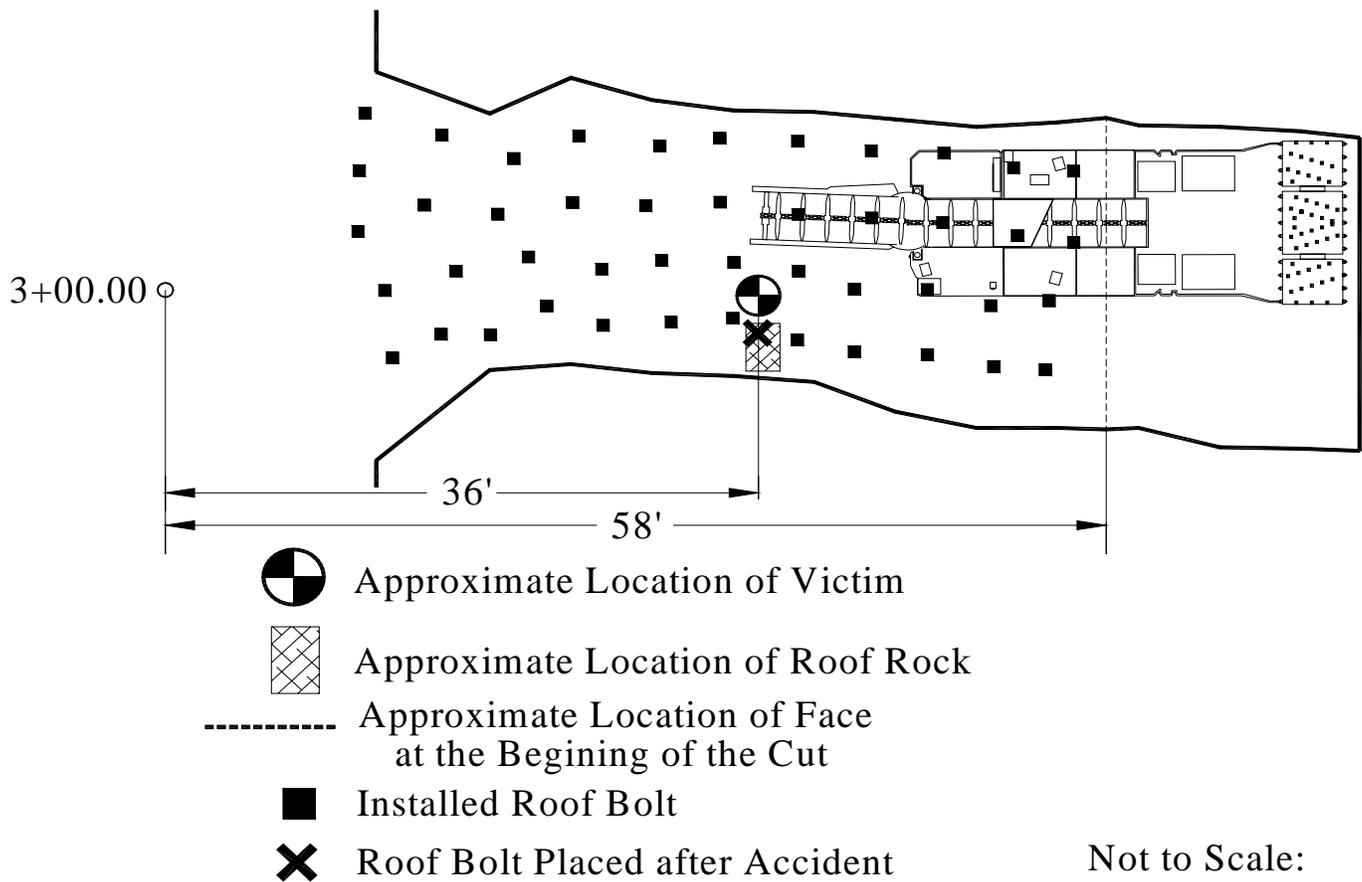
## OVERVIEW SKETCH

remote-control, his back to the right rib, positioned between the 5<sup>th</sup> and 6<sup>th</sup> row of roof bolts (see OVERVIEW SKETCH). A piece of roof rock, with an estimated size of 30-inches x 30-inches x 6-inches, separated from the mine roof, struck Humphries against his head and back and knocked him down onto the mine floor.

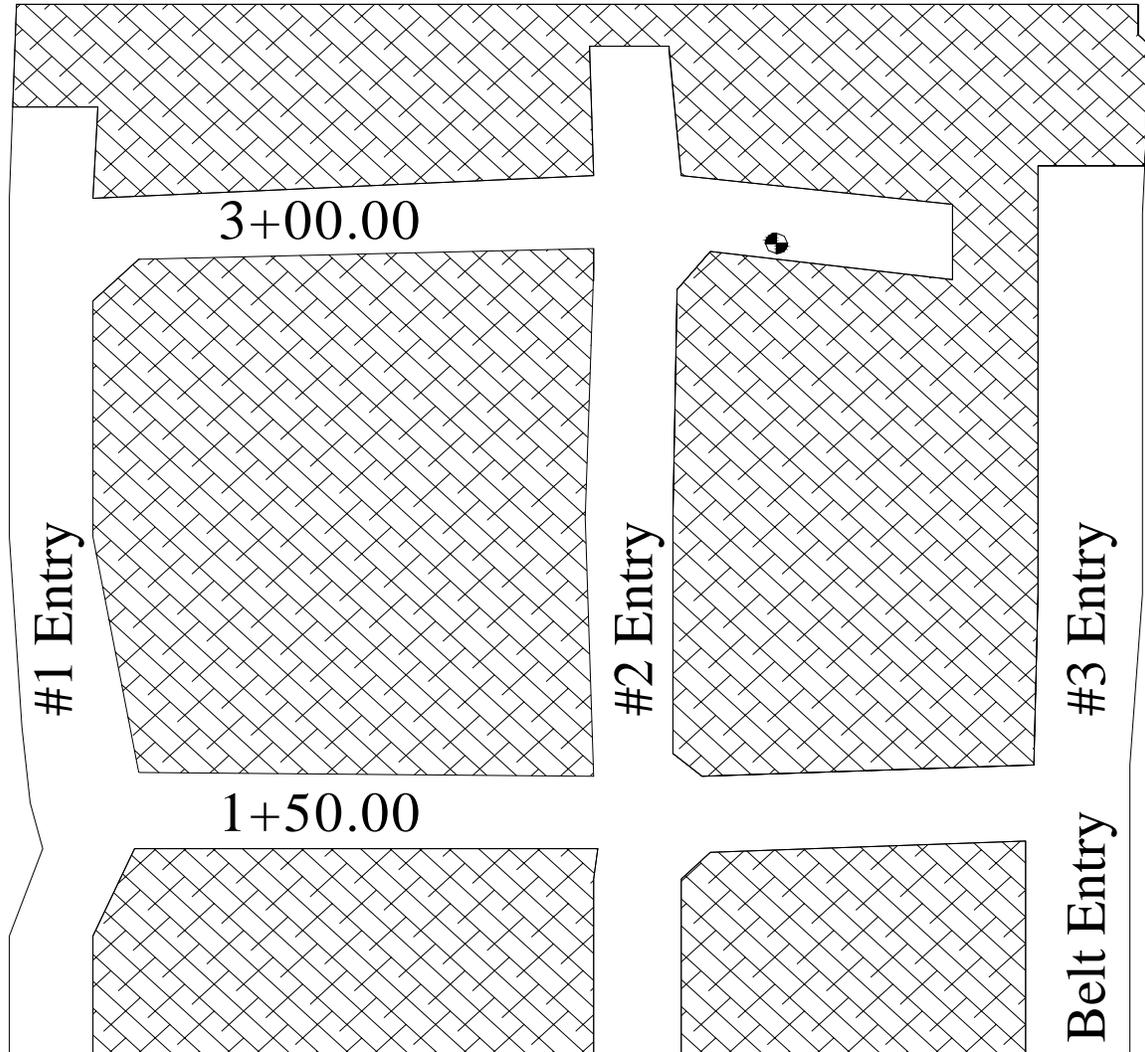
## N-0 Setup Entries as of August 10, 2005

Approximate Location of Victim

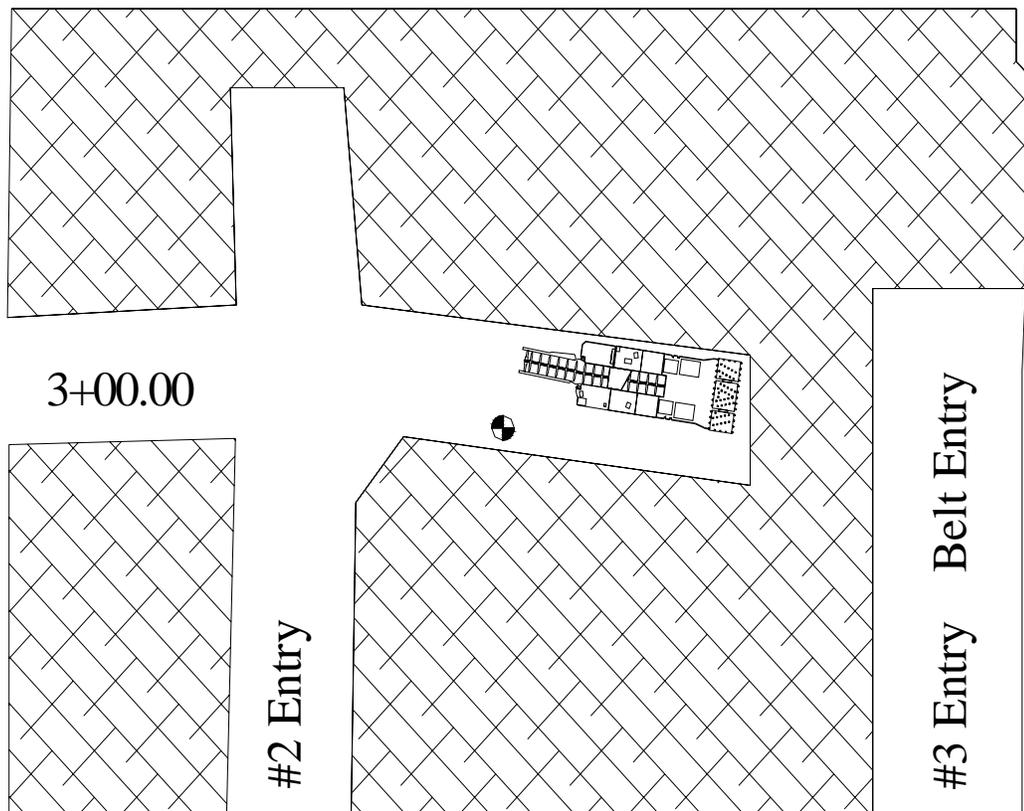
## Continuous Mining Machine 2 - Right Crosscut (Entry 2 to 3)

Mining operations proceeded normally. At approximately 7:00 p.m., the continuous miner was moved to the 2-right crosscut (Appendix C). The crosscut was mined during the previous shift and permanent roof support was installed during the current evening shift. Edwards went to eat, while Humphries operated the continuous miner. At approximately 8:00 p.m., Edwards returned to the 2-right crosscut. The continuous miner was on the left side of the entry. Humphries was operating the machine via radio

Approximate Location of Victim

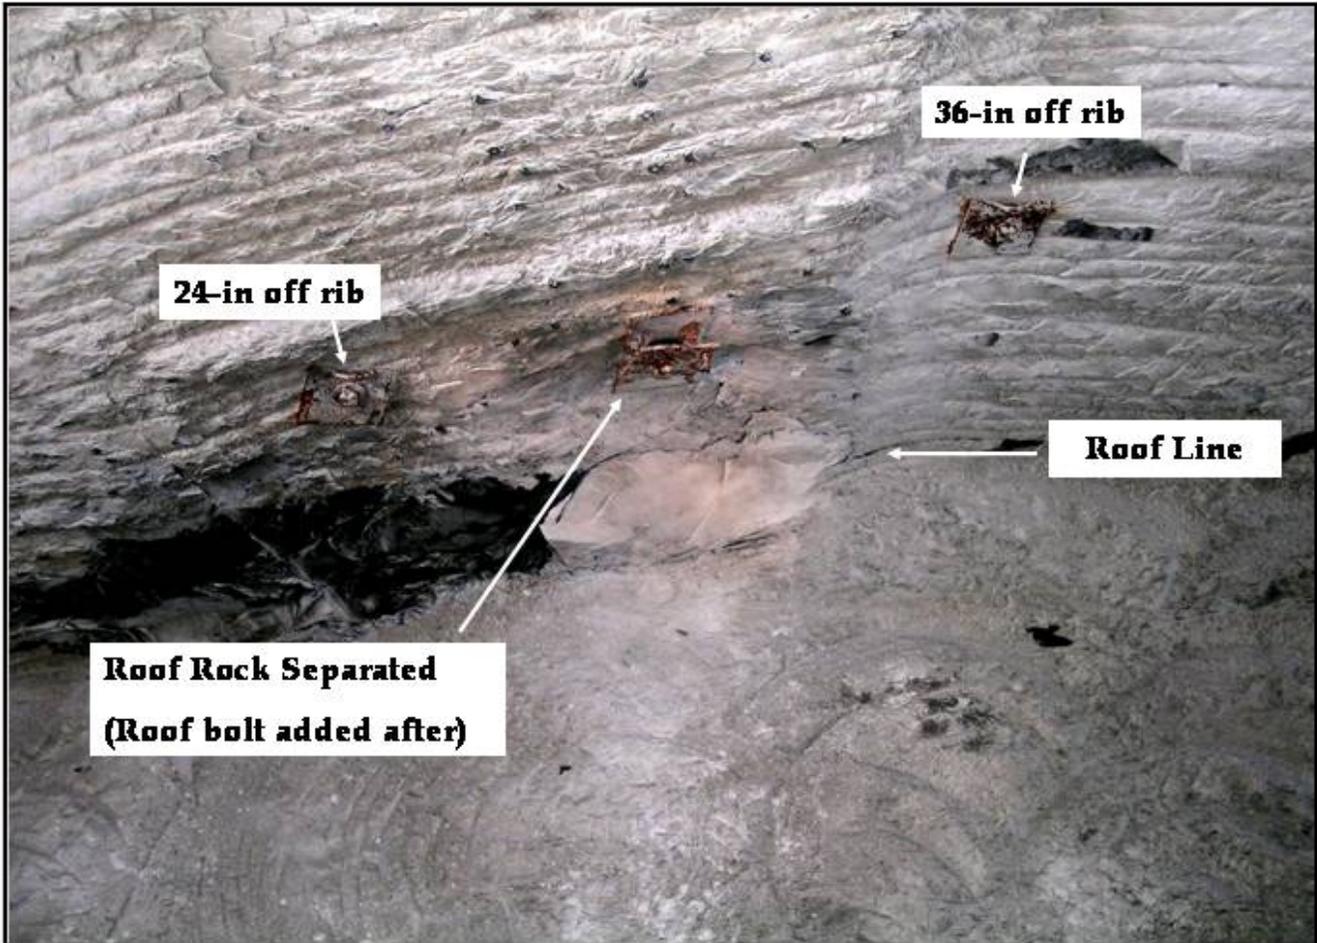
Photograph where fall originated

The rock that separated from the roof and struck the victim was a small, localized, geologic discontinuity, 30-inches x 30-inches x 6-inches and had been exposed during the previous mining cycle (Appendix D). The rock was characterized by smooth contact planes that afforded little adhesion to the immediate roof. This formed an area of natural weakness that could only be corrected by additional support and/or scaling. No sound and/or vibration test had been done in the area prior to the accident.

*Causal Factor:* A localized geologic discontinuity, exposed during mining, was not recognized and adequate precautions to eliminate the hazard were not taken.

*Corrective Action:* The mine operator installed additional support in the area of the fall. Safety awareness discussions have been conducted on the importance of workplace examinations, emphasizing roof, rib, and floor conditions.
