REPORT OF INVESTIGATION

Fatal Powered Haulage Accident
December 6, 2005

Wadesville – P33
Reading Anthracite Company

Wadesville, Schuylkill County, Pennsylvania
ID No. 36-01977

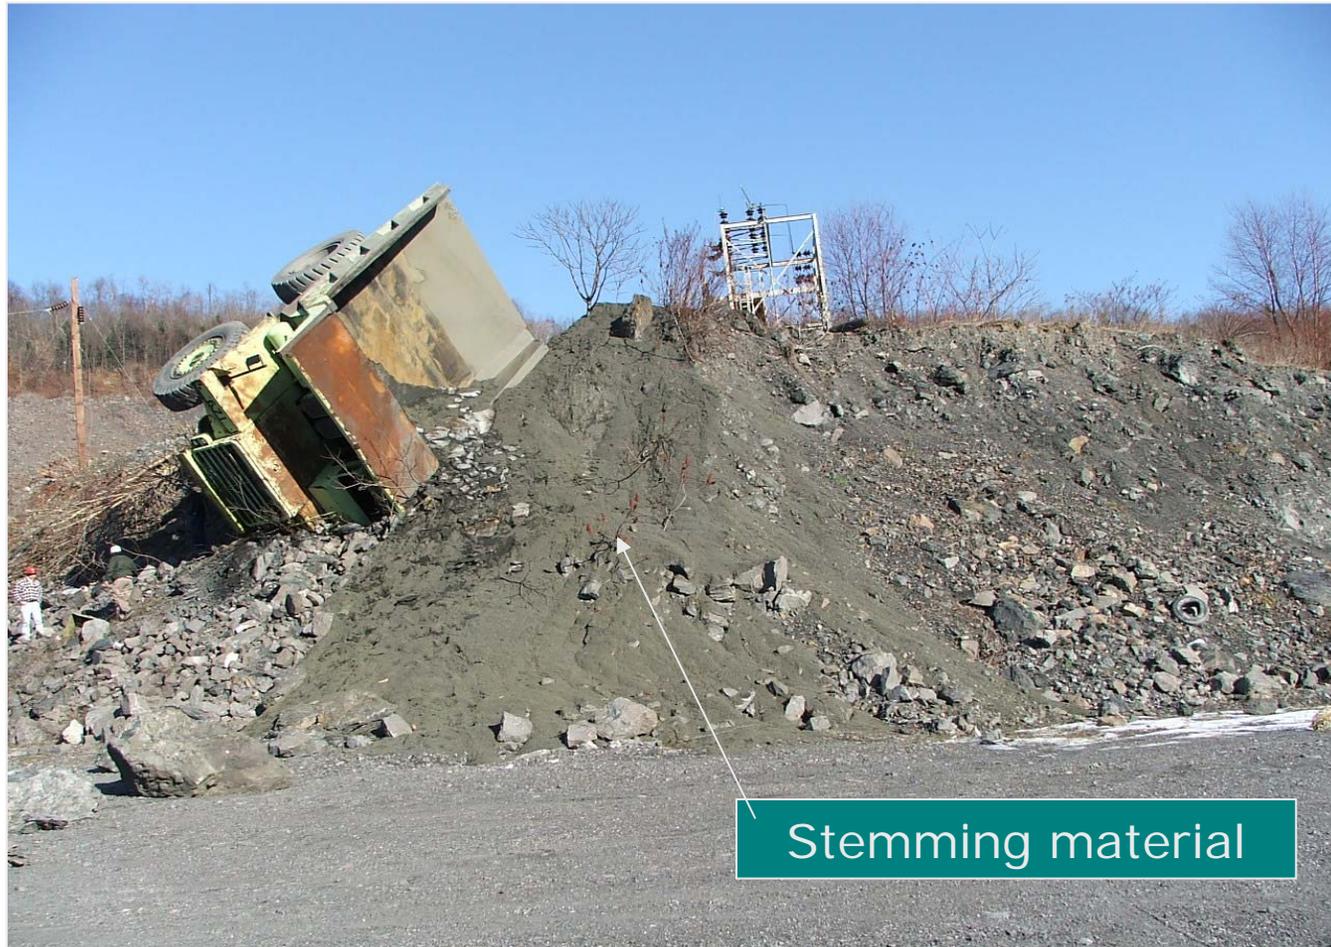
PHOTOGRAPH OF ACCIDENT SITE

The Wadesville pit was accessed via an unpaved haul road. This haul road was approximately 4000 feet long and ranged in width from 50 to 75 feet. Maximum/minimum grades for this haul road were 17 and 1 percent respectively. The average grade for this haul road is 10.5 percent. The haul road surface was reasonably smooth and clear of snow. Although portions of the haul road were frozen, they were not icy. Left-side tire marks were visible on a rock refuse bank approximately 600 feet from the accident scene. This area of the haul road had a variable grade of 9.6 to 14 percent. After exiting the haul road the victim steered the Euclid R-85 haul truck sharply to the right. The truck traveled between a deactivated substation and a wooden utility pole, hitting a guy wire and snapping off the top of the pole. The truck overturned on the driver's side as it traveled through the earthen berm. The truck came to rest approximately 20 feet down a 60-foot sloped embankment. The truck traveled a distance of approximately 330 feet after it left the haul road to where it stopped on the slope. Stemming material and items from the victim's lunch box were scattered on the ground near the substation. The majority of the stemming material was on the sloped embankment.

The victim found in the cab, positioned between the seat and the hand railing with his back against the handrail. The victim was not wearing the seat belt. When checked, the seat belt fastening mechanism worked properly. The driver's cab door was open and bent toward the dump body. The driver's side walkway and handrail were pushed in toward the cab, striking the victim. The transmission shift lever was in sixth gear and the retarder lever was in the on position.
