REPORT OF INVESTIGATION

Surface Nonmetal Mine
(Sand and Gravel)

Fatal Falling Material Accident
May 23, 2005

Michels Pipeline Construction, Incorporated
Plant #2
Kewaskum, Washington County, Wisconsin
Mine I.D. No. 47-02789

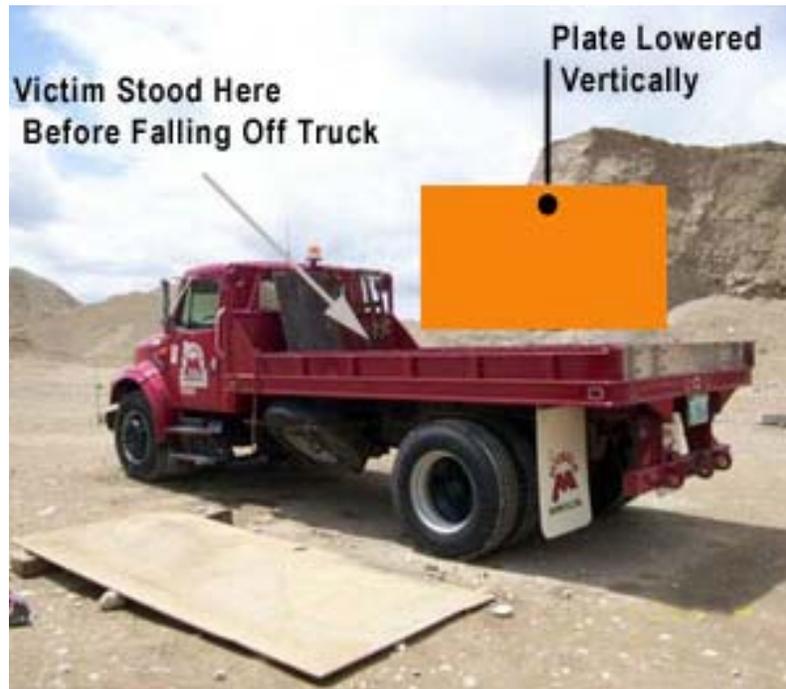
**Victim Stood Here
Before Falling Off Truck**

**Plate Lowered
Vertically**

David A. Randall, laborer, age 57, was fatally injured on May 23, 2005, when he was struck by a steel plate while loading it onto a flatbed truck. A front-end loader was used to lift the plate with a chain hook while Randall steadied the plate with his hand, standing on the edge of the truck bed. As the plate was lowered into the truck bed, it detached from the hook. Both Randall and the plate fell to the ground and the plate crushed him.

The accident occurred because the procedures and equipment used to load the steel plate were inadequate. The victim had to stand in the bed of the truck and guide the suspended plate by hand because the rigging system that was used did not control the steel plate.

Causal Factor: Management policies and controls were inadequate. Procedures were not in place to ensure suitable hitches, slings, and tag lines were used to load the steel plate into the truck bed. The hook came out of the hole in the plate as it was loaded onto the truck.

Corrective Action: Perform a risk assessment to identify and eliminate or control any hazards. Discuss what could go wrong and identify locations where miners should not be positioned to eliminate hazards from suspended loads. Use a tag line to control the load from a safe location. Ensure that rigging suitable for the load being lifted has been provided. Hooks should have safety latches that close the throat opening and secure the suspended load.
