REPORT OF INVESTIGATION

**Fatal Fall of Person Accident
September 15, 2005**

**Texas-Lehigh Cement Plant & Quarry
Texas Lehigh Cement Company LP
Buda, Hays County, Texas
Mine I.D. No. 41-02781**

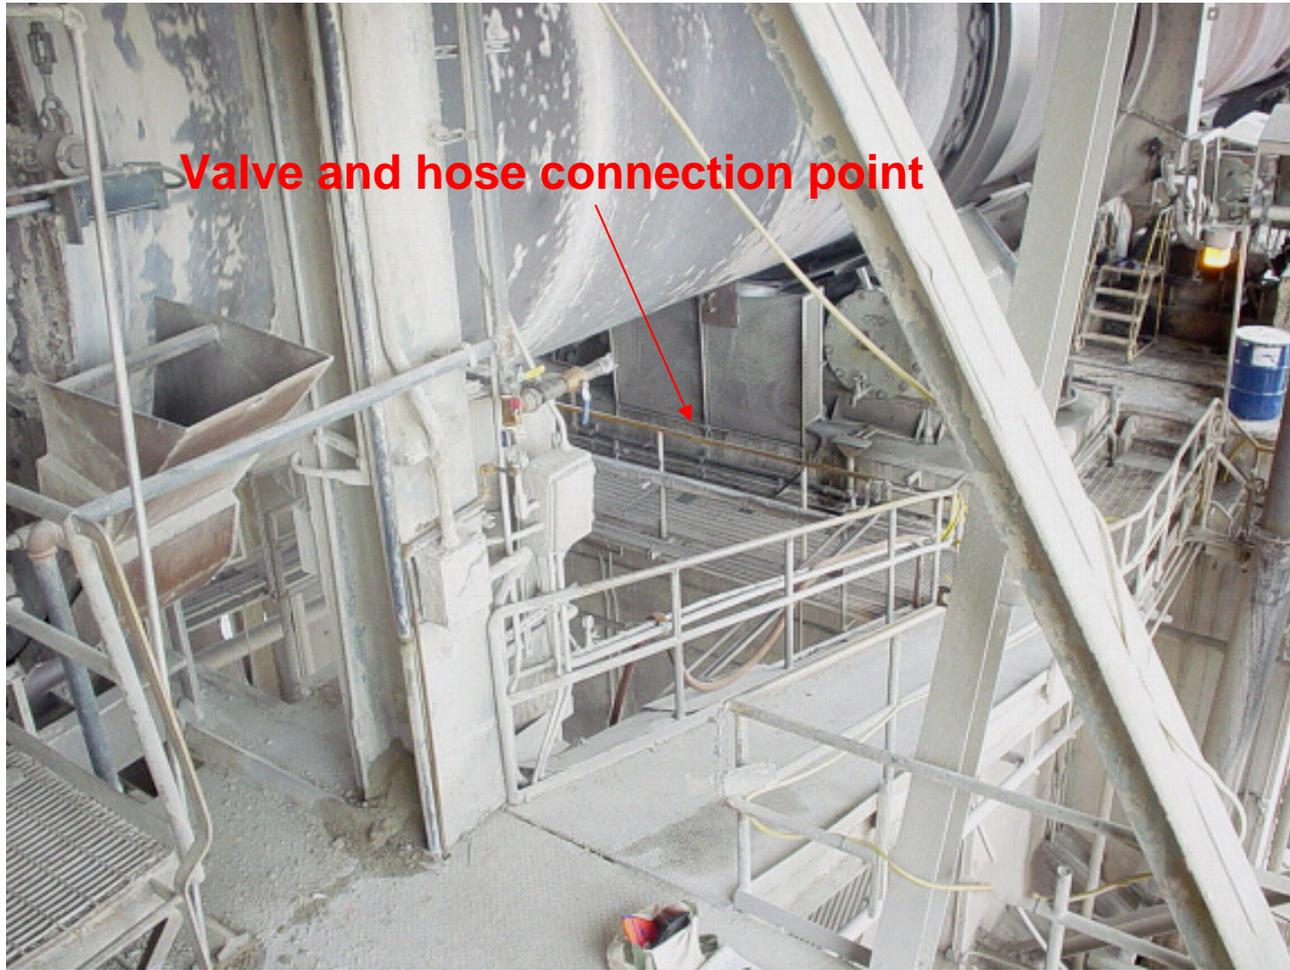
Valve and hose connection point

The third valve was a Dixon in-line ball valve that had been installed by Brown only two days before the accident. It connected to the main line through a pipe tee and had a 4-lug Air King end (quick coupling) on the other side to accommodate an air hose similarly equipped. The valve was 6.75 feet above the walking surface and 2 feet from the south

end of the walkway. The Air King end was 7 feet above the walking surface and 3 feet from the south end of the walkway.

Causal Factor: Administrative controls needed improvement in that a risk assessment was not conducted prior to installing the air valve for the temporary air line seven feet above the walkway, equipped with hand rails, that was inclined at a 29 degree slope. The victim may not have recognized the hazard associated with reaching above the hand rails to uncouple the air hose. The victim was working where there was a danger of falling and was not secured by a safety belt and line.

Corrective Action: Conduct a risk assessment to identify all potential hazards and ensure valves and controls are positioned where persons operating them are not exposed to hazards.
