REPORT OF INVESTIGATION

**Fatal Powered Haulage Accident
September 28, 2005**

**Stamper Underground
Hunt Martin Materials LLC
Kansas City, Platte County, Missouri
Mine ID No. 23-02232**

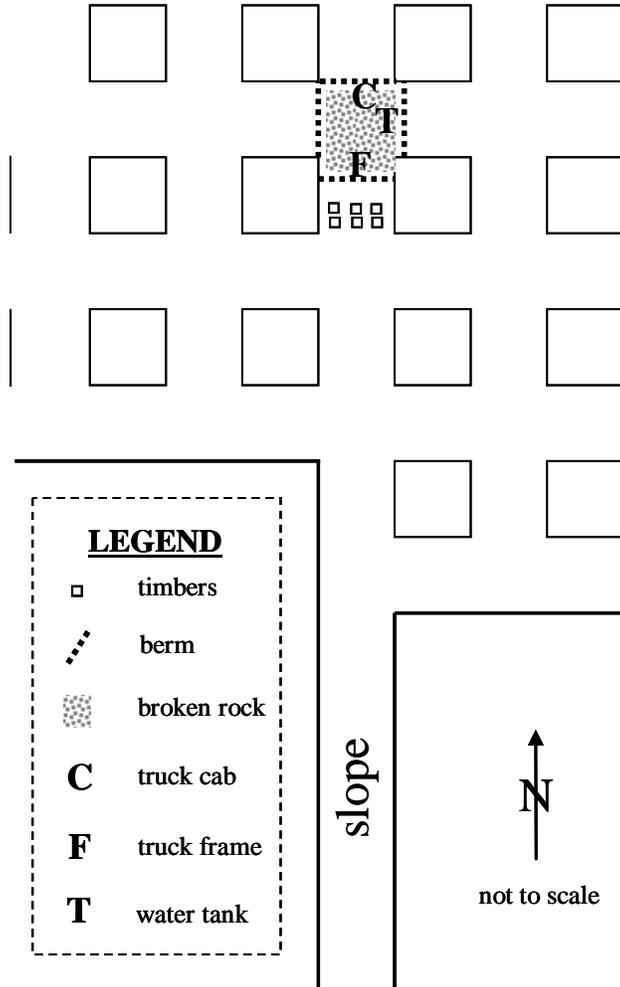
DIAGRAM OF THE SLOPE BOTTOM AND ACCIDENT SCENE

The accident occurred at the intersection of the 0 entry and the 2 north crosscut in the underground mine. The intersection was 116 feet north of the slope bottom and was about 40 feet long and 40 feet wide. Rock berms had been constructed 8-10 feet high at each entrance to the intersection to prevent exposure to loose ground in the intersection. Several dozen wooden timbers were stored just south of the intersection of the 0 entry and the 2 north crosscut. Each of the timbers was six inches square and four feet long.
