REPORT OF INVESTIGATION

**Underground Nonmetal Mine
(Potash)**

**Fatal Powered Haulage Accident
October 18, 2005**

**Intrepid Potash NM, LLC
Intrepid Potash East
Carlsbad, Lea County, New Mexico
Mine ID No. 29-00170**

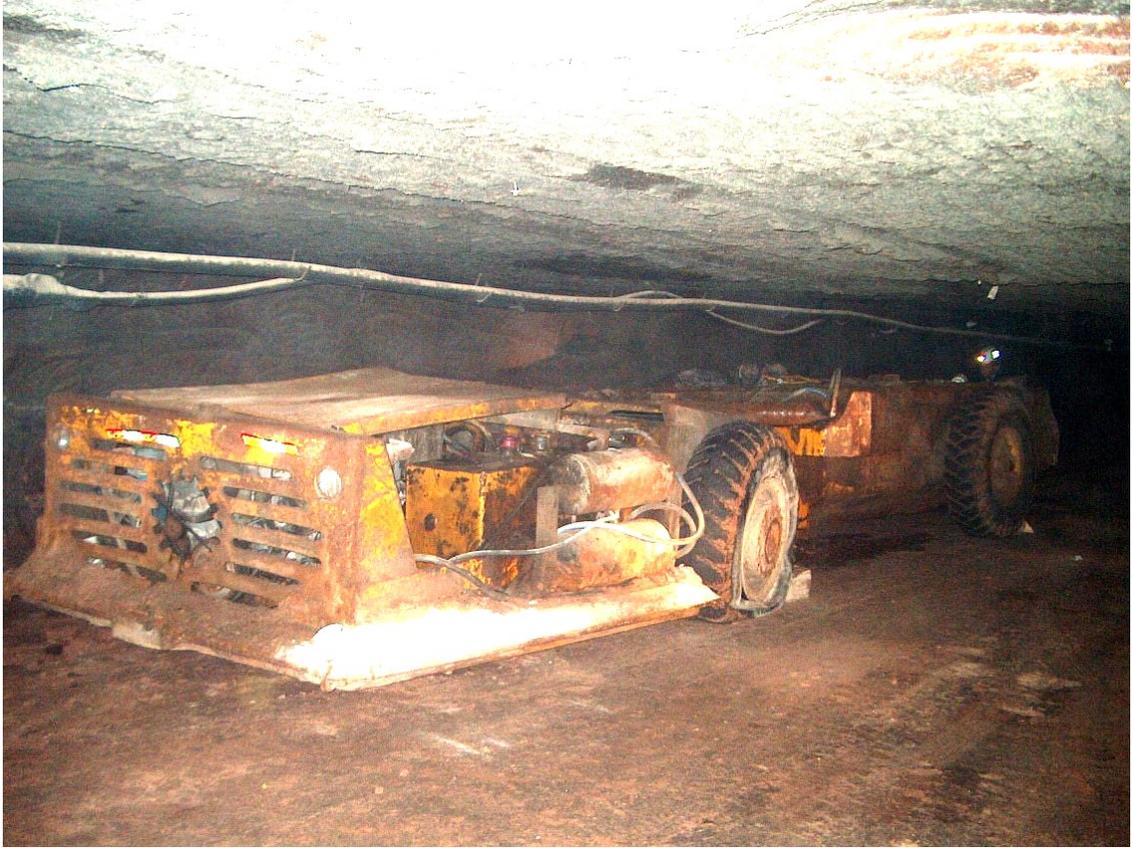
On October 18, 2005, Brian P. Marrs, utility worker, age 36, was fatally injured when a utility water truck rolled onto him. Marrs parked the truck on a grade and went to connect a pump cable. Apparently the truck began to drift and Marrs attempted to stop it but was pinned beneath one of the wheels.

The accident occurred because safe operating procedures were not followed. The utility water truck was left unattended on a grade. The parking brake was not set and the wheels were not chocked or turned into the rib.

Causal Factor: Administrative controls needed improvement. The victim left the water truck unattended and failed to set the parking brake. The truck was parked on a grade and the wheels were not chocked or turned into the rib.

Corrective Action: Procedures should be implemented to monitor mobile equipment parking procedures. The procedures should ensure that mobile equipment operators set the parking brake of unattended mobile equipment and, if parked on a grade, chock the wheels or turn them into the rib.
