Coal Mine Fatal Accident 2006-18

Operator:	Long Branch Energy
Mine:	#18 Tunnel Mine
Accident Date:	February 1, 2006
Classification:	Fall of Rib
Location:	Dist. 4, Boone County, West Virginia
Mine Type:	Underground Coal Mine
Employment:	61
Production:	1,027 Tons/Day

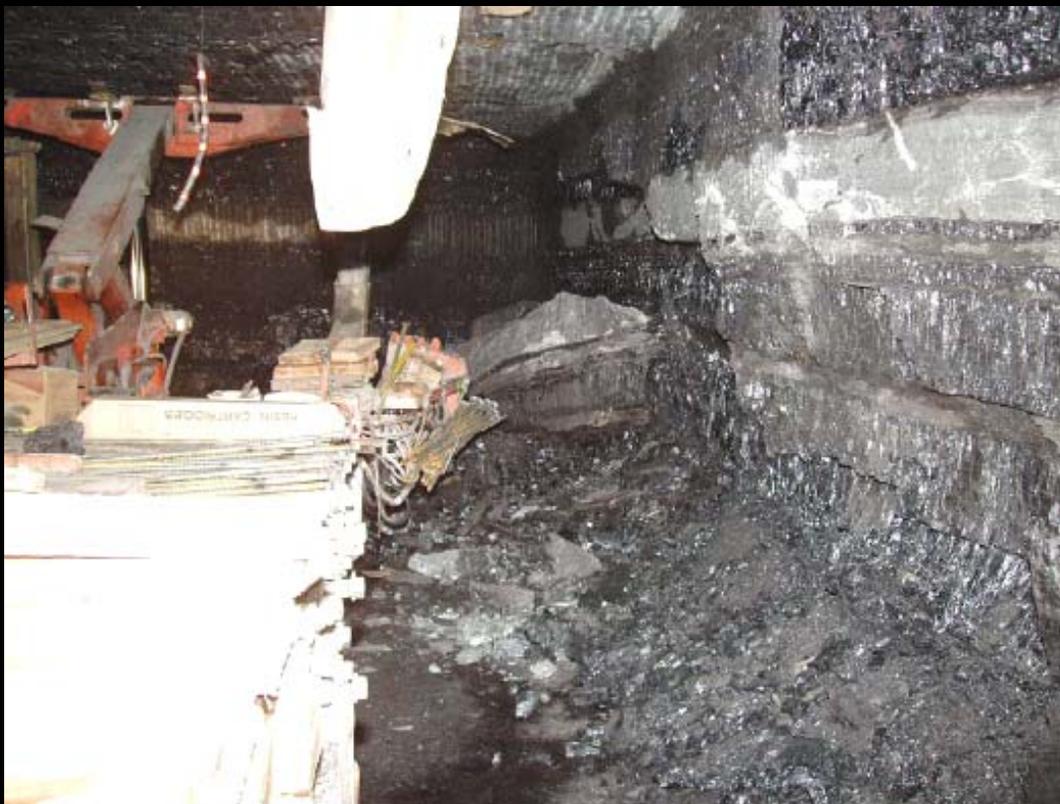
At approximately 12:40 p.m. on Wednesday, February 1, 2006, a 46-year old roof bolting machine operator was fatally injured from a rib roll which occurred in the number five entry of the 4 Left Mains section.

As the roof bolting machine operator was preparing to drill a hole in the mine roof to install permanent roof support, a large portion of the right rib fell, pinning the victim. The rib material which fell from the right rib of the number five entry measured: 13 feet long, 7 to 16 inches thick and 40 inches tall. The material fell from the rib from a height of approximately seven feet. When the rib material began to fall, the victim was positioned approximately 30 inches from the coal rib.
