Coal Mine Fatal Accident 2006-23

Operator:	Jacob Mining Company LLC
Mine:	No. 1 Mine
Accident Date:	April 7, 2006
Classification:	Powered Haulage
Location:	Dist. 4, Mingo County, West Virginia
Mine Type:	Underground Coal Mine
Employment:	45
Production:	3,500 Tons/Day

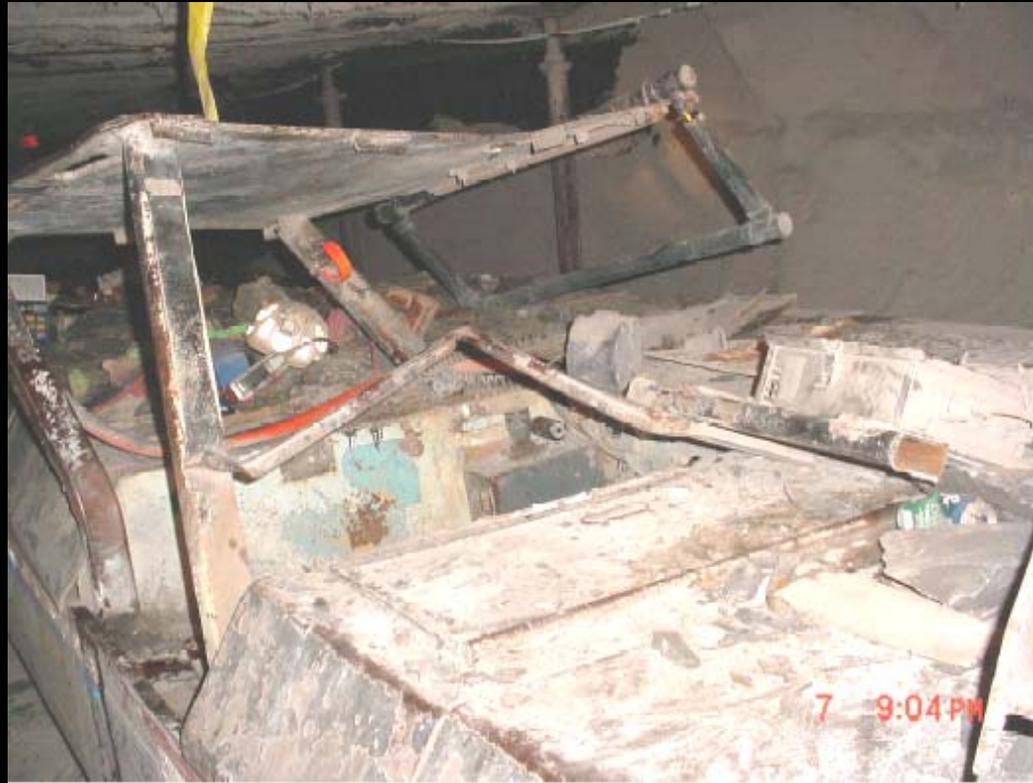
At approximately 2:15 p.m. on Friday, April 7, 2006, a 48-year-old superintendent, was fatally injured in a powered haulage accident. The accident occurred as the victim was operating a 14-ton locomotive between the Toms Branch Switch and the North Marrowbone Creek Portal. As the locomotive traveled along the mine track, the victim was struck by a 4-inch thick steel crossbar (I-beam) when it entered the operator's cab. The steel I-beam crossbar, intended as roof support, was dislodged and hanging from the mine roof.
