Coal Mine Fatal Accident 2006-38

Operator:	Consolidation Coal Company
Mine:	Buchanan Mine #1
Contractor:	Nichols Construction LLC (PZF)
Accident Date:	May 4, 2006
Classification:	Electrical
Location:	Dist. 5, Buchanan County, Virginia
Mine Type:	Underground Coal Mine
Employment:	503
Production:	18,000 Tons/Day

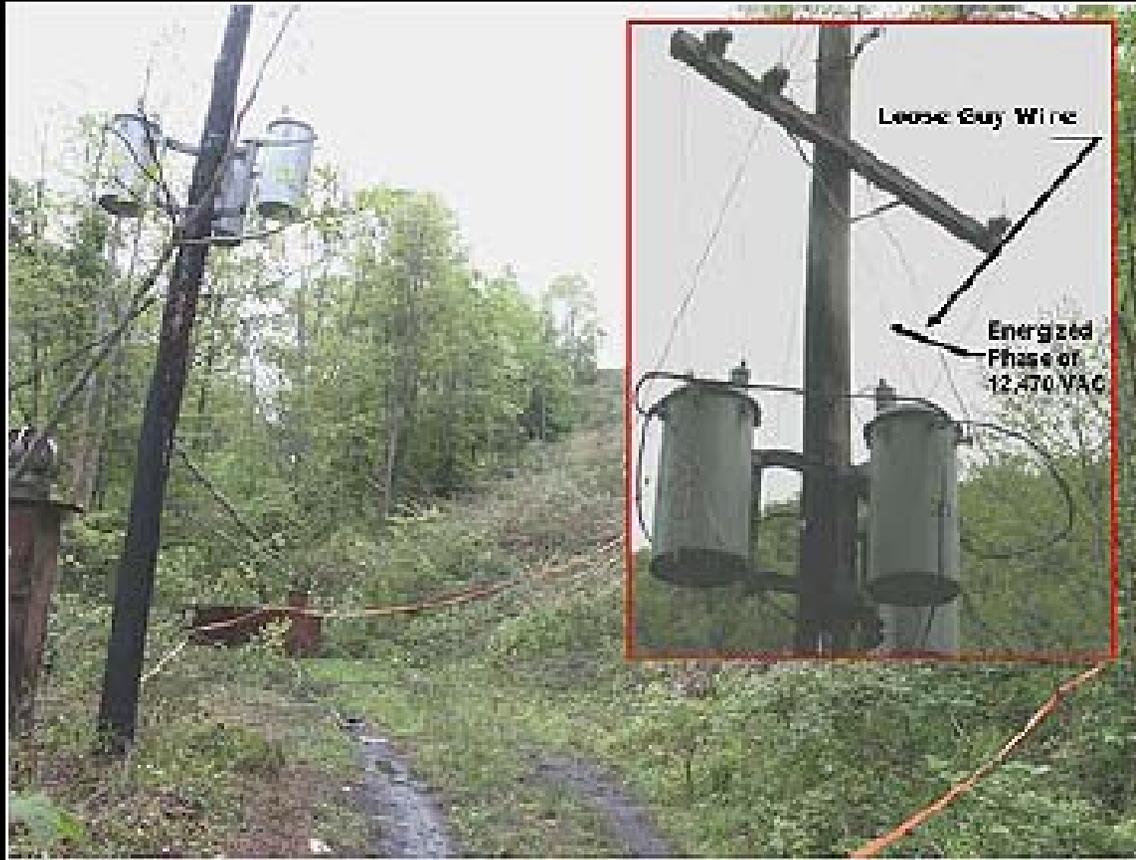
On Thursday, May 4, 2006, at approximately 1:00 p.m., a 40 year old Tree Trimmer/Equipment Operator with two and one-half years mining experience, was electrocuted while trimming brush along a power line that feeds power to a 480 volt bank of transformers. The victim came in contact with a guy wire that had become energized when the base of the guy wire came loose from the log it was wrapped around and the guy wire contacted one or more phases of 12,470 volts.

Root Cause: Management failed to ensure that the guy wire was securely anchored and provided with insulators or connected to the system ground. An adequate procedure or practice was not in place to ensure that electrical equipment, components and structures were properly installed and maintained.

"A power pole, supporting high-voltage transmission lines, located at the pump site supplying water for the Buchanan preparation plant on the Permac Property was supported by guy wires that did not have insulators installed near the pole end. The guy wires were not connected to the system ground."

“The monthly examination of the entire electrical installation including the starter/contacter box for the well pump at the Permac site of the Buchanan Preparation Plant was inadequate. The power pole supporting the bank of transformers for the electrical controls to the well pump was not maintained to assure safe operating conditions, in that, the guy wire was not grounded or insulated and was not adequately anchored.”

Corrective Action: The guy wire at the accident scene was removed. The company has undertaken an inspection of all power lines and supporting infrastructure on mine property to ensure they are maintained in safe operating condition.
