Coal Mine Fatal Accident 2006-45

Operator:	Peabody Western Coal Company
Mine:	Kayenta Mine
Accident Date:	November 5, 2006
Classification:	Electrical
Location:	Dist. 9, Navajo County, Arizona
Mine Type:	Surface Coal Mine
Employment:	454
Production:	22,000 Tons/Day

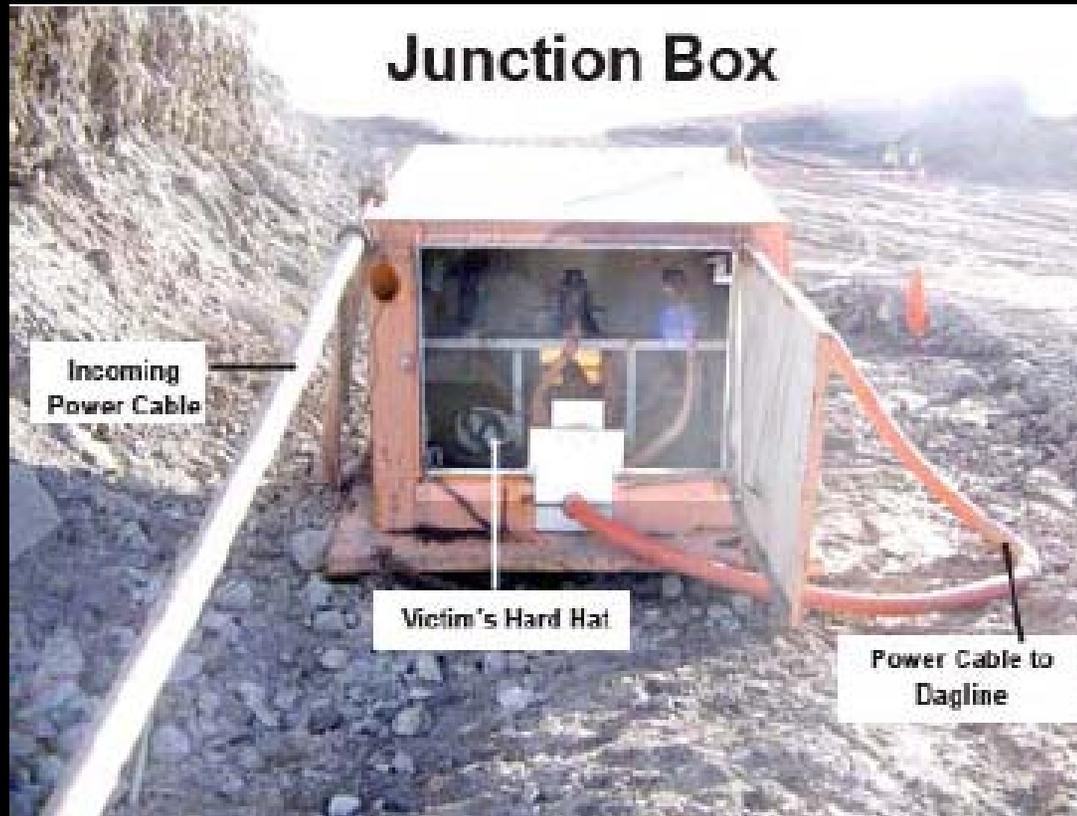
On Sunday, November 5, 2006, at approximately 8:30 p.m. a 52-year old electrician, was fatally injured when he contacted energized phases of a 23,000 volt high voltage circuit for a dragline. He contacted the energized phases in a junction box. He was troubleshooting the dragline trailing cable at the time of the accident.

While he was working on the cable, the dragline crew started the auxiliary diesel generator, located on-board the dragline, and closed (turned on or energized) the auxiliary power circuit breaker. Closing the auxiliary circuit breaker caused electrical power to travel from the dragline, through the trailing cable to the junction box; a direction opposite to the normal direction of power (back feeding). The victim lacked knowledge on the operation of the auxiliary power supply and did not lock and tag out or isolate the on-board auxiliary power supply from the main trailing cable.

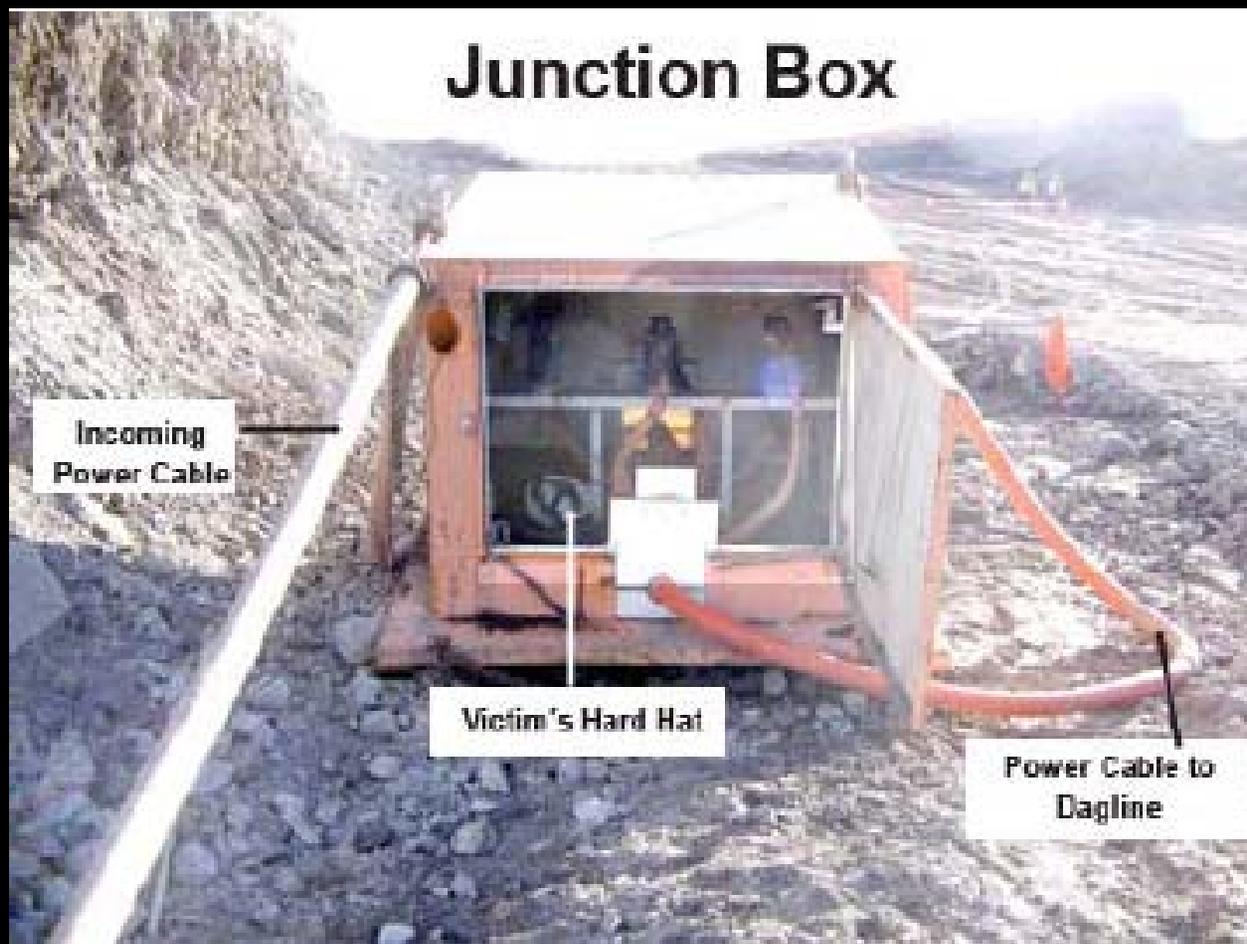
Furthermore, an improperly designed mechanical interlock device allowed both the main and auxiliary circuit breakers to be closed at the same time. Also, the phase conductors were not grounded to the system ground. The victim had only disconnected and locked the visual disconnect for the normal power supply that feeds the dragline. The absence of a safety transfer switch, as shown on the dragline wiring diagram in the 480-volt auxiliary power supply circuit, contributed to the cause of the accident.
