MNM Fatal 2006-07

- Fall of Highwall
- April 21, 2006 (Indiana)
- Dimension Limestone Operation
- Driller/Breaker
- 35 years old
- 48 weeks mining experience

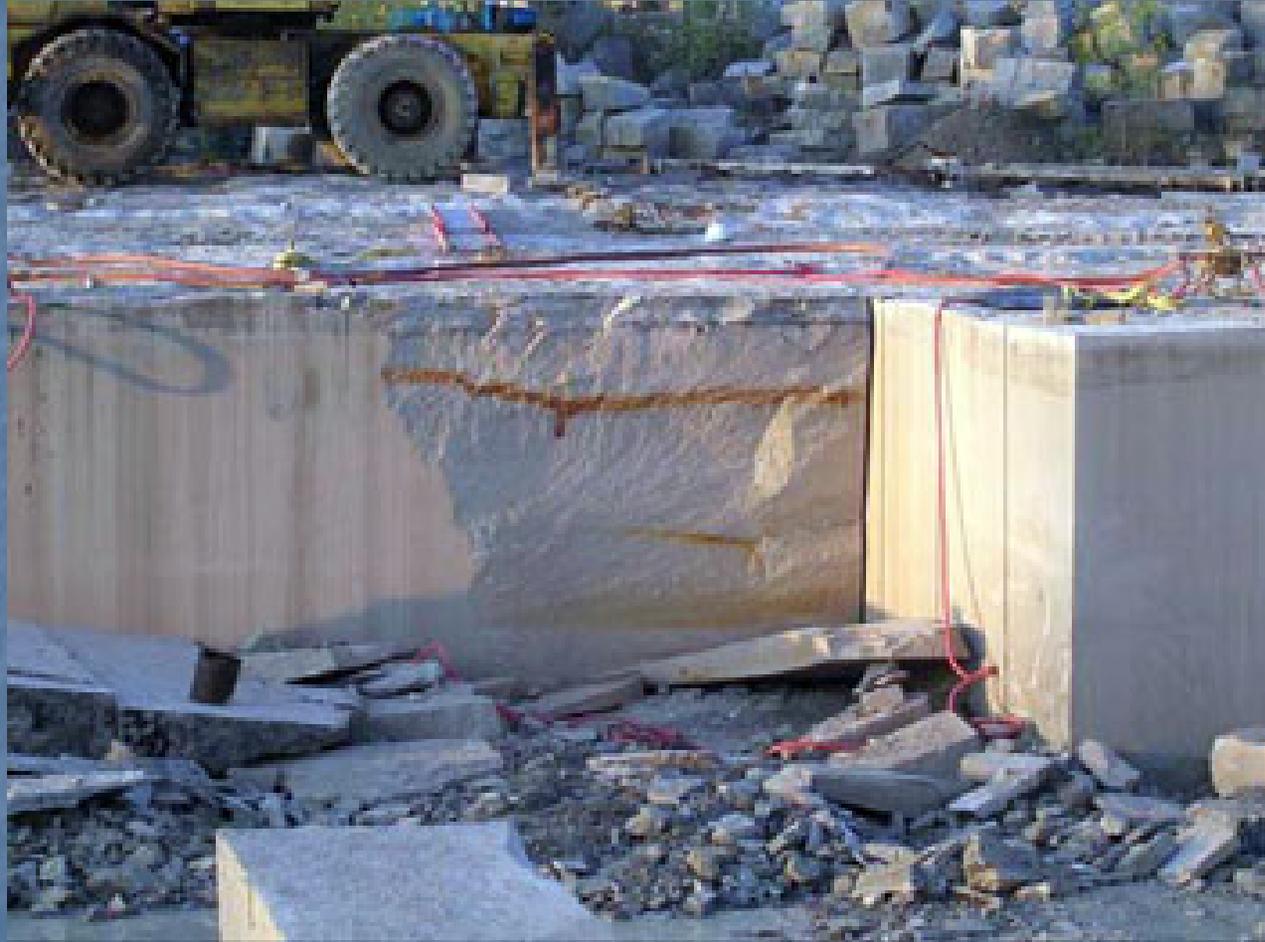
The victim and a co-worker were drilling an uneven area of the quarry floor at the base of a limestone block that had been cut from the bench. Subsequent movement of the limestone block caused a cracked section to fracture and fall on top of both men. The victim was fatally injured and the co-worker was seriously injured when they were crushed under the limestone slab.

- Management policies and controls were inadequate. Procedures were not in place to require that hazardous ground conditions be taken down or supported before work or travel commenced.
- Management failed to formalize policies and procedures that would require thorough examinations of air control valves to identify defects. The defective air control valve was not removed from service.

- Always conduct examinations of highwalls to identify loose ground or unstable conditions before work begins and as changing ground conditions warrant.
- Ensure that the person conducting the examination has the training and experience to recognize potential hazards.
- Prohibit work or travel in areas where hazards from unstable ground have not been corrected.
- Discuss work procedures and identify all hazards associated with the work to be performed along with the methods to protect personnel. Stop, Look, Analyze, Manage (SLAM)
