REPORT OF INVESTIGATION

Surface Area of Underground Coal Mine

Powered Haulage Accident
January 23, 2006

Sassy Coal Co., Inc.
No. 4
Biggs, Pike County, Kentucky
ID No. 15-17964

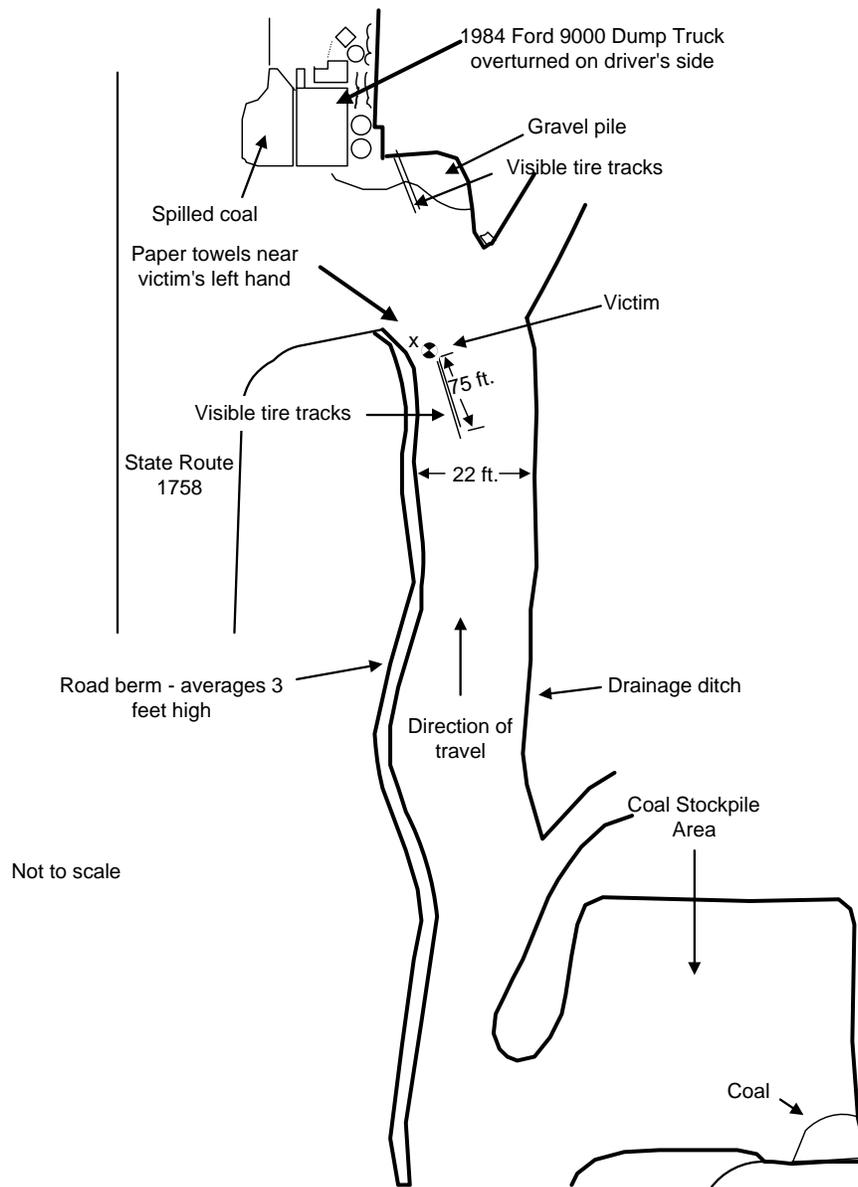
Sketch of Accident Site
 Fatal Haulage Accident
 TBK Haulage, Inc. (RCT)
 Sassy Coal Co., Inc.
 No. 4
 MSHA ID No. 15-17964
 January 23, 2006

The post-accident visual examination of the haul road revealed no evidence of extreme braking efforts (skid marks) nor evidence that the truck had been in a runaway mode (there was no indication of an attempt to steer the truck into the hillside or the road ditch). Tire tracks that varied from the normal path of travel were visible. The tracks gradually deviated toward the berm on the outside edge of the road starting at a point approximately 75 feet upgrade of the location of the victim. The truck continued traveling in this general direction until it crossed the mine haul road due to encountering a steep curve to the left then went over a gravel berm and into the creek channel.

The clearance between the deviating tire tracks and the road berm was 10 feet where the tracks first left the normal route of travel. As the truck continued downgrade, the clearance between the tire tracks and the berm gradually decreased and was measured to be four feet at the location of the victim.

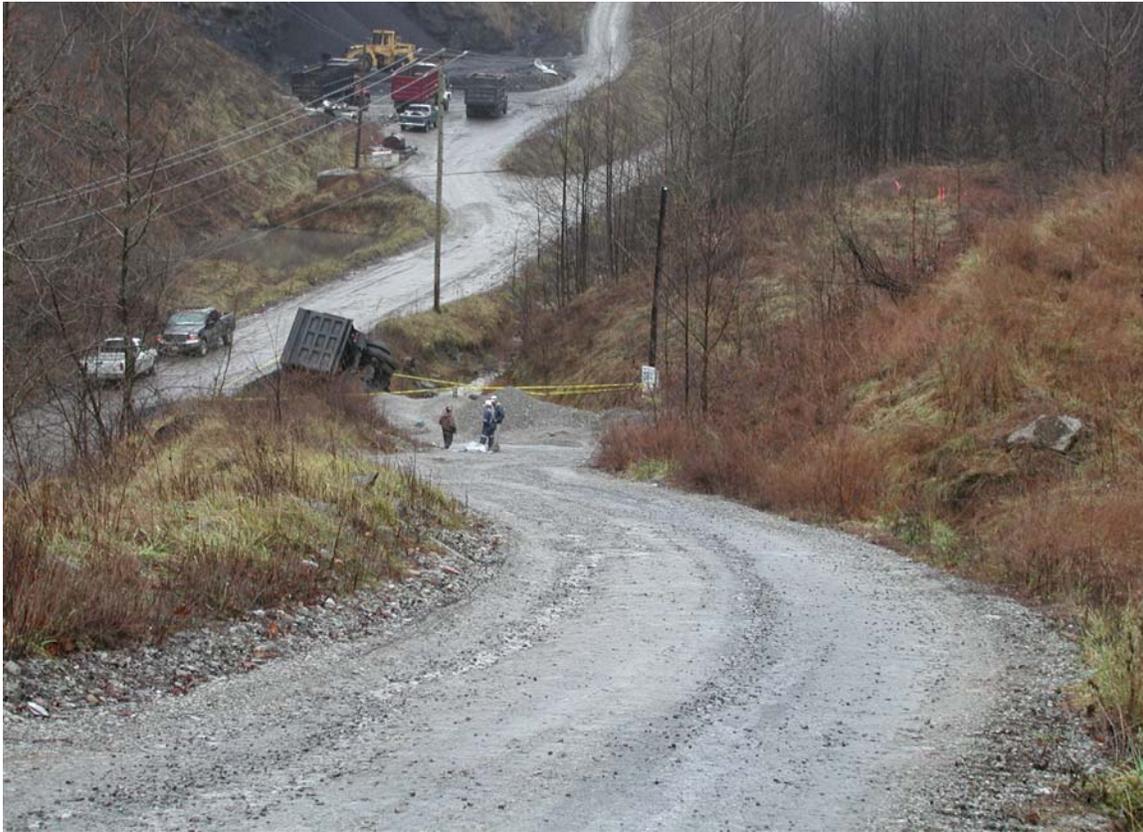
Photo of Accident Scene
Sassy Coal Co., Inc. Mine Haul Road
January 23, 2006

The post accident position of the truck was nose down in the creek channel and resting on the end of a five-foot steel culvert with the truck rolled over onto its left side. The right rear tandem drive wheels were in the air. Persons interviewed stated that the engine was running and the right drive wheels were turning.

Minimal damage occurred to the cab and body of the truck. There was no apparent damage to the interior of the cab. The coal which had been loaded into the truck bed had partially spilled after the truck had turned on its side. No coal spillage was observed except in the immediate area of the truck bed.

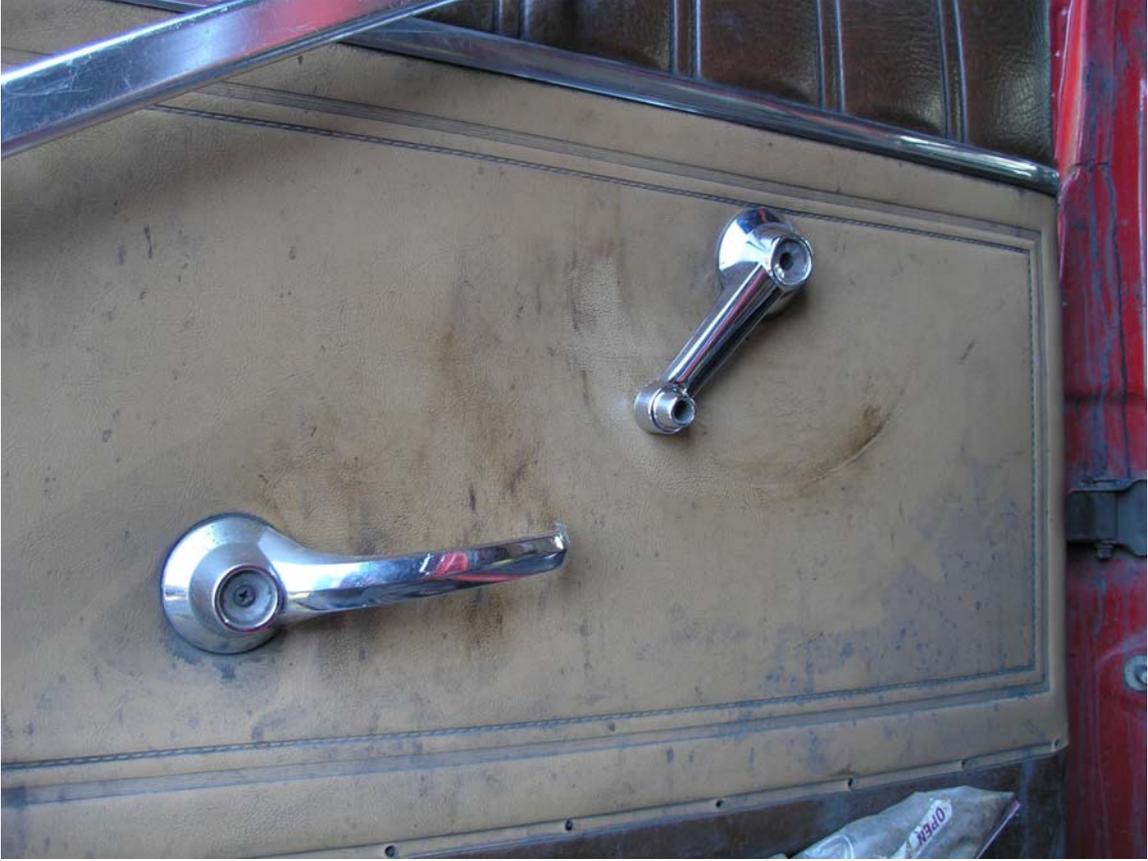
Deficiencies to the window crank handle were identified during the evaluation of the Ford LT 9000 truck. An upward lifting force was required to be applied to the window glass while turning the window crank handle in order to close the window.

The knob was missing from the window crank handle which required the crank to be grasped from the end. The clearance between the end of the window crank handle and the end of the door latch handle was measured to be two inches.

The door latch mechanism was operative and properly functioning to hold the door closed. The motion required to release the door latch was an upward lifting motion of the inside latch handle, while the motion to roll up the door window was a counter-clockwise motion. The two motions are converse to one another, but as noted, it was necessary to back off the window crank handle intermittently in a clockwise motion to achieve realignment of the crank mechanism. The effort required to release the door latch was significantly less for the driver's side door than for the passenger side door. The distance from the driver's side door to the outside rear view mirror was 15 inches.

3. The driver's side window crank mechanism was defective. In order to roll the window up, a shifting of weight toward the door by using the right hand to lift the window glass while cranking with the left hand was required. The knob for the window crank was missing which meant that the window crank handle would have to be grasped from the end which was located two inches from the door latch handle. Based on these facts, it appeared that the door latch was inadvertently tripped while the driver rolled up the window.

Condition or Practice: "The Ford LT 9000 truck was not being maintained in safe operating condition. The driver's side window crank did not operate properly and the window crank knob was missing."

Ford LT 9000 truck, Photo of center section of driver's side door, window crank and door latch handle

Corrective actions: The contractor has developed an accident prevention policy to require truck drivers to: “do a pre-shift examination of the equipment before moving the equipment on a daily basis. A record of the daily examination is to be kept in the end loader.”

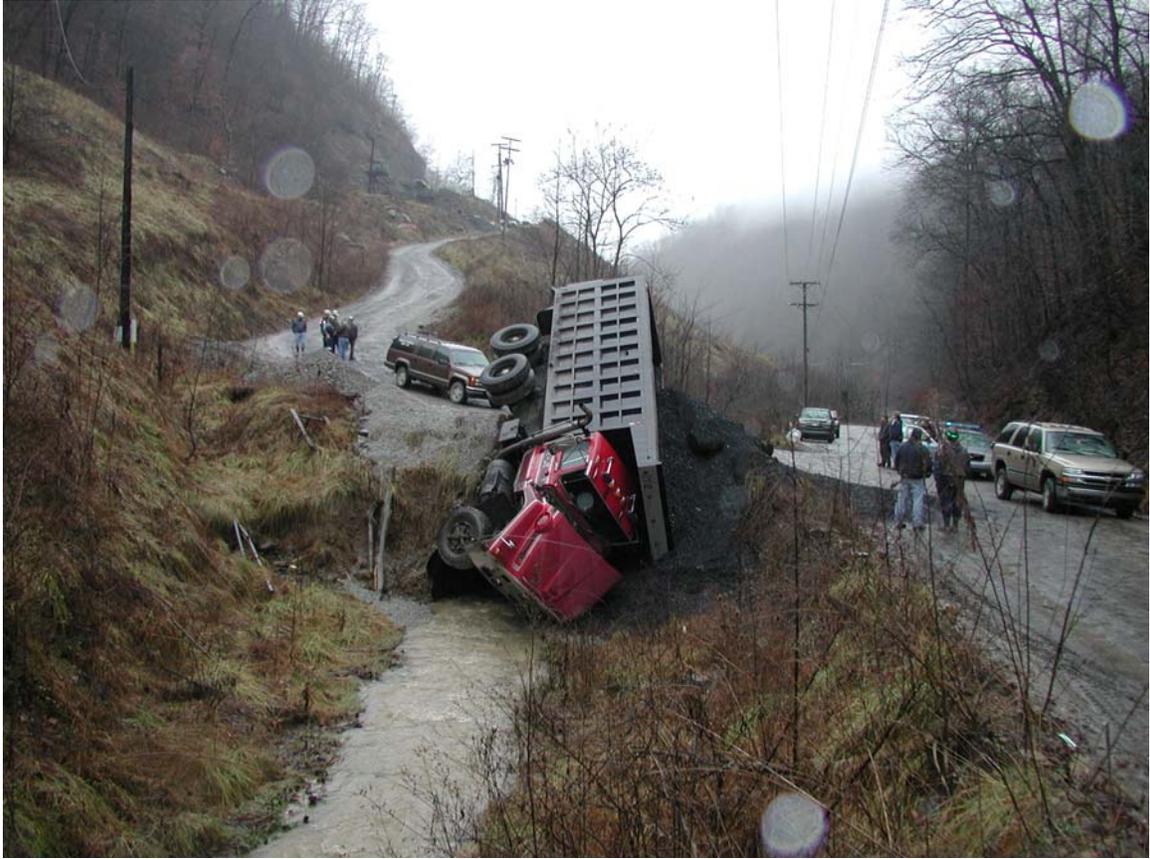
The mine haul road began at the stockpile area where the truck was loaded by the driver. The mine haul road extended downgrade for a distance of approximately 600 feet where it joined a graveled state road. The overall grade of the mine haul road was 14.1%, according to surveying information provided by Clintwood Elkhorn Mining Company, Inc. The haul road base was well compacted and the surface consisted of graded, limestone gravel. The berm on the outside edge of the road averaged three feet in height.

Photo of accident scene looking up the mine haul road
