REPORT OF INVESTIGATION

Fatal Electrical Accident
May 4, 2006

Nichols Construction LLC (PZF)
Vansant, VA
at
Buchanan Mine #1
Consolidation Coal Company
Mavisdale, Buchanan County, Virginia
I.D. No. 44-04856

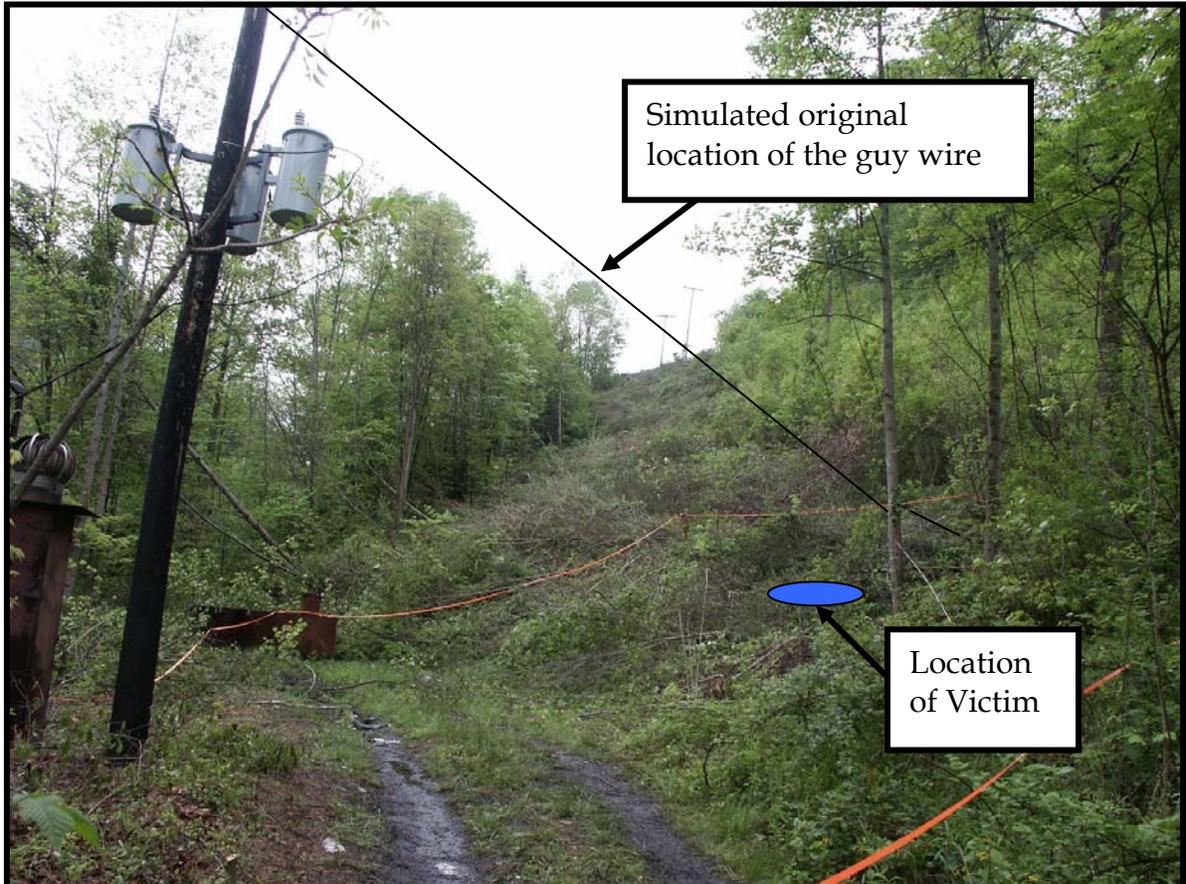
ACCIDENT SCENE

On Thursday, May 4, 2006, at approximately 1:00 p.m., Richard Allan Cox, a 40 year old Tree Trimmer/Equipment Operator with two and one-half years mining experience, was electrocuted while trimming brush along a power line that feeds power to a 480 volt bank of transformers. The victim came in contact with a guy wire that had become energized when the base of the guy wire came loose from the log it was wrapped around and the guy wire contacted one or more phases of 12,470 volts.

The accident occurred because the guy wire was not grounded or provided with an insulator below all lines and was not properly anchored. The operator failed to conduct required electrical examinations. Proper examinations would have detected the condition and prompted corrective action.

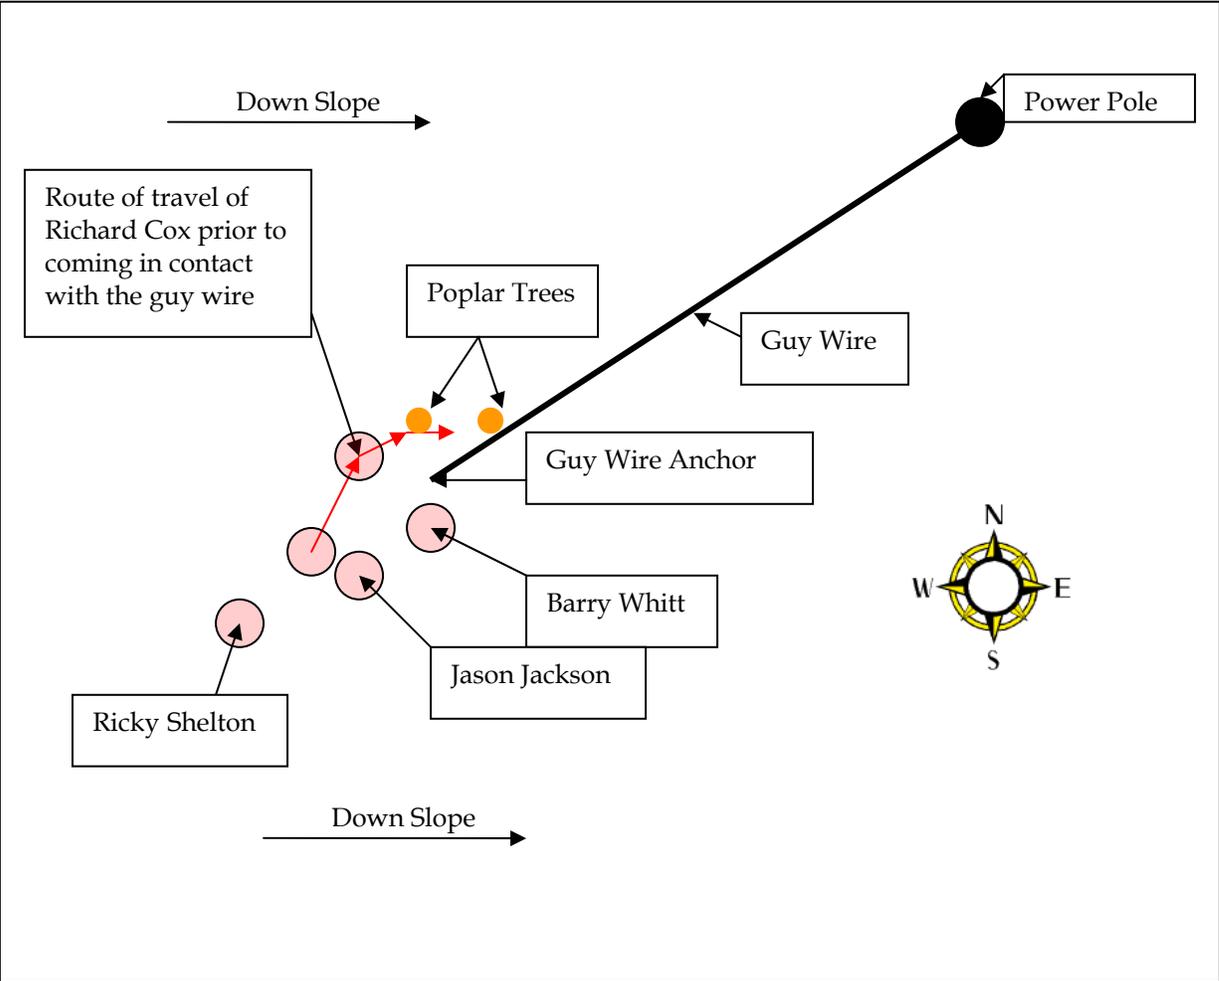
APPENDIX D - Sketch showing the location of the four men just prior to the accident.

Appendix D shows the location of the four men just prior to the accident.

The hillside where they were working was steep and slippery. Jackson and Whitt were operating chain saws while Shelton and Cox were removing the cut foliage. Whitt was cutting brush with a chain saw and was positioned south of the anchor point of the guy wire. A vine was entangled in the branches of some of the small trees that Whitt was attempting to cut and Jackson stopped cutting to provide assistance. Jackson was positioned up slope from Whitt and grasped the vine to hold it tight for Whitt to cut one of the small trees. At this time, Shelton was removing brush and was located up slope from Jackson. Cox was removing brush and was located up slope from Whitt.
