REPORT OF INVESTIGATION

Fatal Methane Explosion

October 23, 2006

R&D Coal Company, Inc. Mine
R&D Coal Company, Inc.
Lincoln, Schuylkill County, PA.
ID No. 36-02053

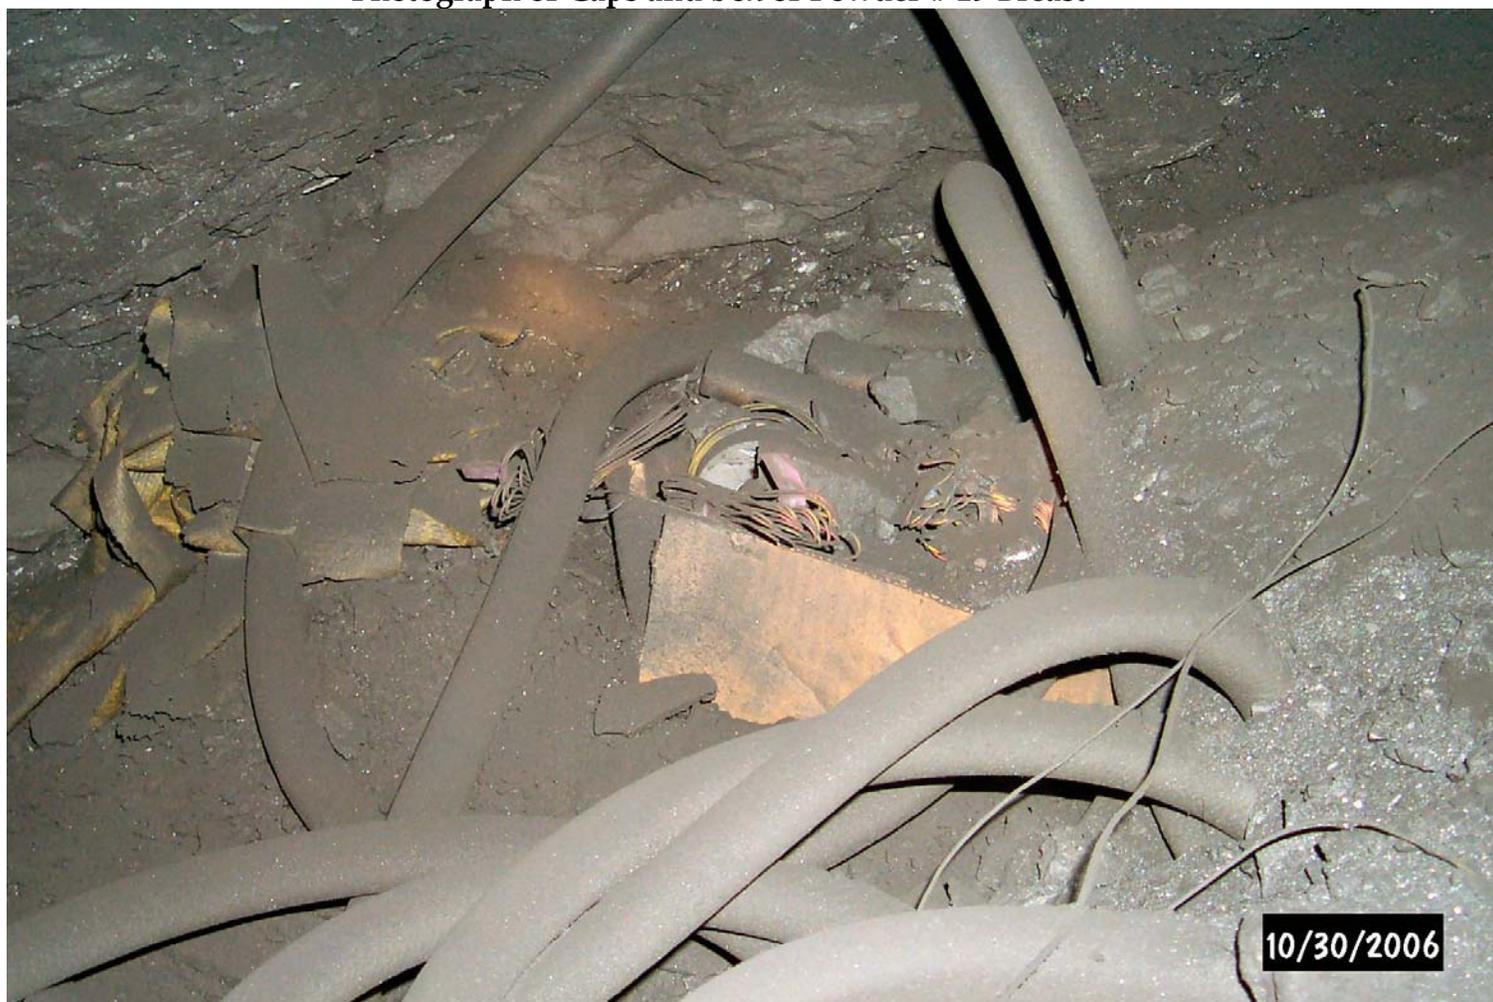
used per hole with Electric LP detonators. The explosives were manufactured by Orica USA Inc. No stemming (dummies) was used. The remainder of the powder and caps were stored together in an uncovered cardboard box in which the powder was originally shipped. The stored explosives were located approximately thirty feet from the face that was to be fired (Appendix C). Klinger asked Reightler if he should move the powder prior to the blast and Reightler said no.

Photograph of Caps and box of Powder # 19 Breast

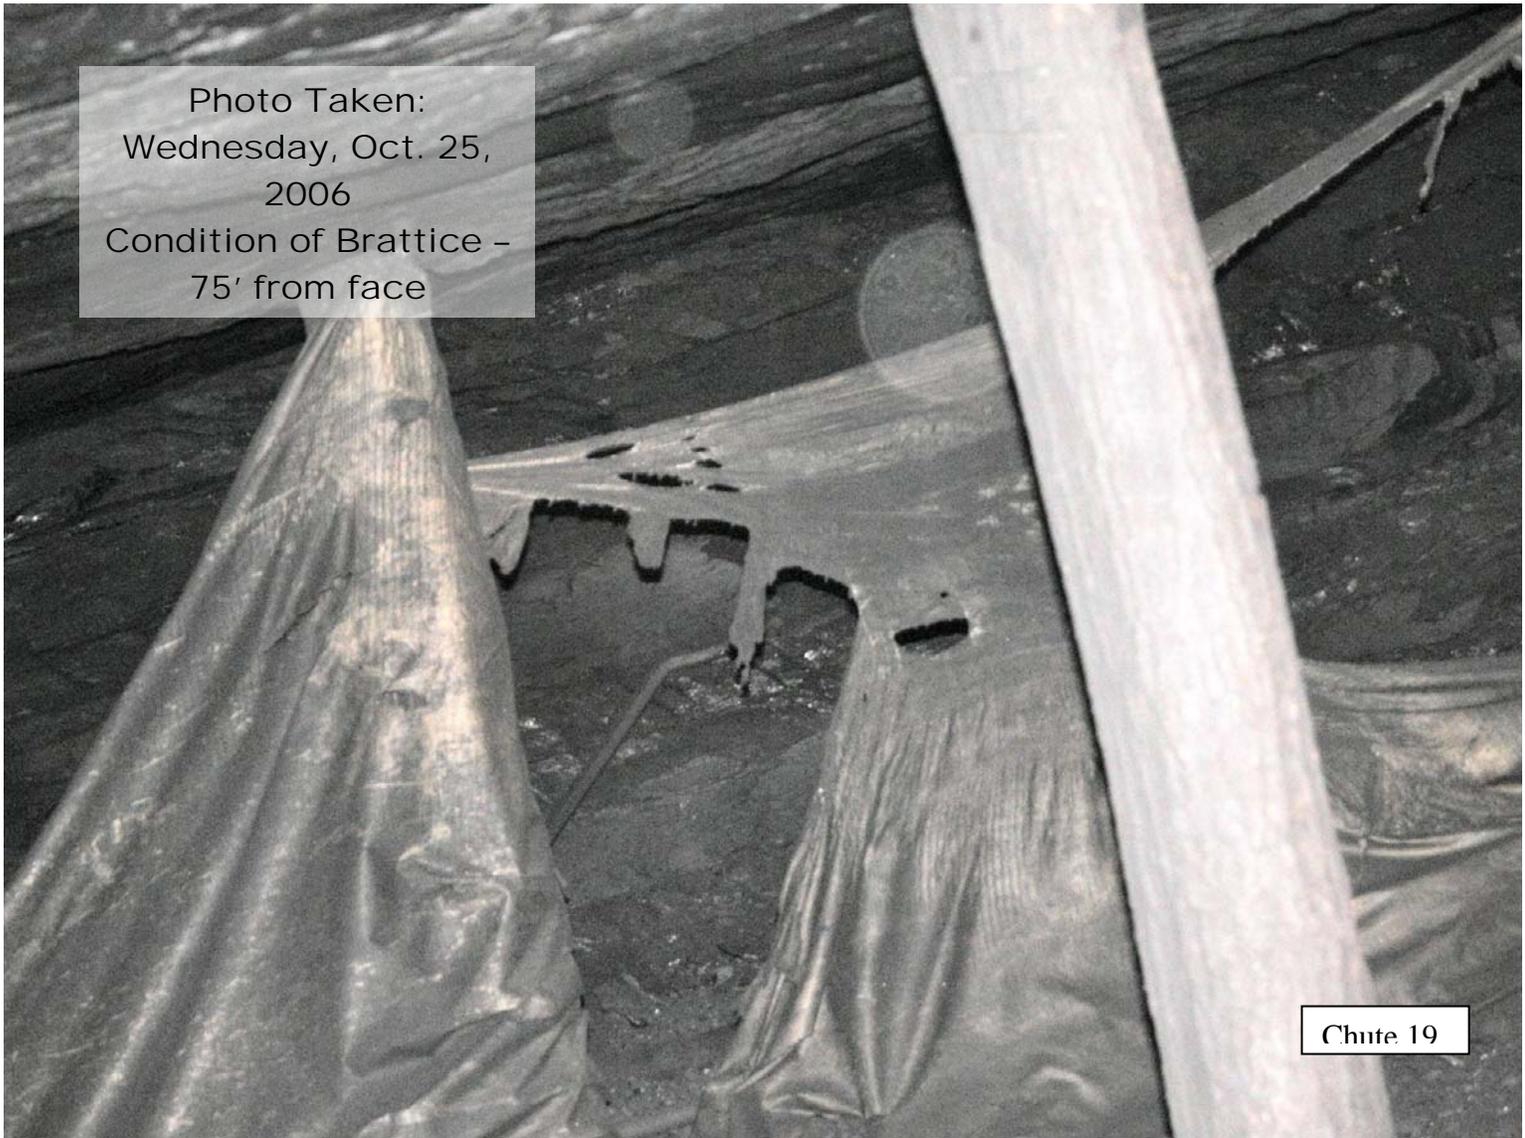
Chute 19

Based on results of interviews with miners and the mine operator, prior to the explosion, the face of the #19 breast was ventilated by line curtain (brattice) hung to within approximately ten feet of the face of the #19 breast. The brattice was hung close to the left rib, the setup providing exhausting face ventilation. An air fan with tubing attached was located approximately 300 feet from the face of the #19 breast to assist the mine ventilation. A bazooka, an auxiliary air mover powered by compressed air from the surface, was located approximately fifty feet from the face of the #19 breast. Tubing was attached to the bazooka to assist the ventilation to the face. The air line for the pneumatic equipment was also used to blow air to the face. During the accident investigation no evidence of any tubing was found in proximity to the air mover.

The face of the #19 breast was ventilated as follows. Line curtain (brattice) was hung to within approximately ten feet of the face of the #19 breast. The brattice was hung close to the left rib, the setup providing an exhaust ventilation situation. An air fan was located approximately 300 feet from the face of the #19 breast closer to the left side. This located the air fan inby the last open crosscut (fifth miner heading). A bazooka was located approximately fifty feet from the face of the #19 breast, closer to the right side. Twelve inch tubing is attached to the bazooka and extends to within approximately twenty feet of the face. The air line for the pneumatic equipment was also used to blow air to the face.

Photo Taken:
Wednesday, Oct. 25,
2006
Condition of Brattice -
75' from face

Corrective Action: The operator should submit a fully revised ventilation plan, containing provisions that guarantee air quantities that will dilute, render harmless and carry away flammable, explosive, noxious and harmful gases. In addition, personnel should be retrained in the requirements and use of gas detectors.
